Safe and Effective Exterior Insulation Retrofits: Phase II

by Colin Craven and Robbin Garber-Slaght
January 15, 2012

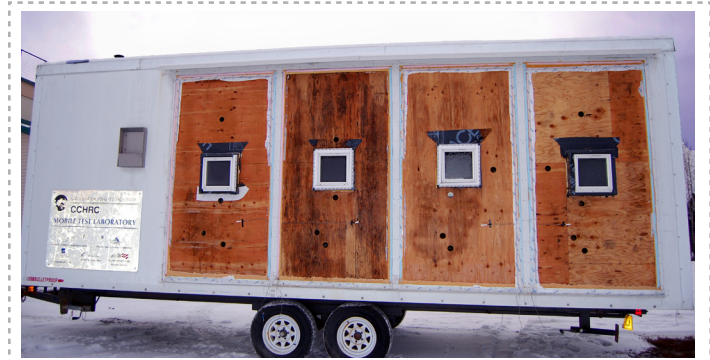
Exterior of the Mobile Test Lab at the end of the 2-year study, with the siding and insulation removed.

In the summer of 2011, the MTL test walls were disassembled and inspected. Some of the test walls had varying degrees of mold and water damage on the wood components. Note that rot would take longer to develop, so the observations summarized here are limited to measured data and visible mold. CCHRC found that the monitoring and inspection results can be largely explained based on the presence or absence of an interior vapor retarder and the distribution of interior-to-exterior insulation.

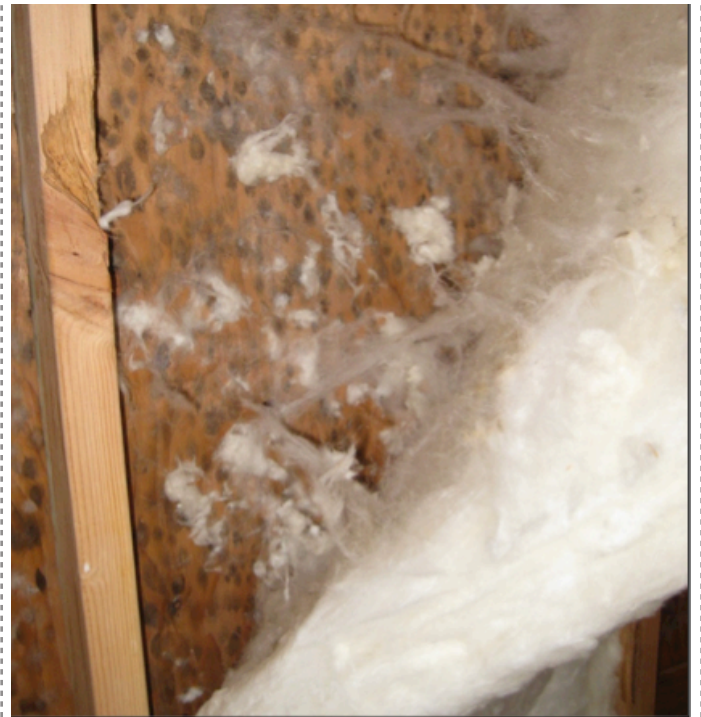
In contrast, the test wall with thin exterior insulation (the red line) remained below the dew point for almost all of the first winter and most of the second winter. Correspondingly, this test wall had abundant mold after the two-year experiment. The test wall with no exterior insulation (the blue line) had the coldest sheathing. In fact, sheathing on this test wall was below freezing for almost the entire winter. Interestingly, this test wall had only small areas of visible mold, so colder sheathing and dew point analysis alone is not sufficient to explain our observations. One explanation is that the continuous subfreezing temperatures inhibited the ability of mold to grow. Also, the

Figure 2. Mold on the sheathing behind the fiberglass on a wall with thin exterior insulation.

plywood sheathing without exterior foam provided an effective path for condensation to later evaporate to the outside air. The combination of these factors allowed for this test wall to escape with only minor amounts of mold.

Based on the MTL experiments and WUFI® simulations, retrofitting walls with foam insulation is safest when 65% or more of the total wall R-value is exterior to the sheathing. However, the “double vapor barrier” effect only seems to be a concern for wall systems with approximately 30% or less of their R-value exterior to the sheathing coupled with relatively high interior humidity. While only one of the test walls fit that description, it is common for residential retrofits to have less than 30% of the wall’s R-value exterior to the sheathing. In such cases, the

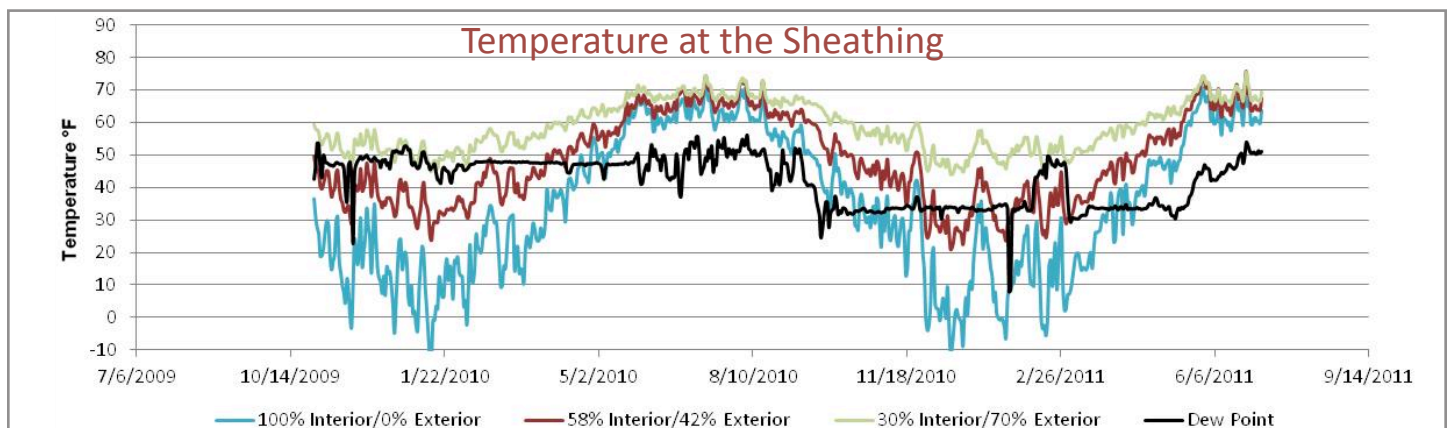
Insufficient exterior insulation means that the sheathing can become colder than the dew point in winter, allowing water vapor to condense on the inside sheathing surface (see sidebar, Dew Point and Humidity). If this occurs frequently, it can lead to mold growth and eventually rot. Ideally, the wall will have sufficient exterior insulation so that the sheathing remains above the dew point. This is illustrated by the green line in Figure 3, where the test wall with the most exterior insulation remained above the dew point for almost the entire test period. Correspondingly, this test wall was free of visible mold after the two-year experiment.

Figure 3. Temperatures at the sheathing plane. The test wall with the most exterior insulation stayed above the dew point for both winters, successfully avoiding condensation on the sheathing.

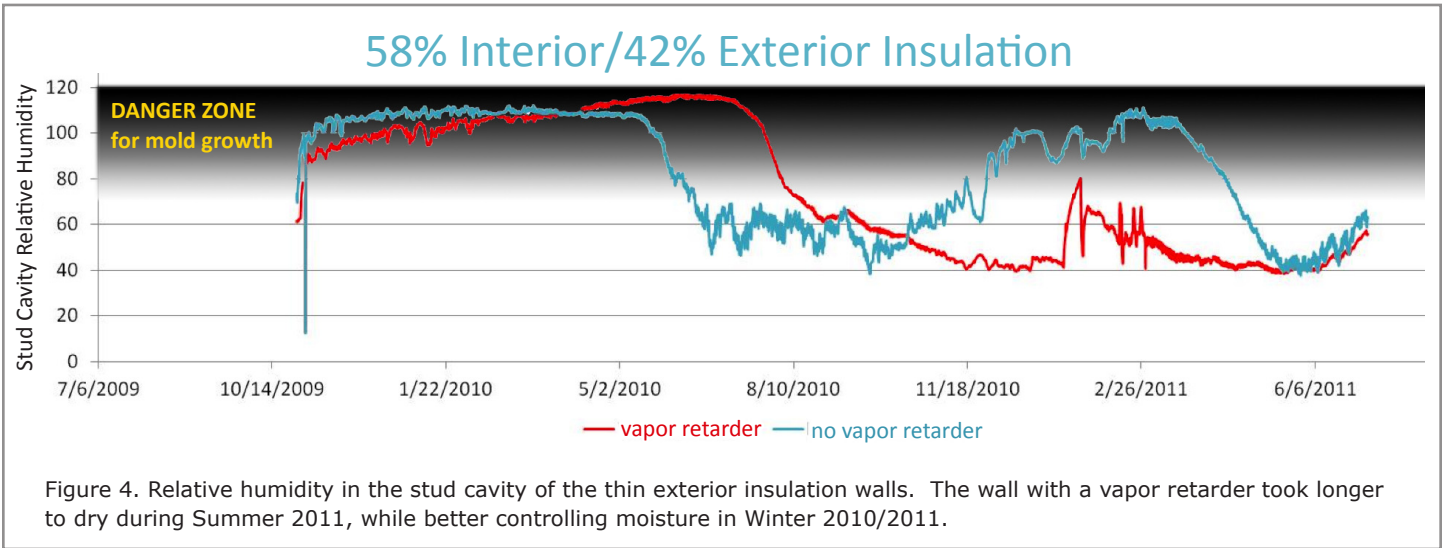
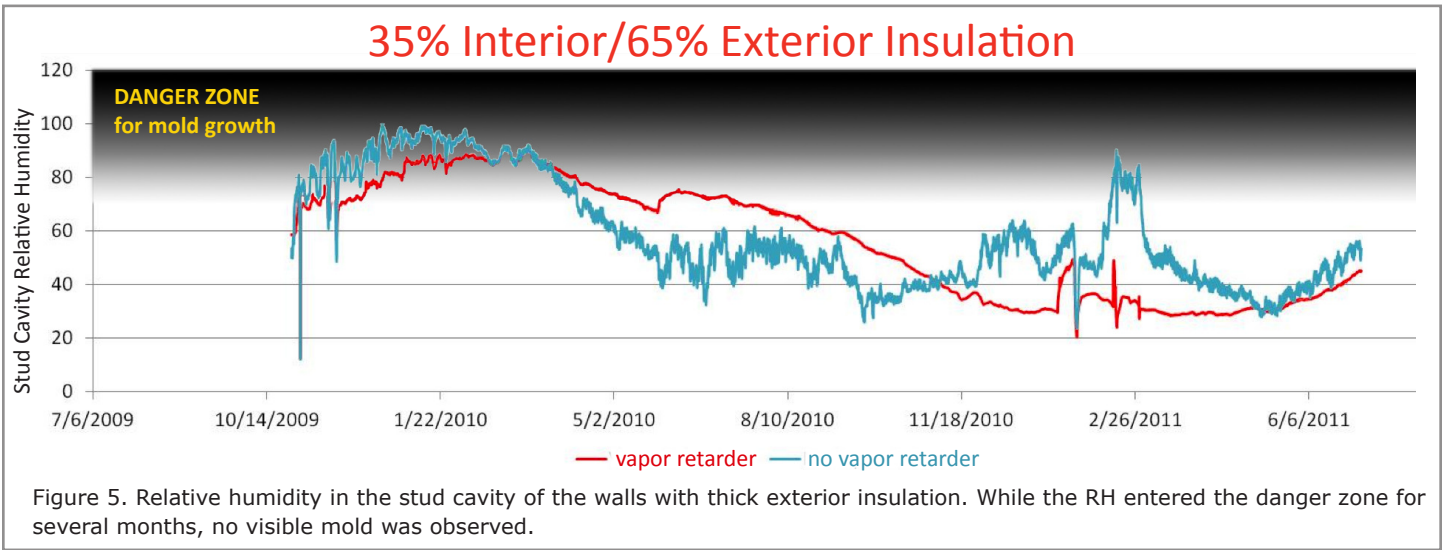
100% relative humidity in terms of potential for mold growth. The higher the humidity, the less time it takes for visible mold growth to become established (Viitanen, 1994). The walls with thin exterior insulation were essentially at 100% humidity all of the first winter, with or without a vapor barrier (Figure 4). In contrast, the walls with thick exterior insulation were able to stay under 100% relative humidity (Figure 5). The test wall with 65% exterior insulation and a vapor retarder was even able to remain under 90% relative humidity. Notable for both graphs is that the test walls with a vapor retarder took longer to dry during the summer than the test walls without a vapor retarder. This matches expectations, as walls without vapor retarders can dry more easily to the inside. However, this drying capability did not spare the test walls without vapor retarders from abundant mold growth on the sheathing.

During the second winter when humidity and pressure within the MTL were more representative of typical home conditions (25% RH and neutral pressure), the contribution of an interior vapor retarder was more apparent. Humidity was consistently higher for the test walls without vapor retarders. The test walls with a vapor retarder stayed safely under 80% relative humidity at the sheathing, as long as 42% or more of the wall R-value was exterior to the sheathing. The test wall with 30% exterior insulation had high humidity at the sheathing plane (data not shown), and demonstrated the most widespread mold growth of all the test walls with a vapor retarder.
