Straw Bale Building In Alaska

A CCHRC Presentation

FOUR NON LOAD BEARING HOMES AND A
LOAD BEARING GARAGE IN THE
FAIRBANKS AREA

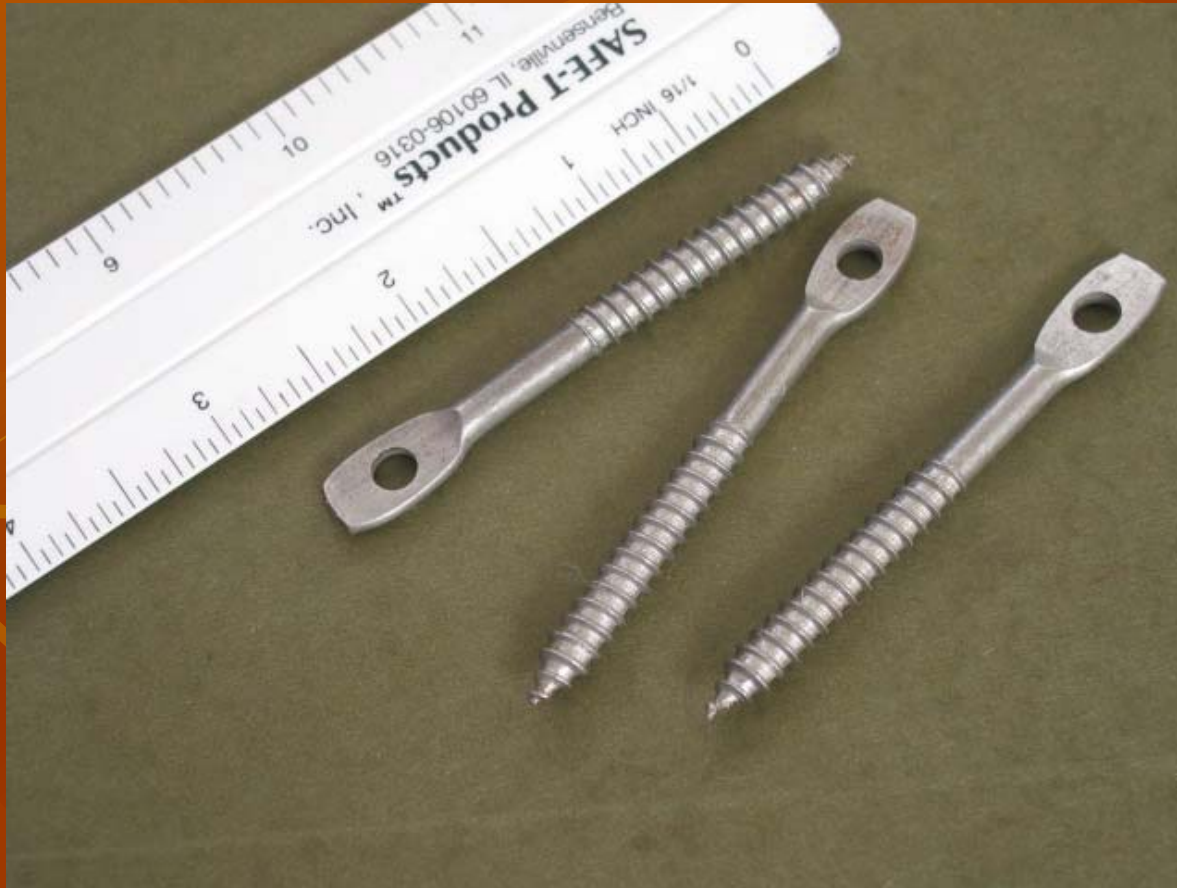
Acoustic ceiling screws are screwed into the outside paneling & into the studs on 2' centers at the top of every other row of bales. Two wires are looped through the eye and back about 10" past the edge of the bale. These are used to hold the bales tightly to the wall and to also hold the vertical 2" X 4" framing studs which in turn are used to hold the siding.

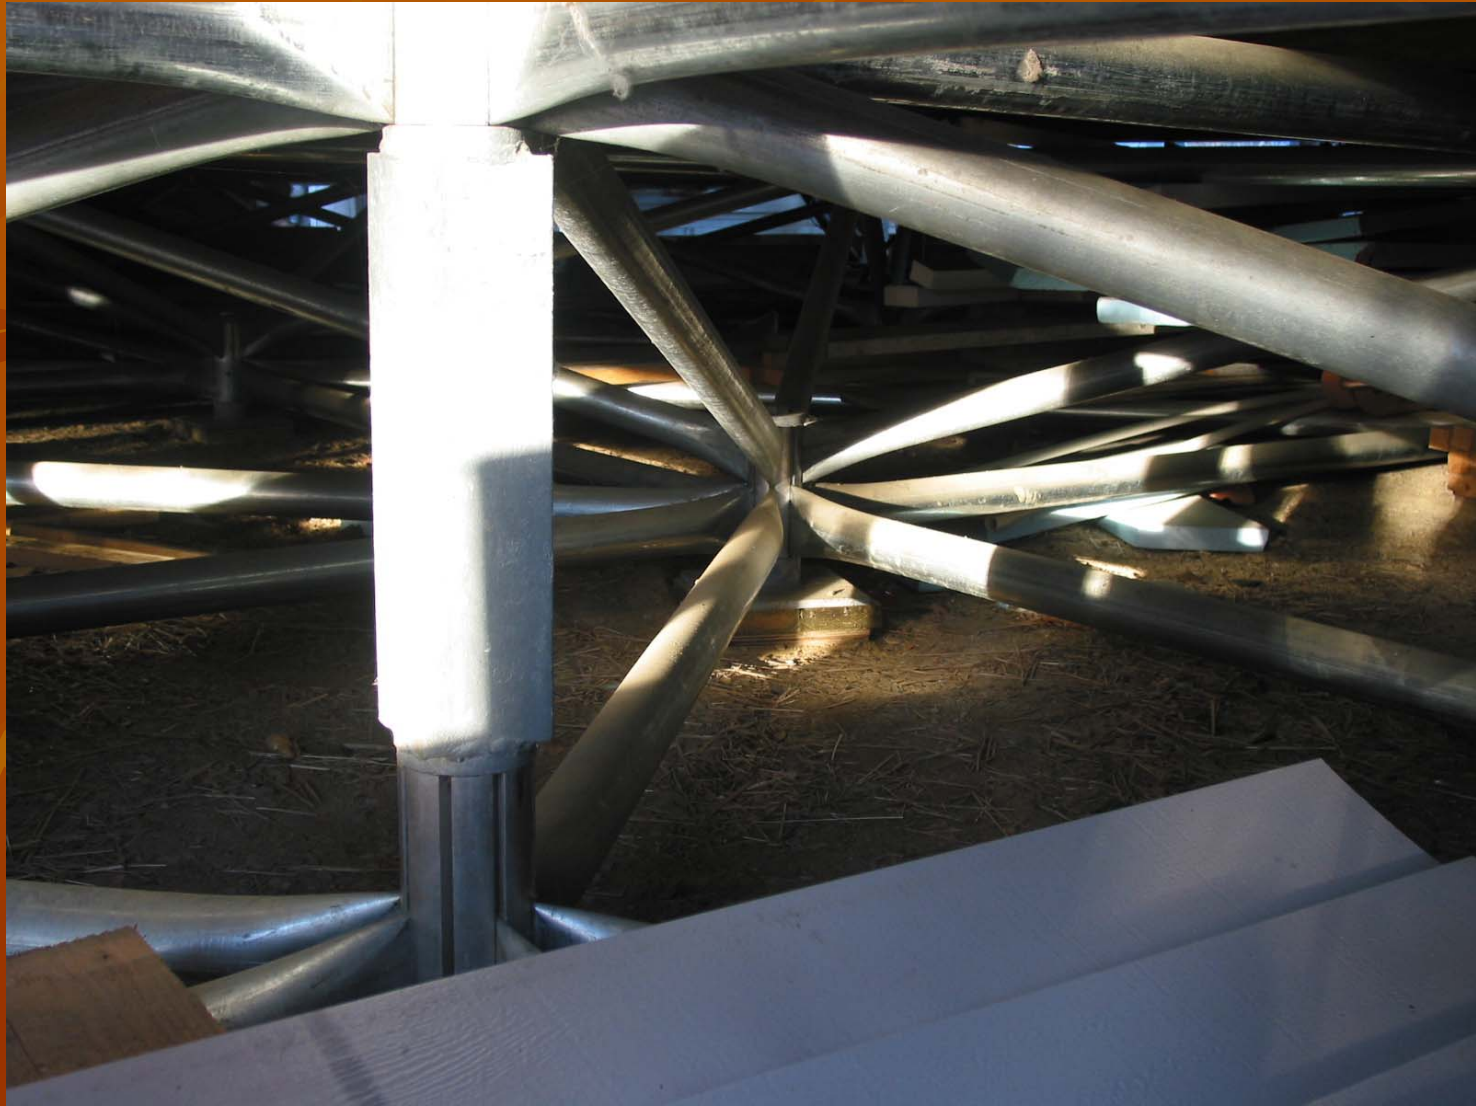
A Triodetic Multi Point Space Frame as a foundation.

- This home is built over permafrost and is supported on a Triodetic Multi Point Foundation frame work which allows it to be leveled or moved when necessary. The straw is stacked on an 18” ledge on the outside of a 2” X 4” framed home. It also has a vapor barrier covering the Oriented Strand Board (OSB) on the outside of the wall. The bales & siding are held in place using acoustic screws & wire.

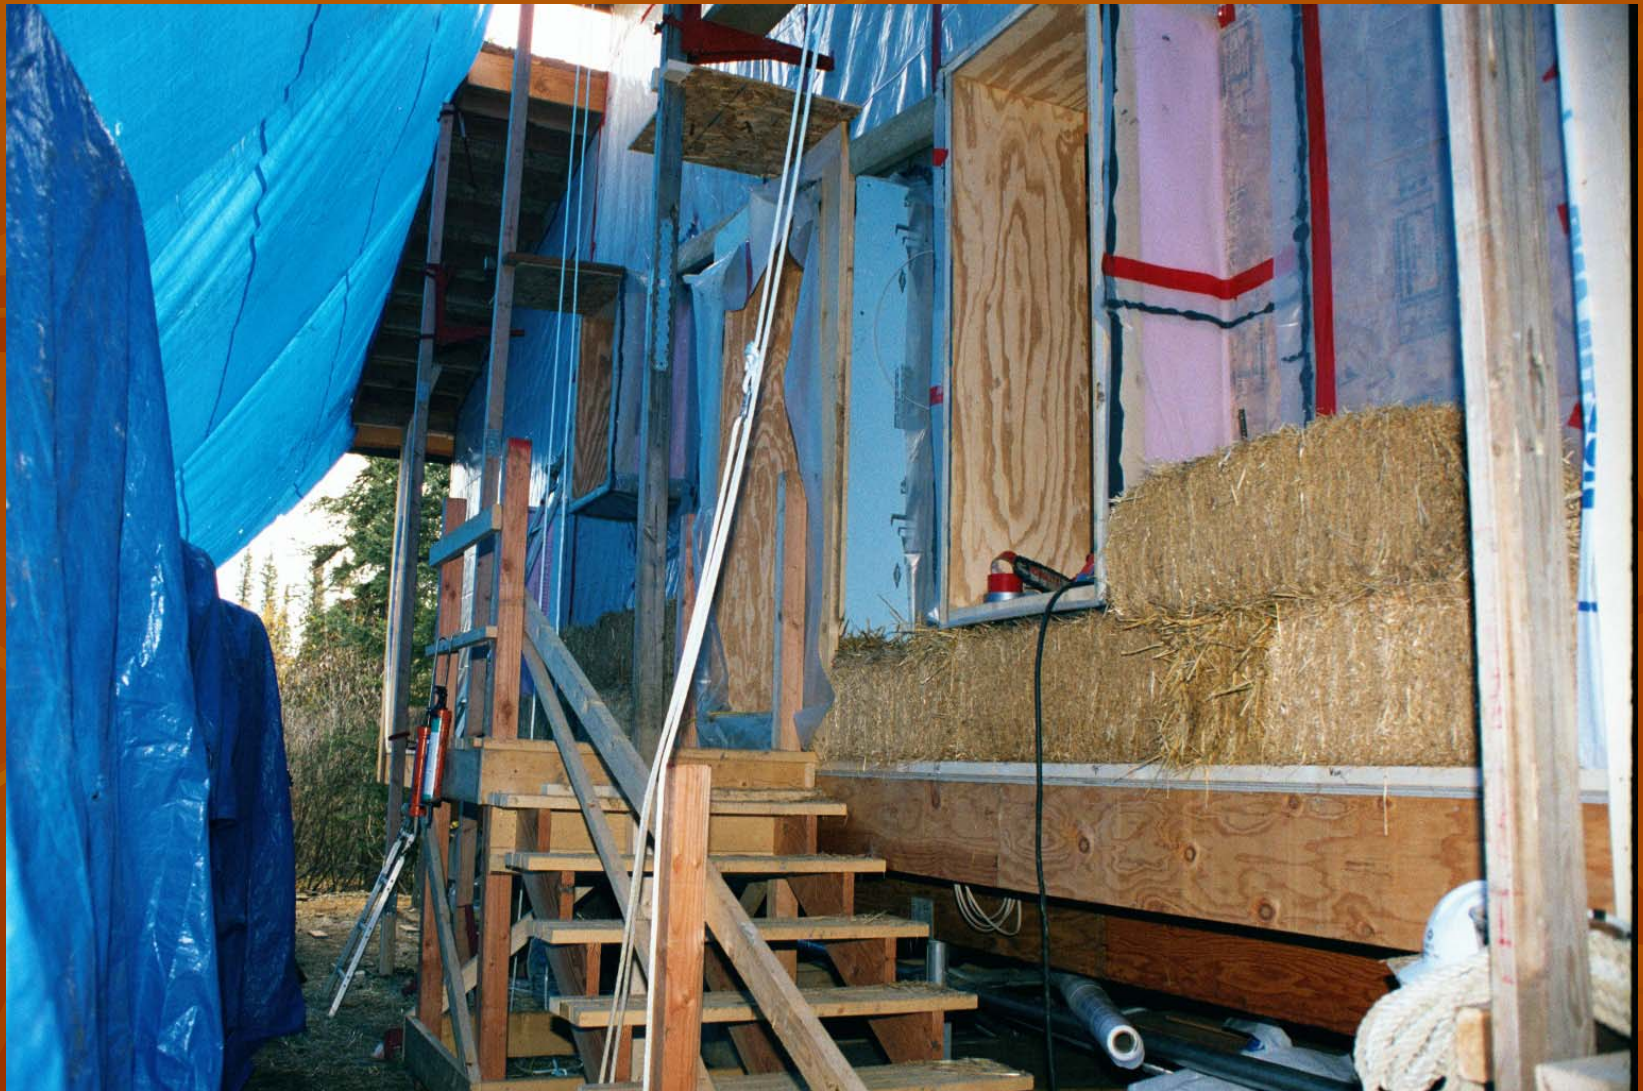
Notice the window bucks and ledge on the outside of the envelope.

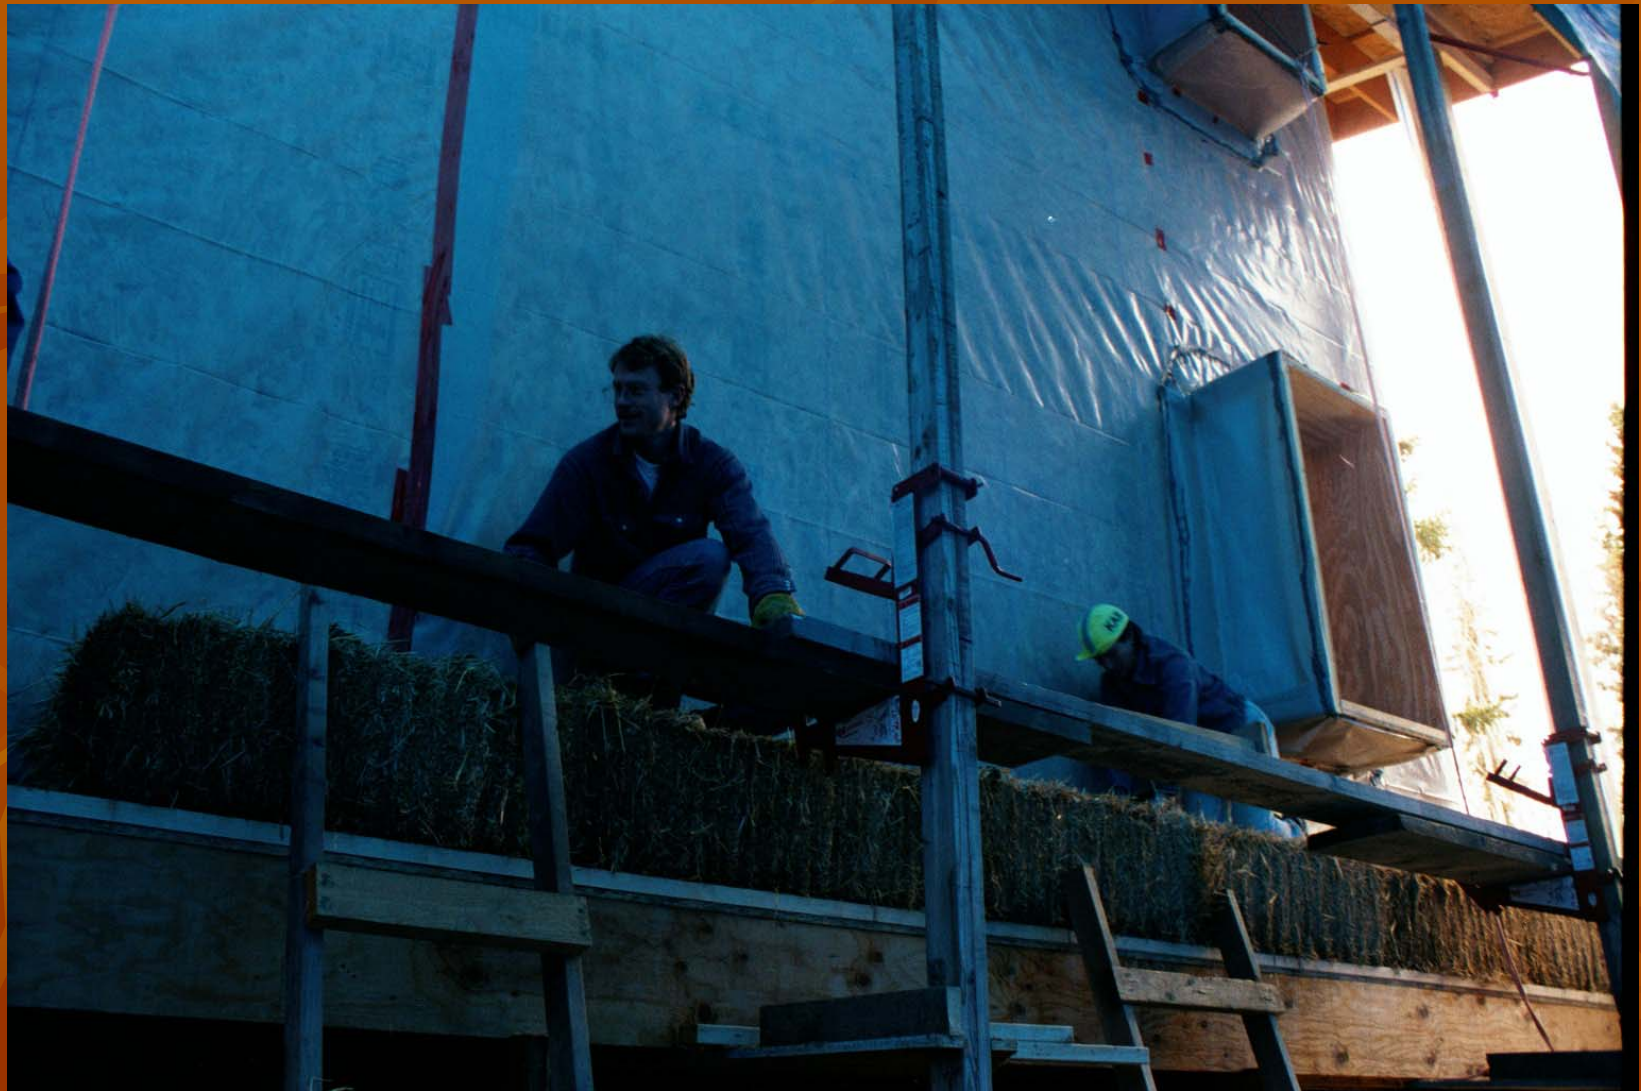
The first row of bales is laid on the ledge. Notice the vapor retarder on the outside and the window openings.

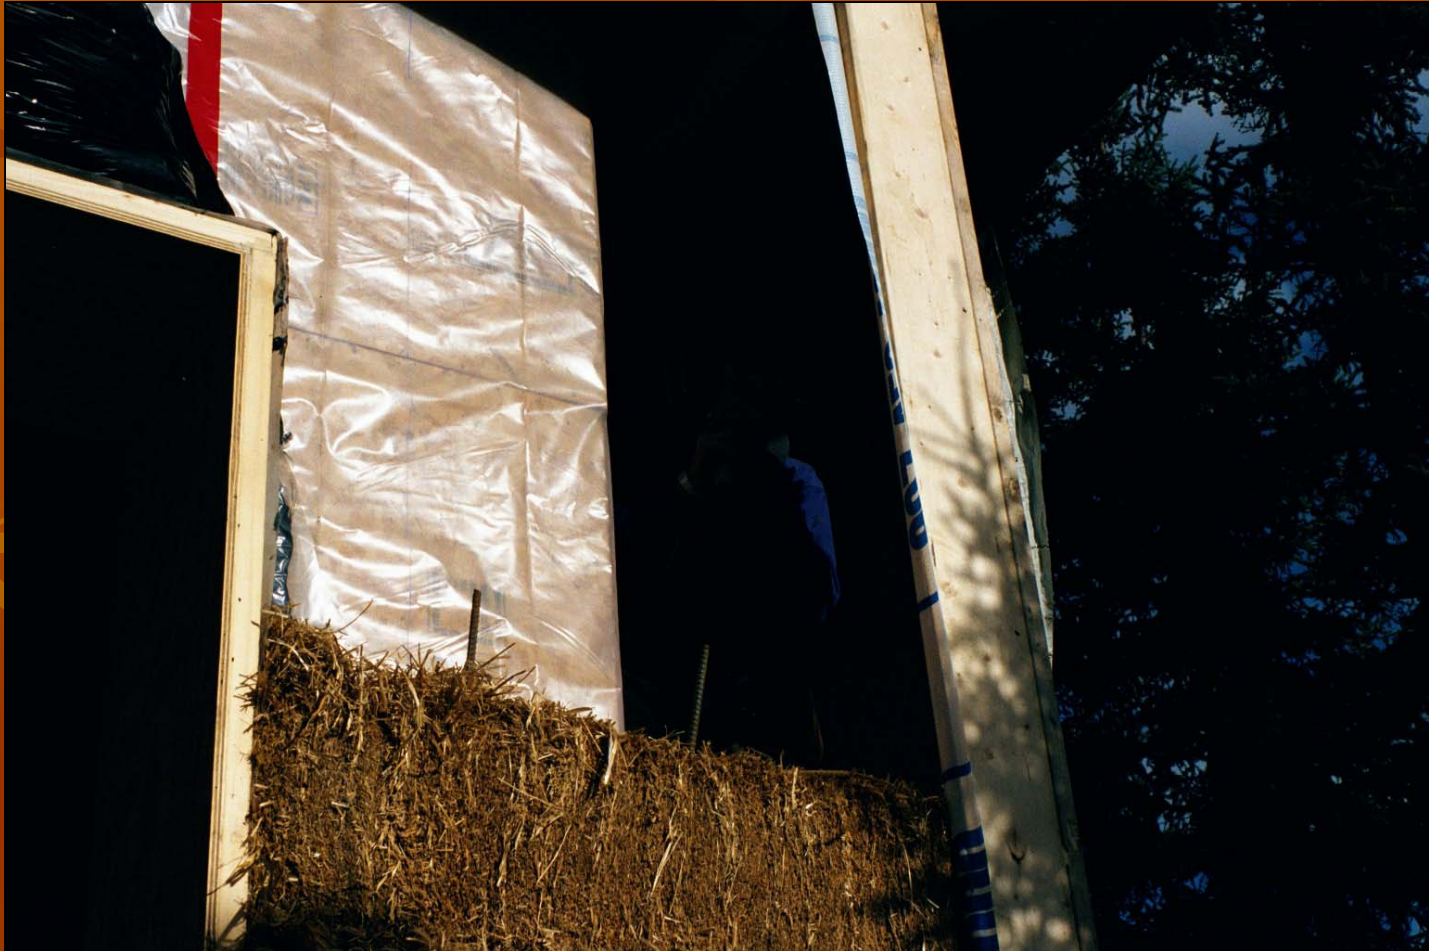
Bales are stacked around the window bucks. The rebar is driven through 1 1/2 bales, and then wire is run through the acoustic screw and wrapped around it which holds the bales tightly against the wall.

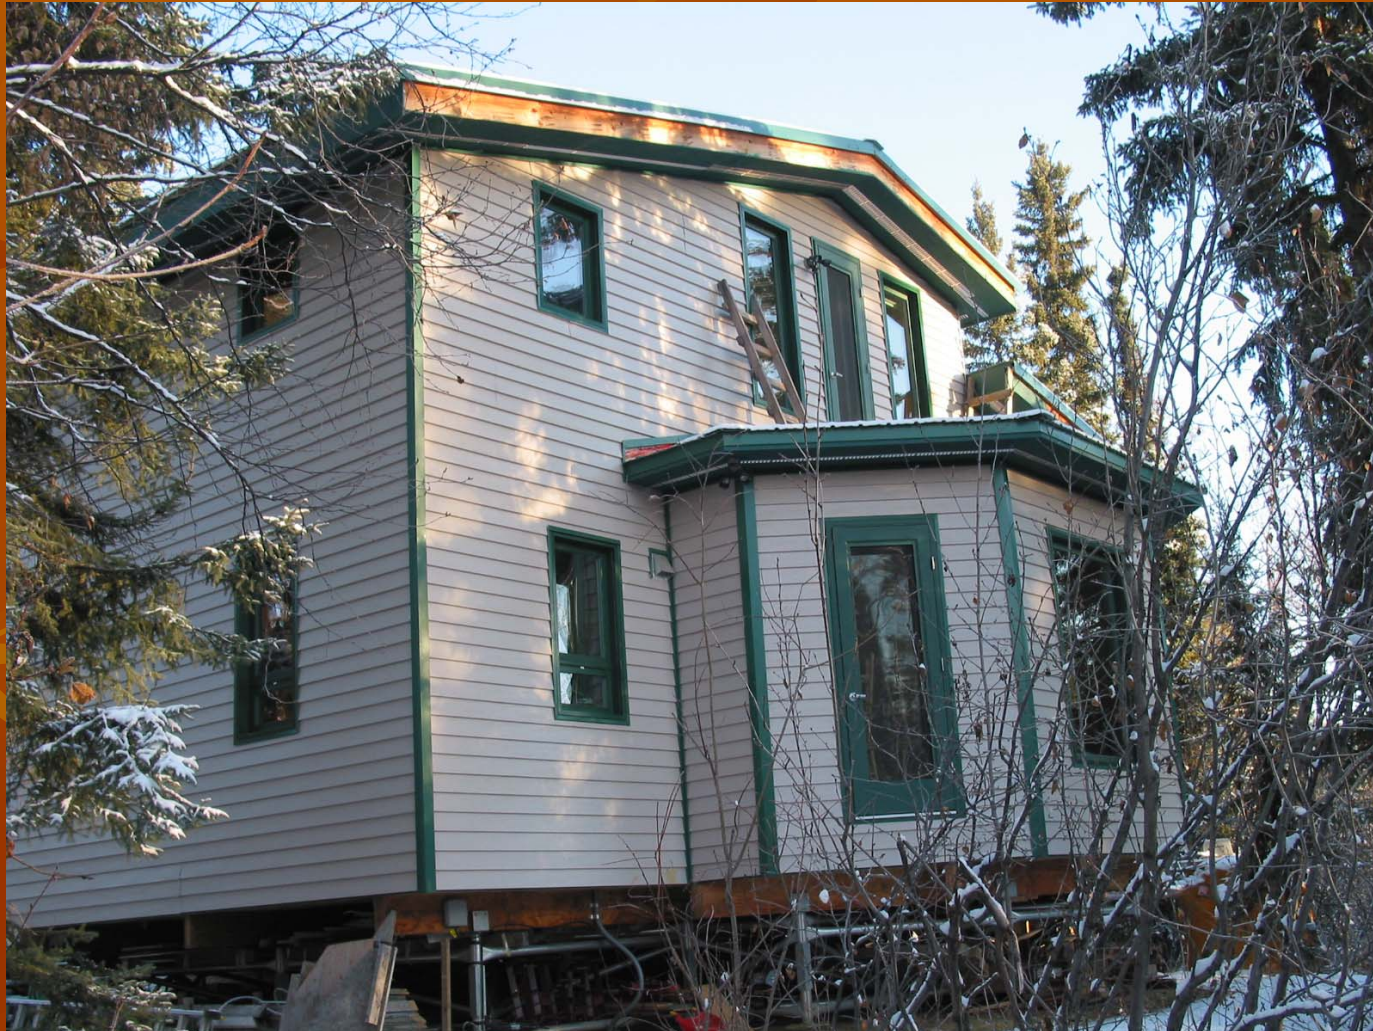
The south side of the Rueter house. The entire house is wrapped in steel siding which has a twenty five year warranty. Low maintance was the goal of this family.

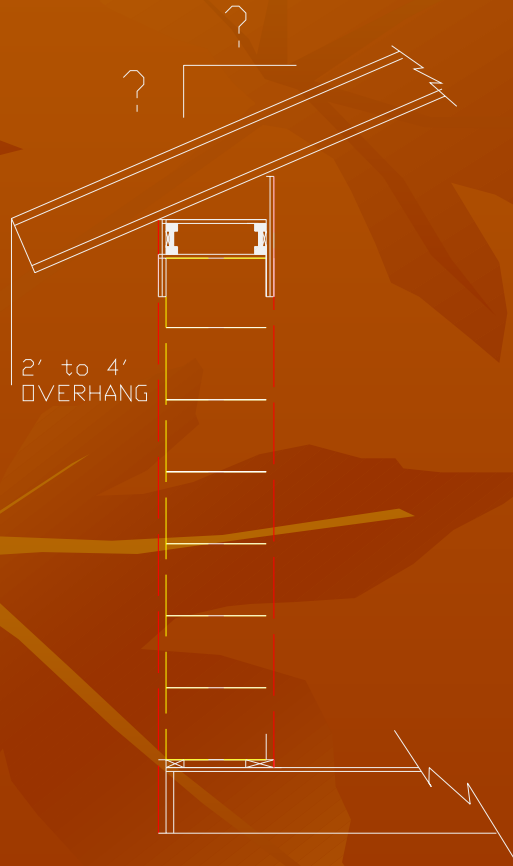
This Is A Load Bearing Wall Section

ROOF TRUSSES OR "1" JOIST ATTACHED WITH SIMPSON TIES, R-38 INSULATION (at least)

"1" JOIST BOX BEAM ROOF PLATE WITH $\frac{3}{4}$ " PLYWOOD TOP AND BOTTOM AND THE SIDES. THE SIDES EXTEND DOWN OVER THE STRAW ABOUT 8" AND CAN BE FURRED OUT TO $1\frac{1}{2}$ " TO SUPPORT SIDING

STUCCO NETTING PINNED TO STRAW AND NAILED TO TOP AND BOTTOM PLATES OR VERTICAL 2" x 4" STUDS ARE ATTACHED ON 24" CENTERS FOR SIDING.

"1" JOIST BOX BEAM HEADER STRAPPED TO UNDER SIDE OF JOIST USING #9 WIRE OR FIBER STRAPPING TO PRELOAD THE STRAW

STRAW STACKED FLAT IN BRICK LIKE FASHION

$1\frac{1}{2}$ " OF STUCCO APPLIED IN 3 COATS OR SOME TYPE OF SIDING CONNECTED TO NAILERS ON 24" CENTERS

2 x 4's LAID ON SIDE TO RAISE THE BALE OFF THE FLOOR

$1\frac{1}{2}$ " SOY BASED FOAM BETWEEN 2 X's
6 MIL VISQUEEN VAPOR RETARDER

$\frac{3}{4}$ " TONGUE & GROOVE GLUED & SCREWED

VAPOR RETARDER
12" "1" JOIST ON 16" CENTERS, 2 x 12 RIM JOIST

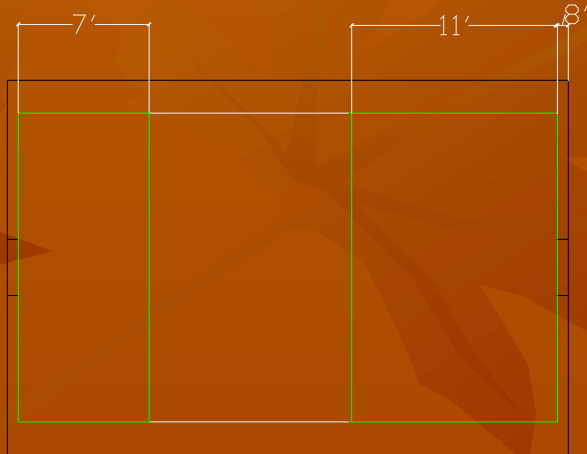
This Building Is A Simple Load Bearing Structure

OPTIONAL LOFT SPACE FOR SLEEPING AND/OR STORAGE

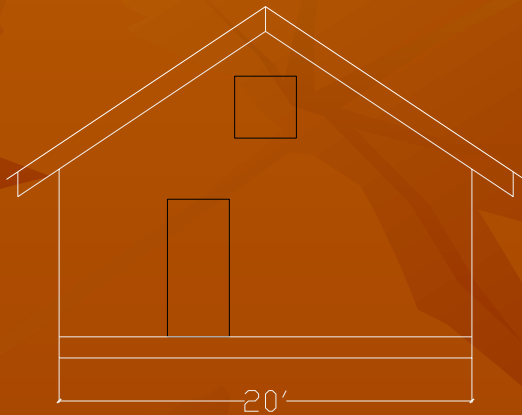
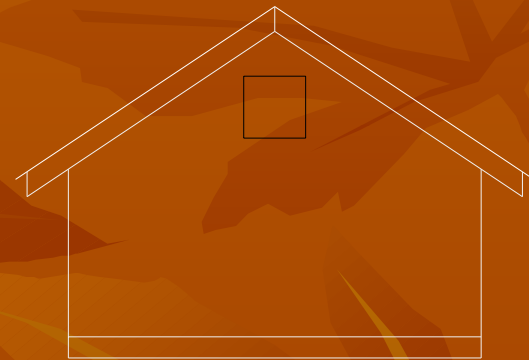
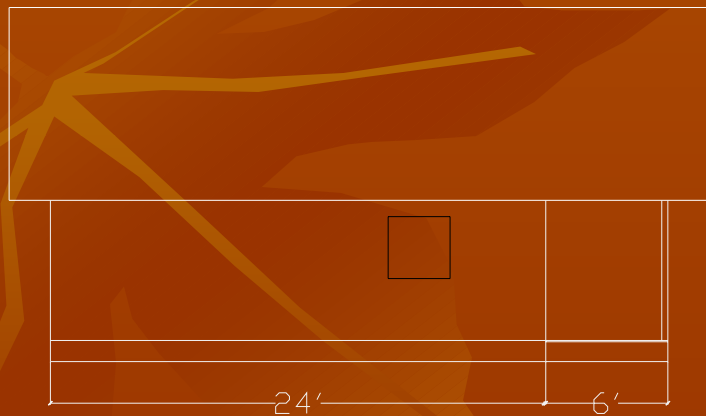
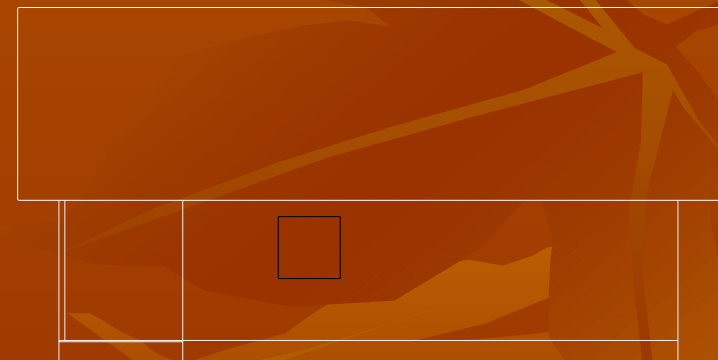
THE MAIN LEVEL MAY BE SET ON ANY TYPE FOUNDATION AND HAVE ANY FLOOR PLAN. PLANS COULD INCLUDE PLUMBING AND ELECTRICAL DETAILS. THE BUILDING MAY BE LARGER OR SMALLER TO FIT YOUR INDIVIDUAL NEEDS.

Typical Alaskan cabin not showing details such as siding, roofing, windows, doors, etc. Those details should be designed to fit the needs of the owner.

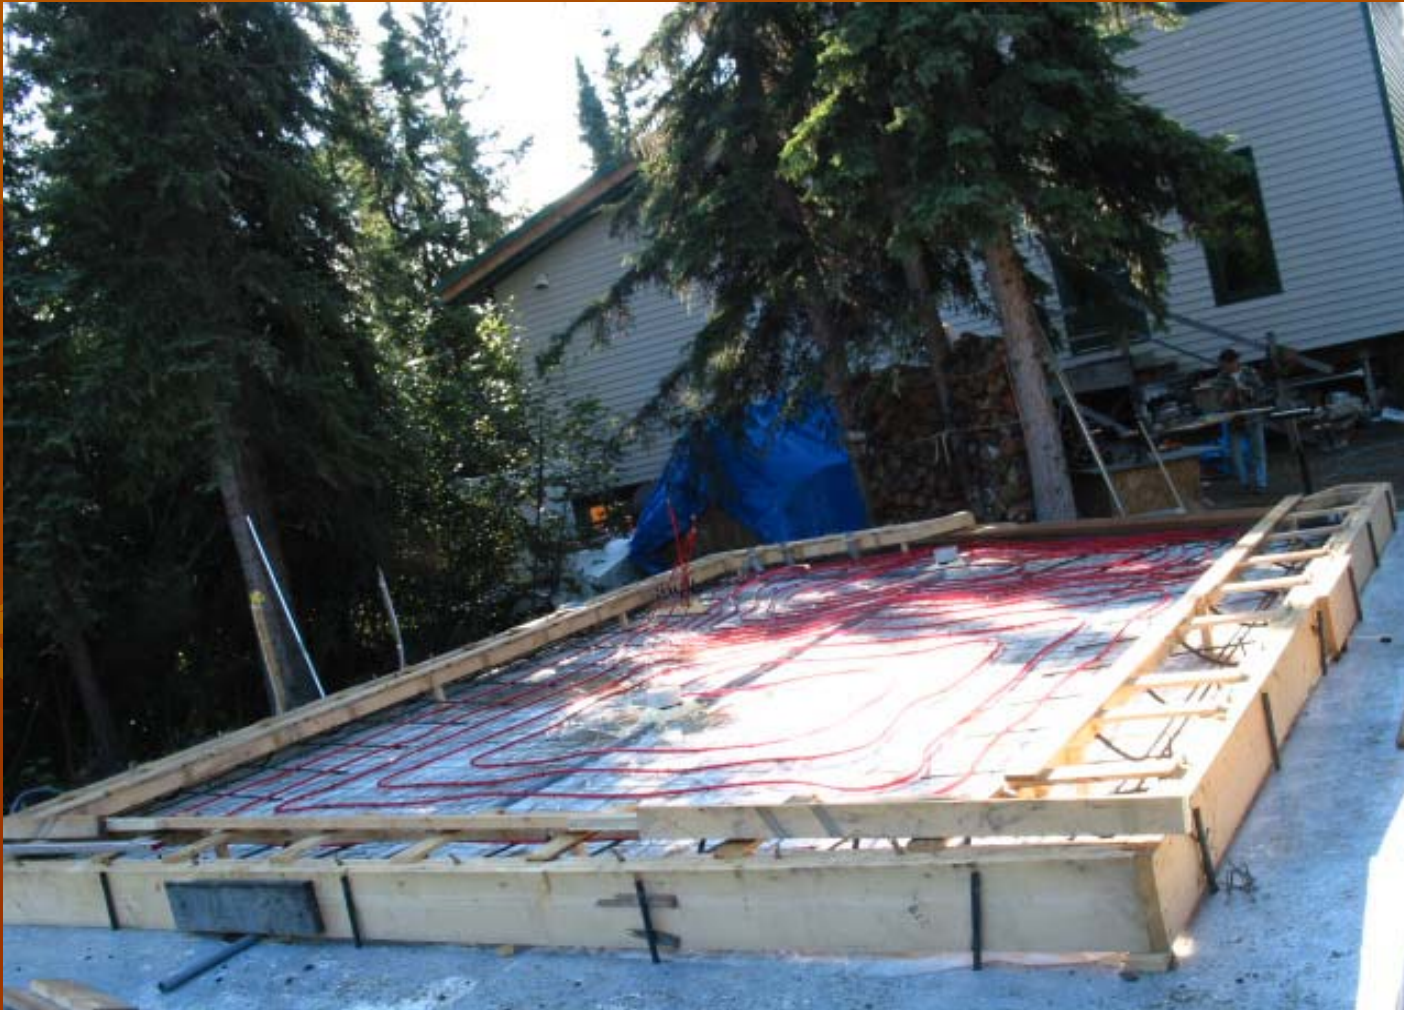
Helena's load bearing garage forms were constructed over permafrost. A heat pump is used to cool the earth below and to heat the slab. This monolithic pour is over 8" of foam.

- Helena designed and constructed this garage to show the feasibility of building a load bearing structure in the Interior. The walls of this building were erected in one day by 4 people.
- It is heated by a heat pump which dumps its cooled liquid into the space below the building to keep the permafrost frozen.
- In the Spring of 2004 the building will be plastered on the inside and outside walls.

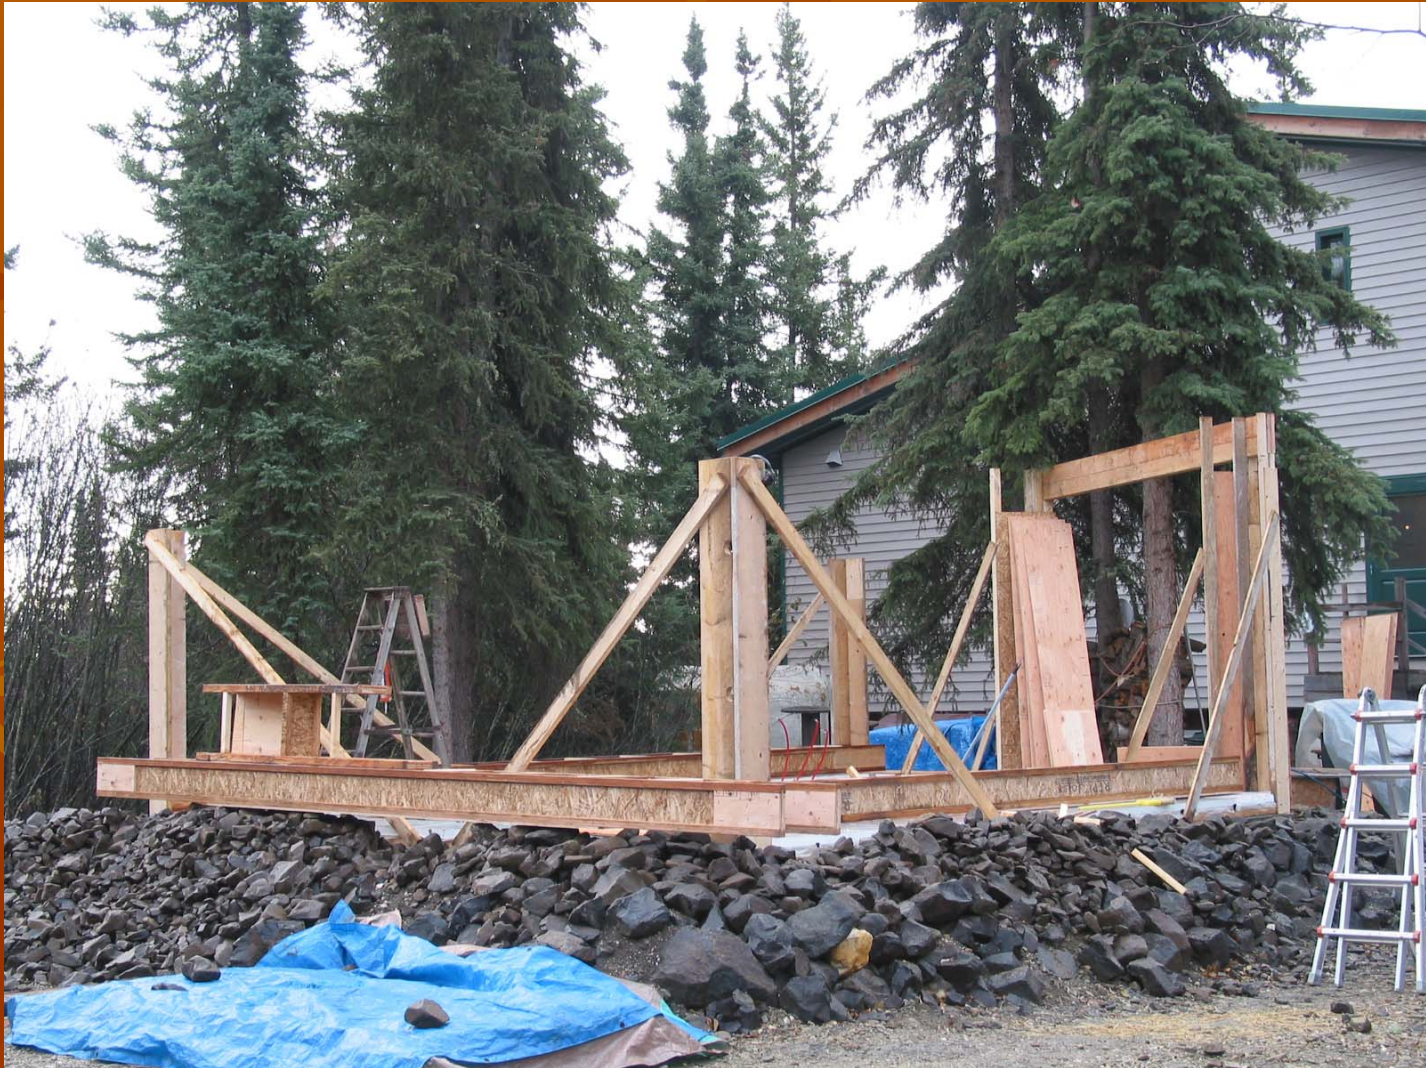
Corner bracing is used to keep the bales in line and to form uniform corners.

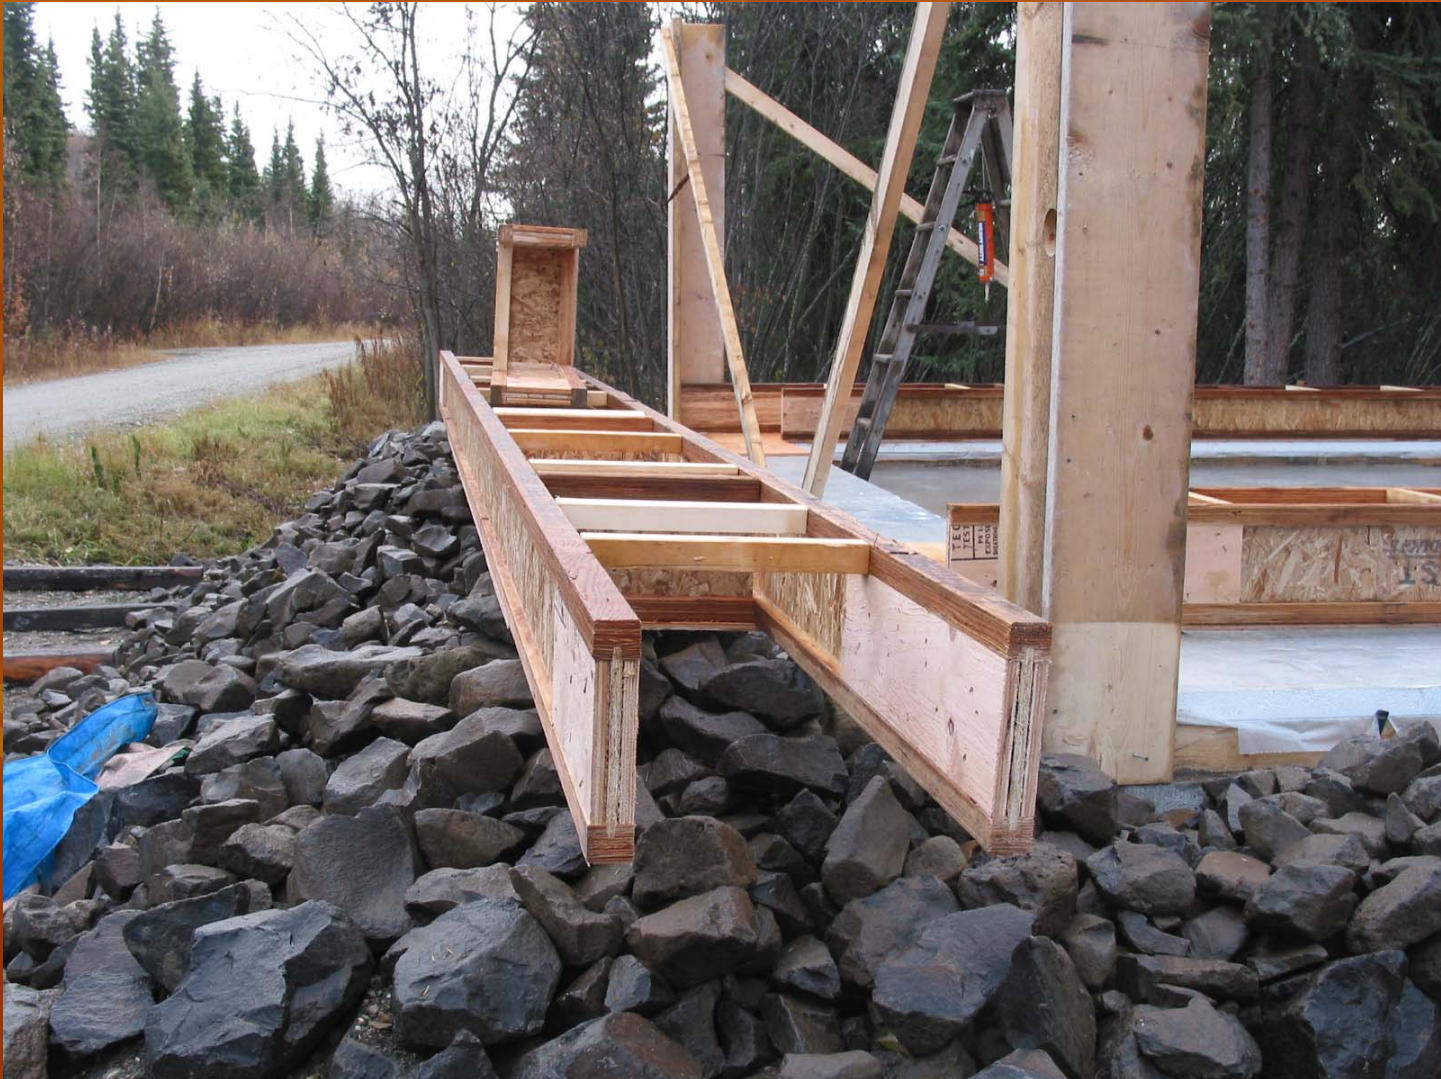
The “I” beam top roof plate assembly is ready to place as soon as the bales are stacked.

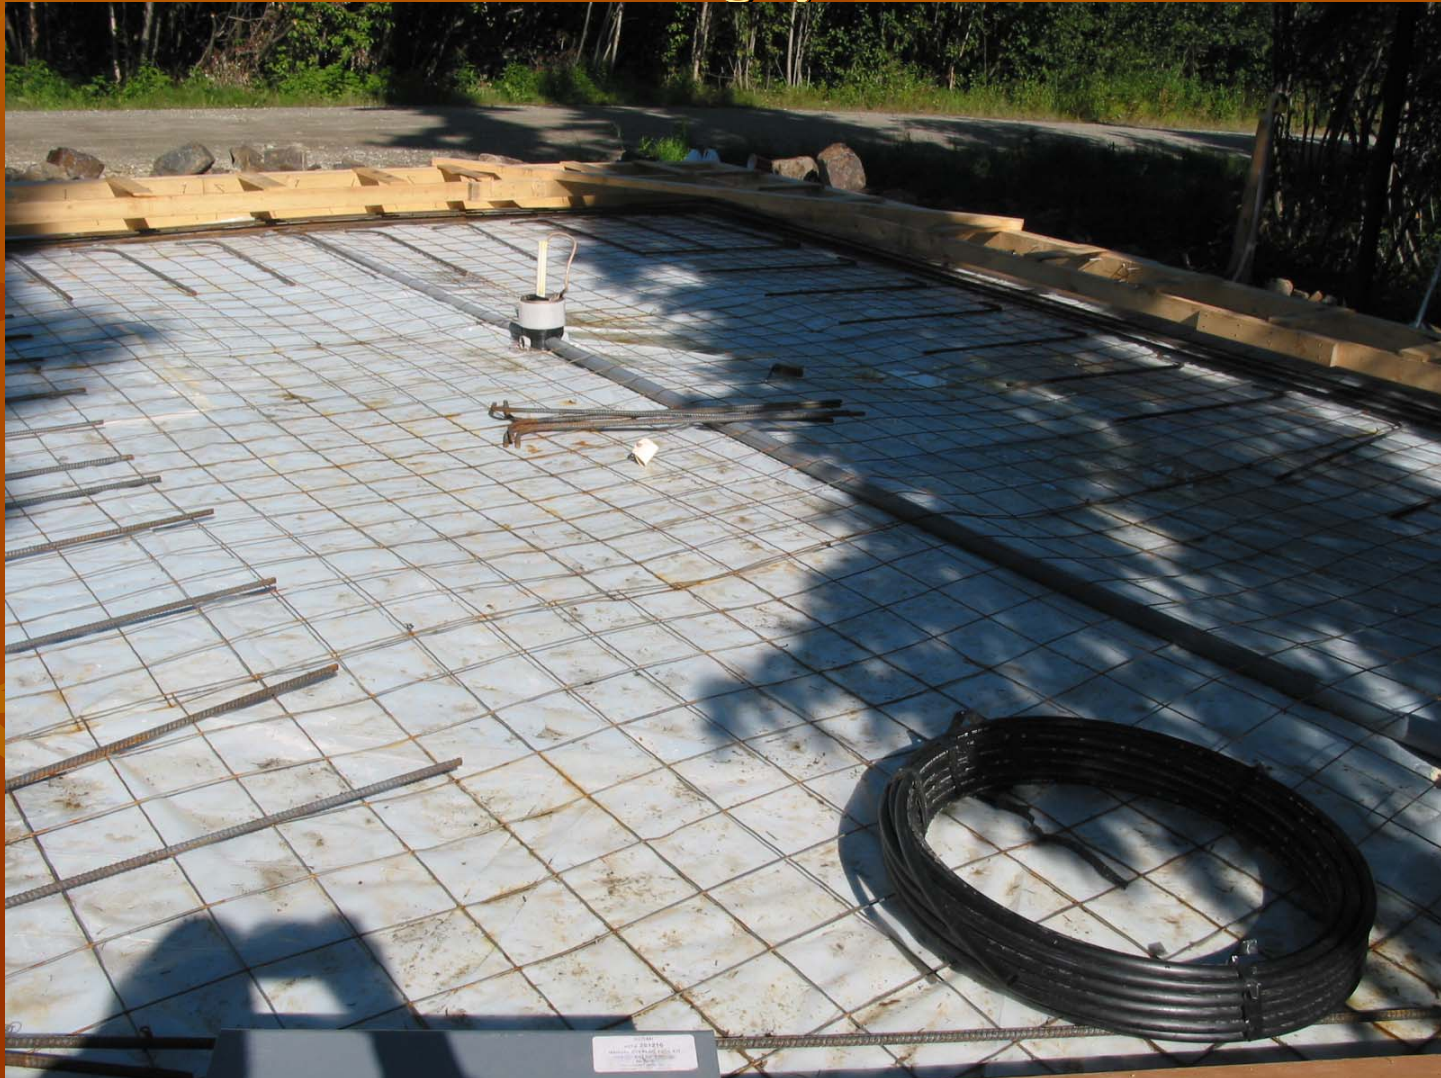
The sensor in the center of the floor is for the heat pump monitoring system.

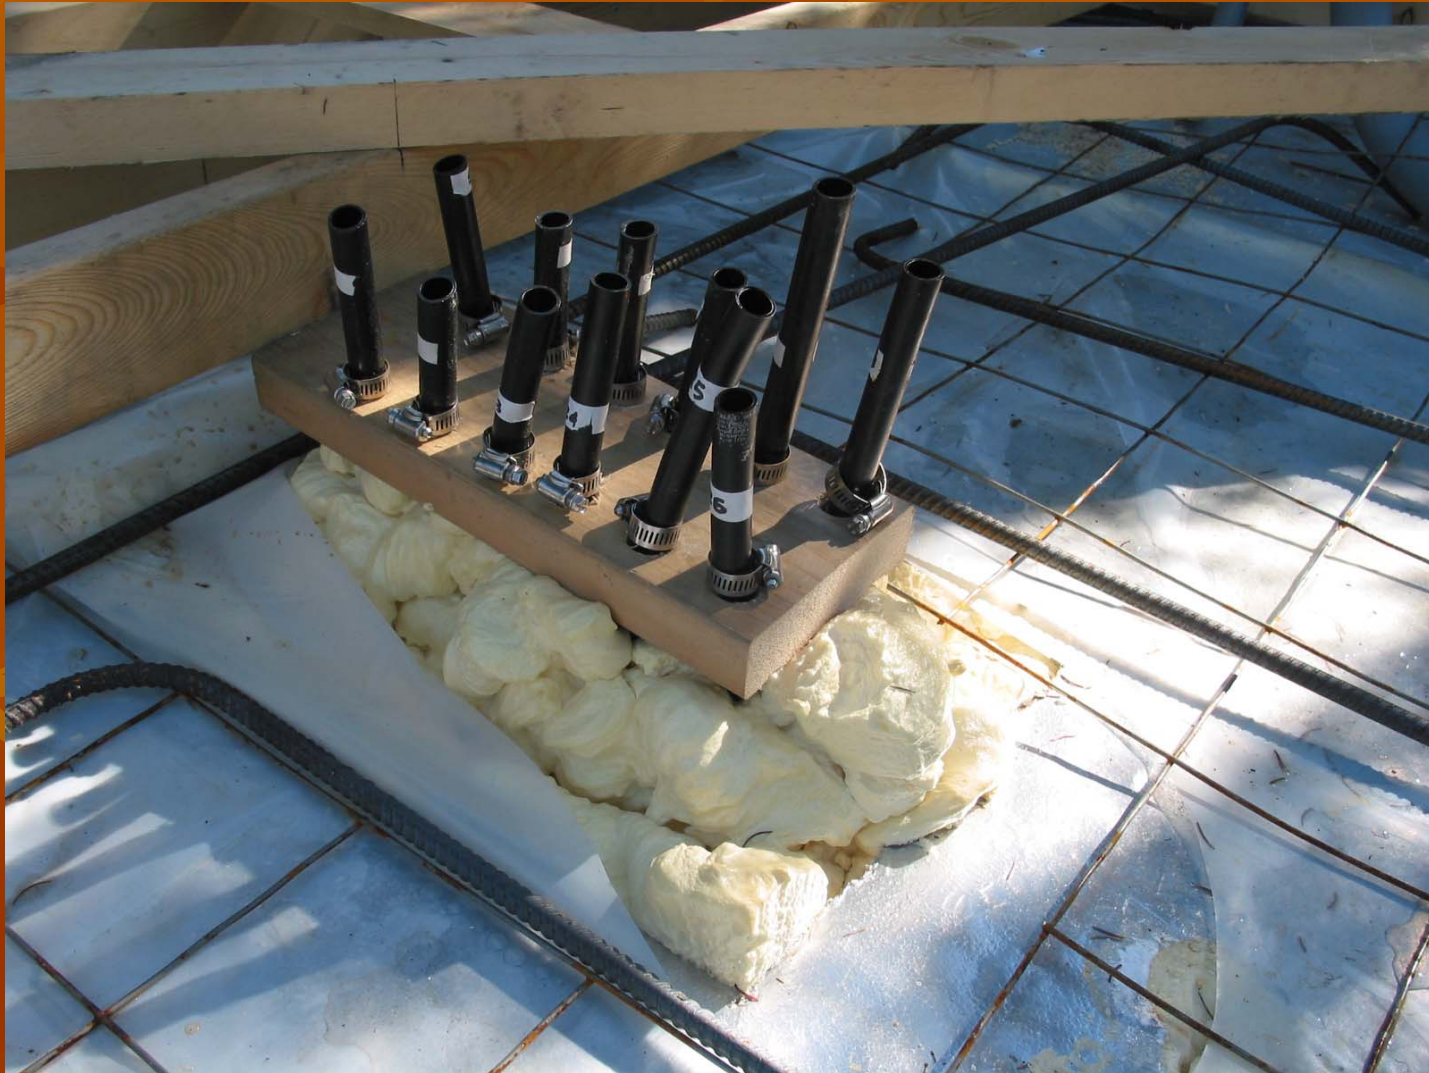
Cooling tubes are inserted into the earth below the floor to keep the ground frozen.

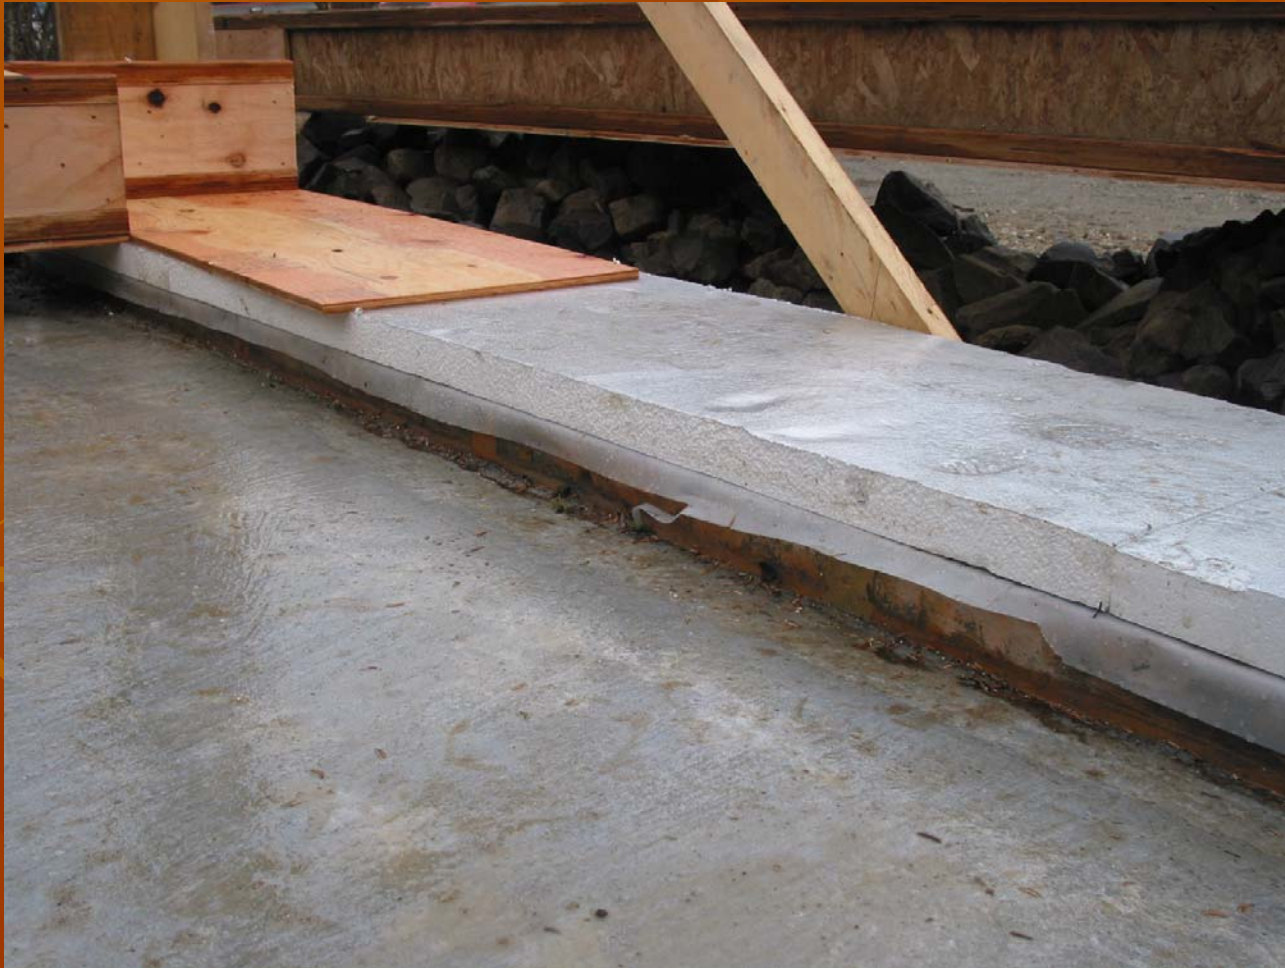
The floor and footers are poured with 2 x 4's inset into the concrete to use as nailers for the mesh lath around the perimeter. Note the foam on top which will act as a vapor retarder and capillary break.

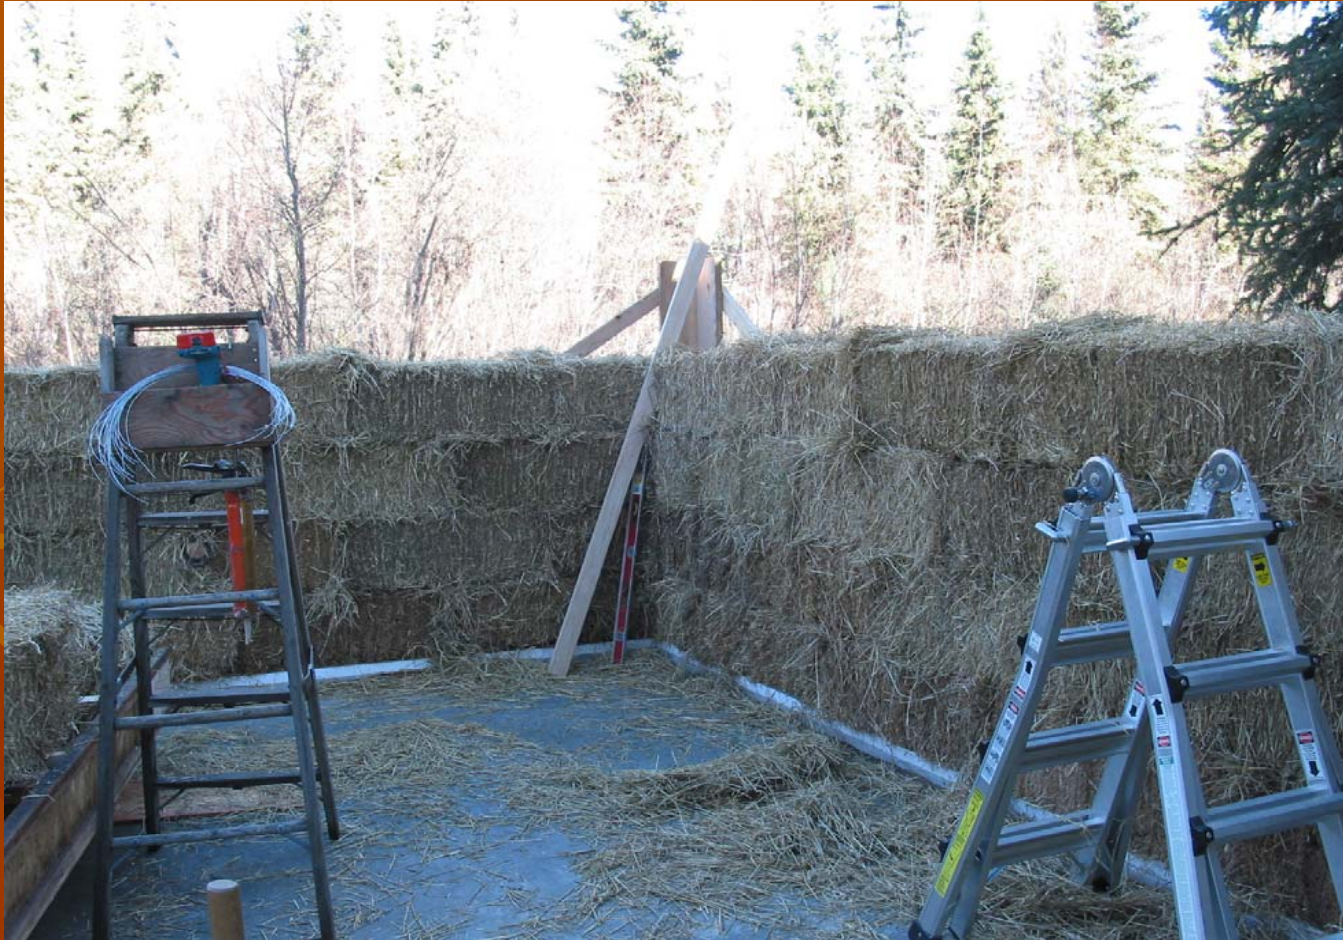
Four of the seven rows are finished at this point, and the wall is quite unstable. Once the wall is preloaded using the #9 wire and a special ratchet-like tool which is used to pull the wall down (preload), it becomes very stable.

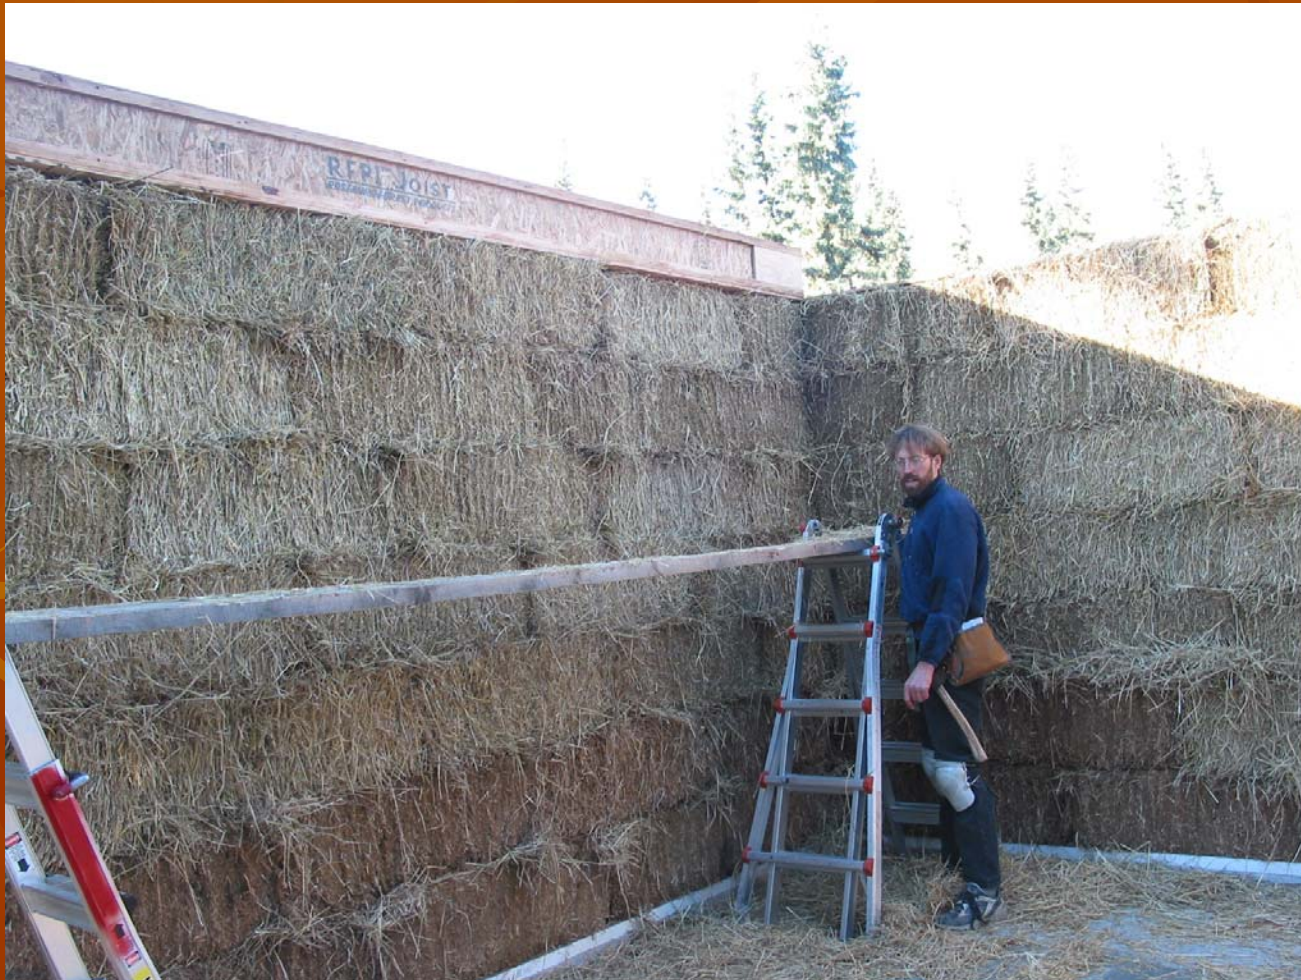
Jose sets the top plate and fastens the corners together. After the top plate is set the bales are preloaded using #9 wire run under the foundation and over the top plate.
