Straw Bale Building In Alaska

A CCHRC Presentation

FOUR NON LOAD BEARING HOMES AND A
LOAD BEARING GARAGE IN THE
FAIRBANKS AREA

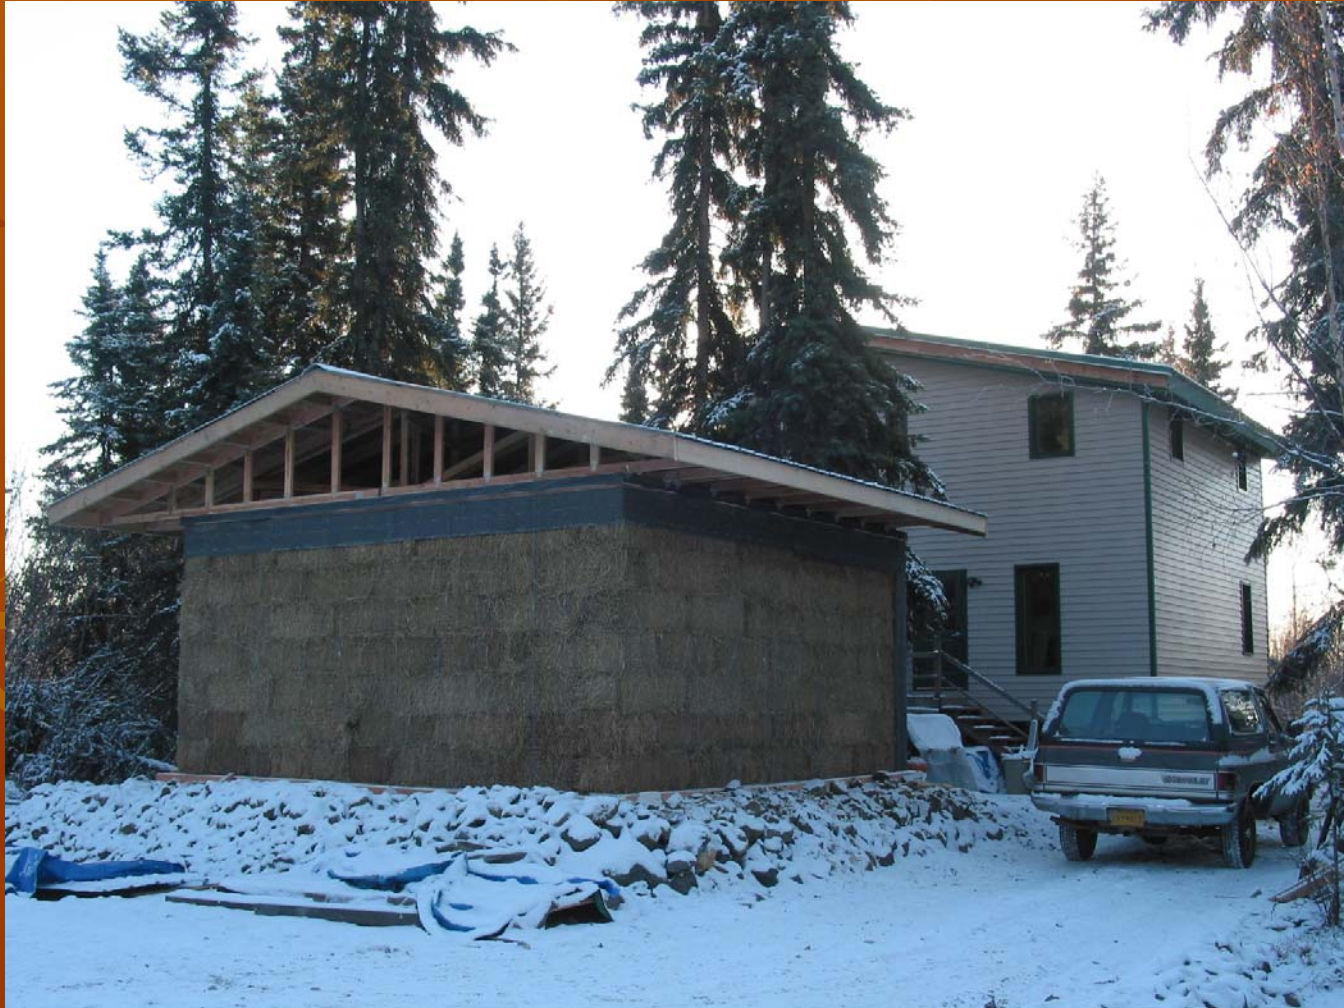
The roof has three feet of overhang on the north, west , and south, and five feet on the east. A non-load bearing home is seen in the back ground.

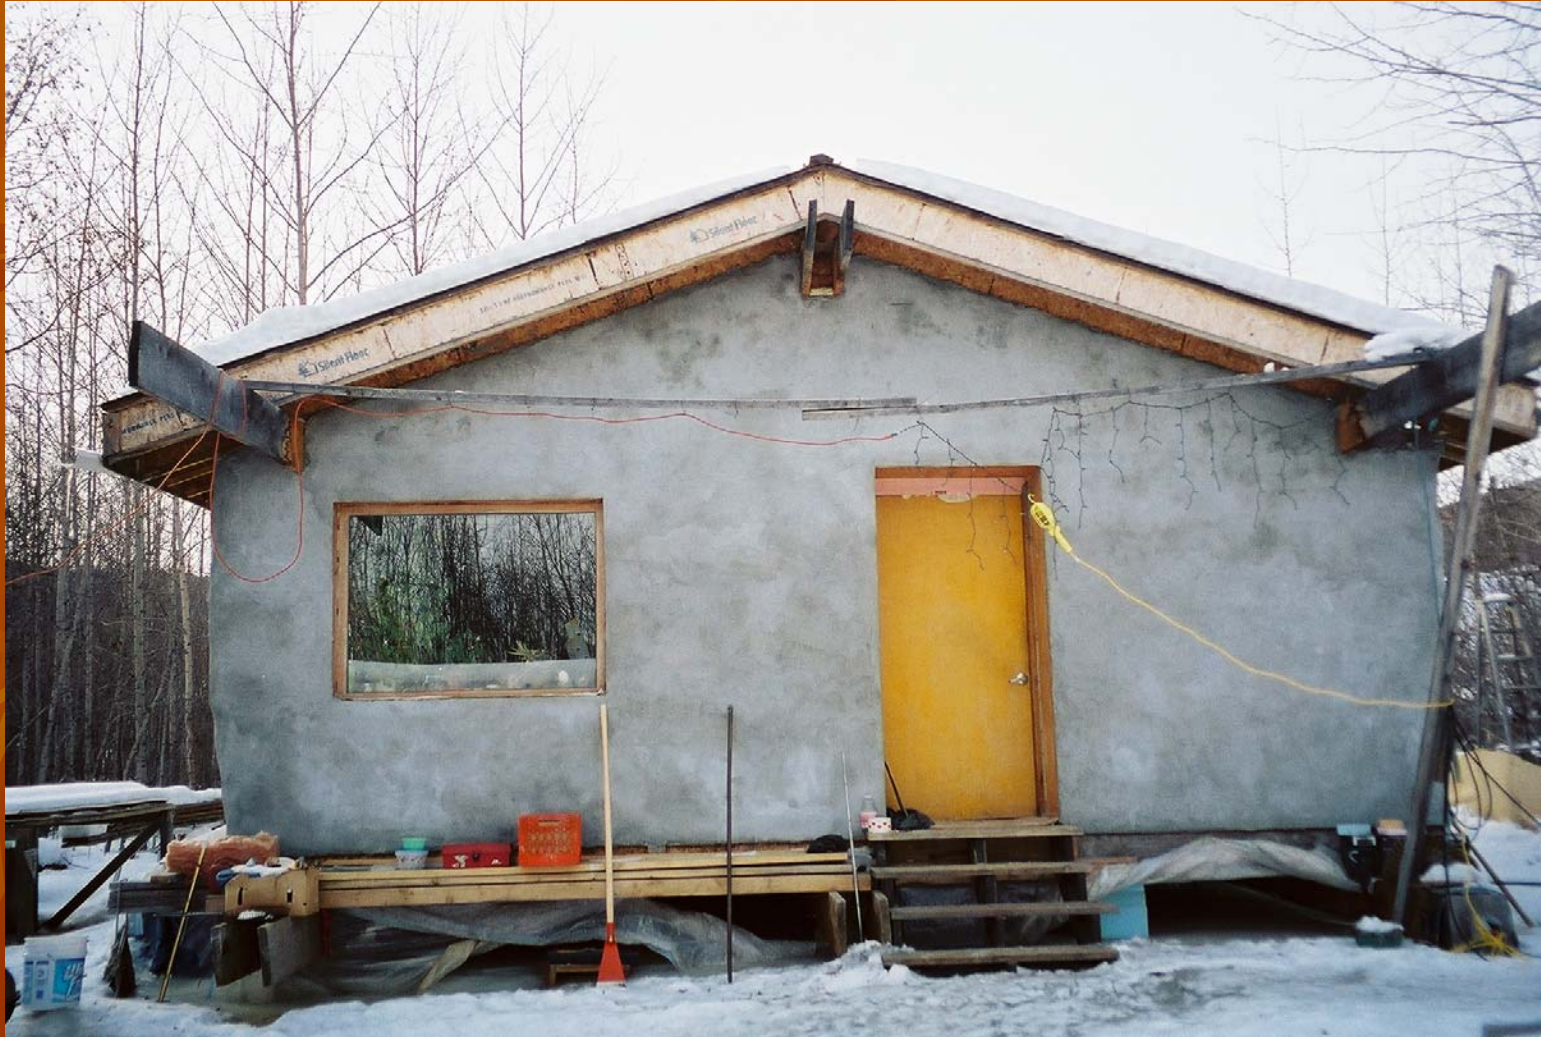
This single story is built on pilings and plastered with a concrete plaster mix.

- A vapor barrier was not planned when this home was built and the owners later retrofitted one. With no outside plaster skin, the wind blew straight through during the first winter, and it was very cold inside. Plastering is a problem in Fairbanks because of the length of time needed to apply and to dry at the end of the building season.

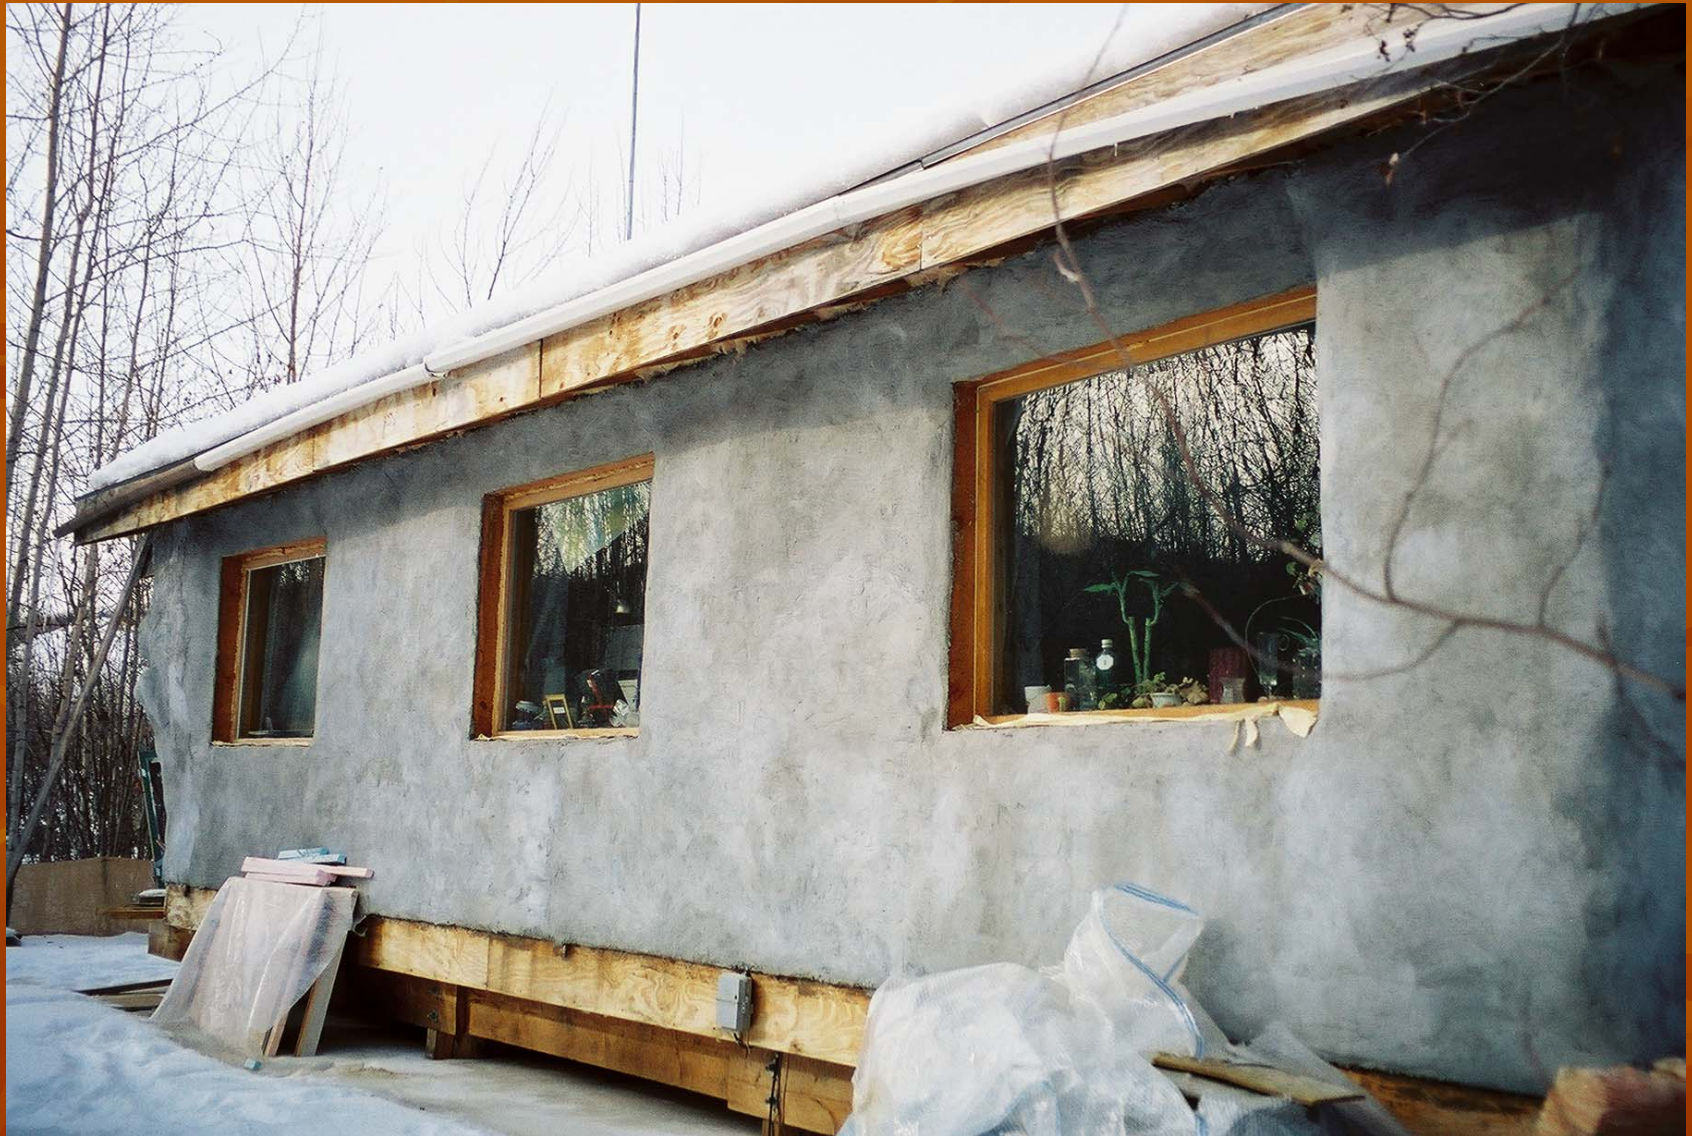
The south side is designed for passive solar gain.

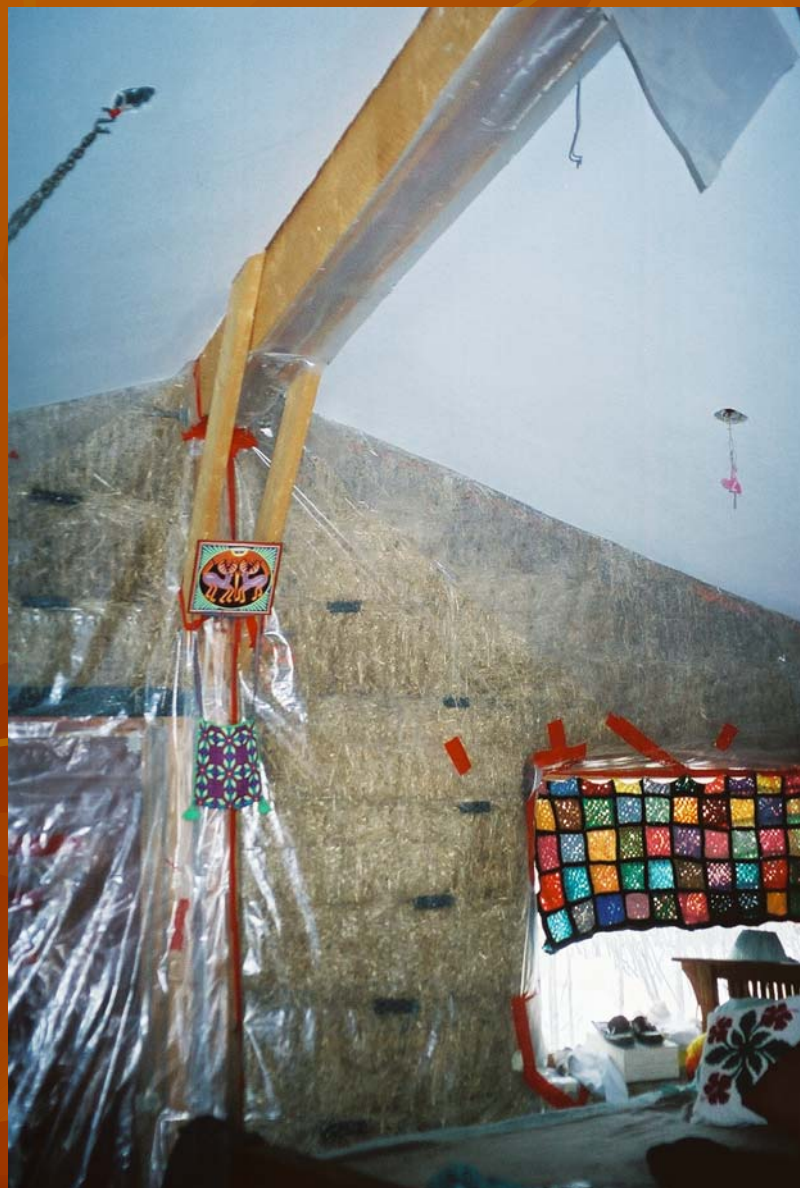
The vapor barrier is hung before furring out for sheetrock.

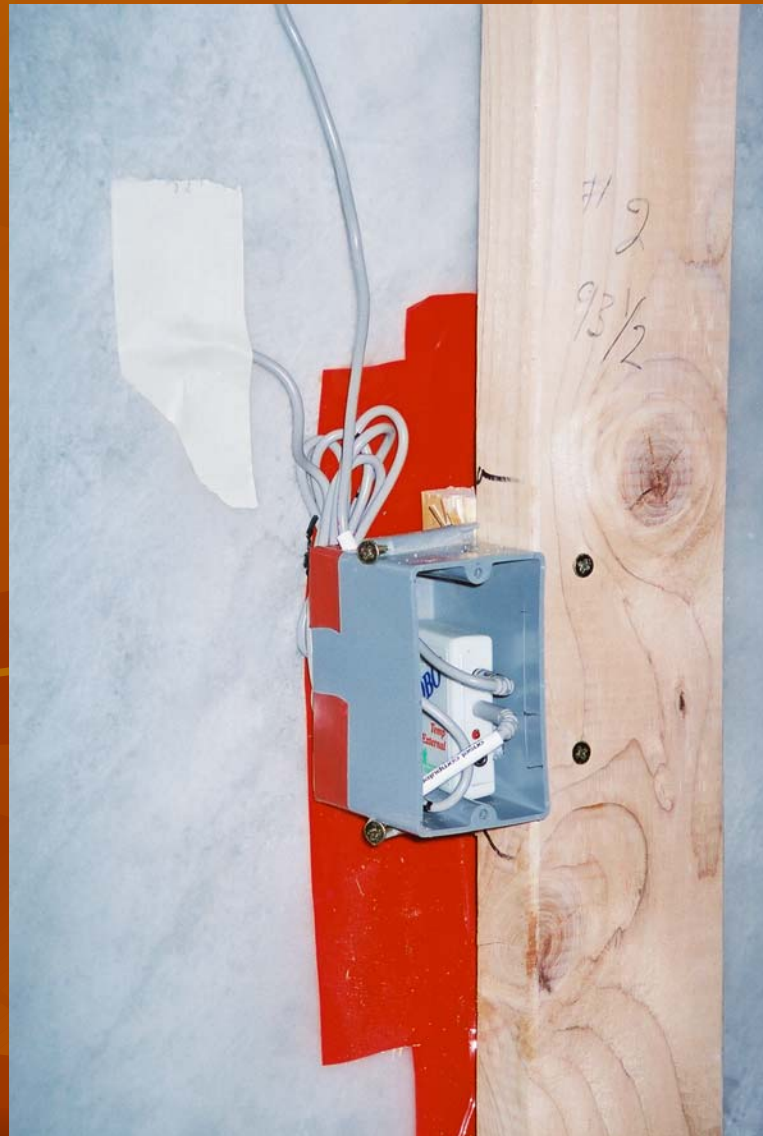
An electrical box is used to house hobo sensors on the north wall.

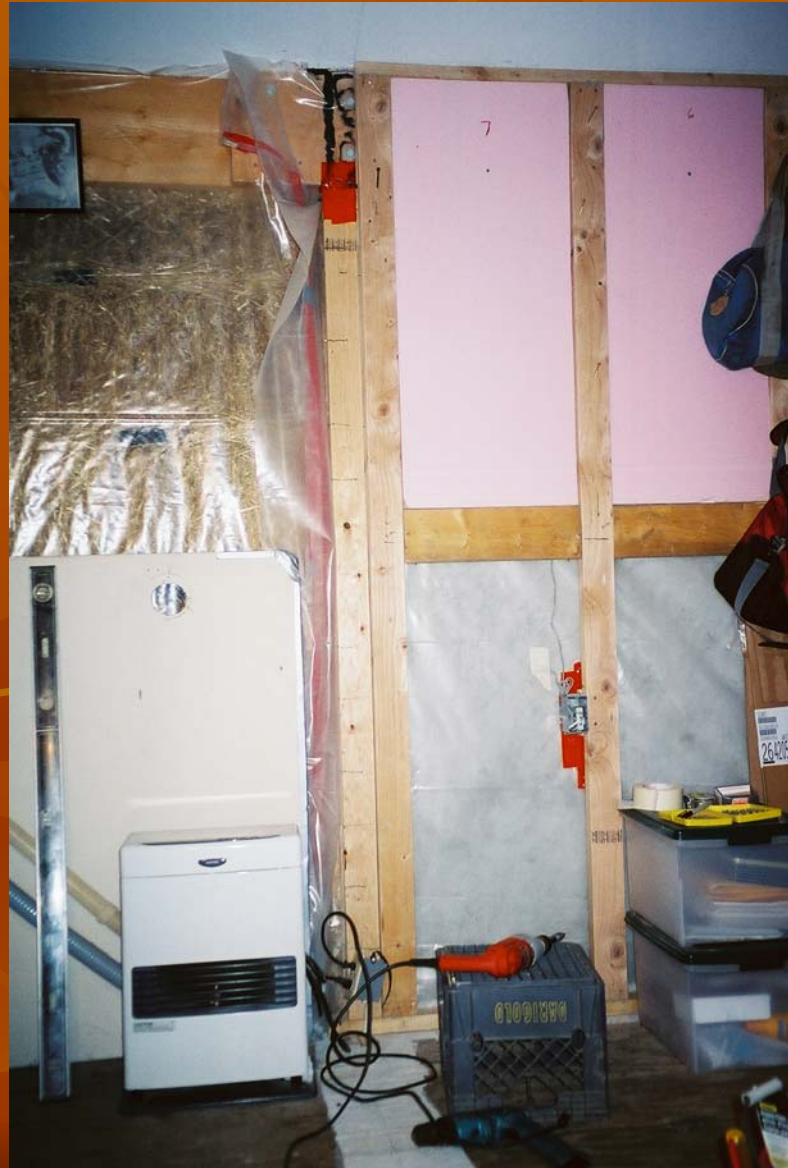
A Toyo heater provides heat. Notice the furring for hanging the sheetrock.

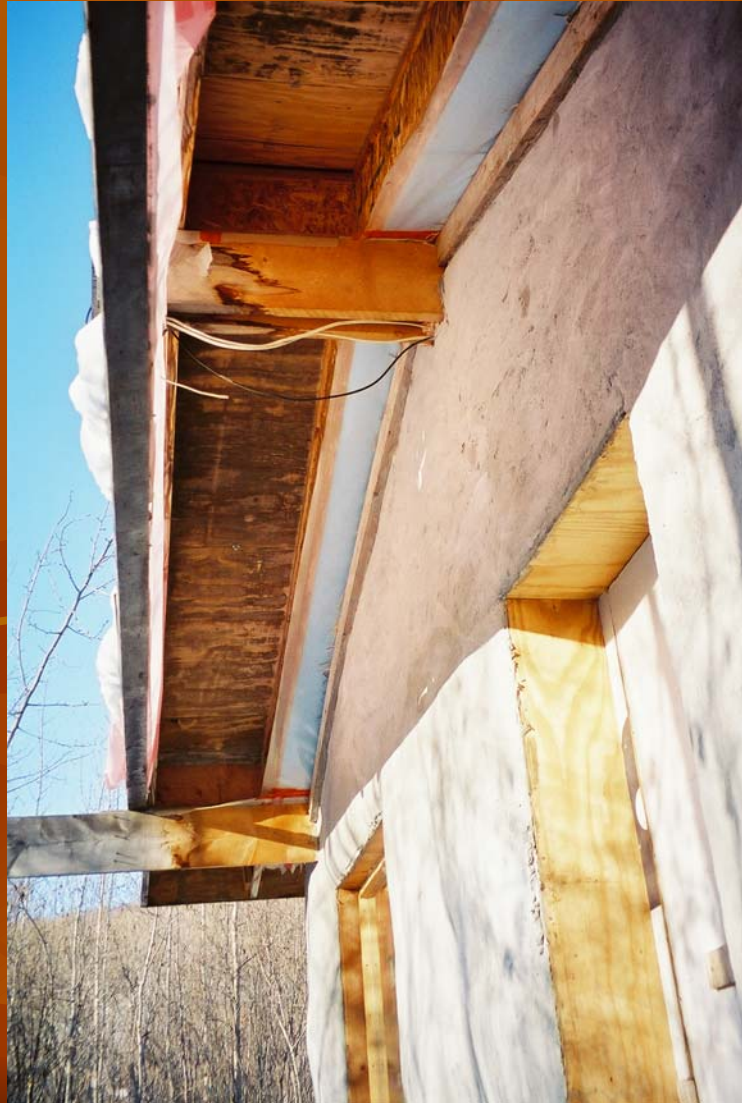
Some mold problems formed under the eaves as the result of air leakage during the winter before the vapor retarder was installed.

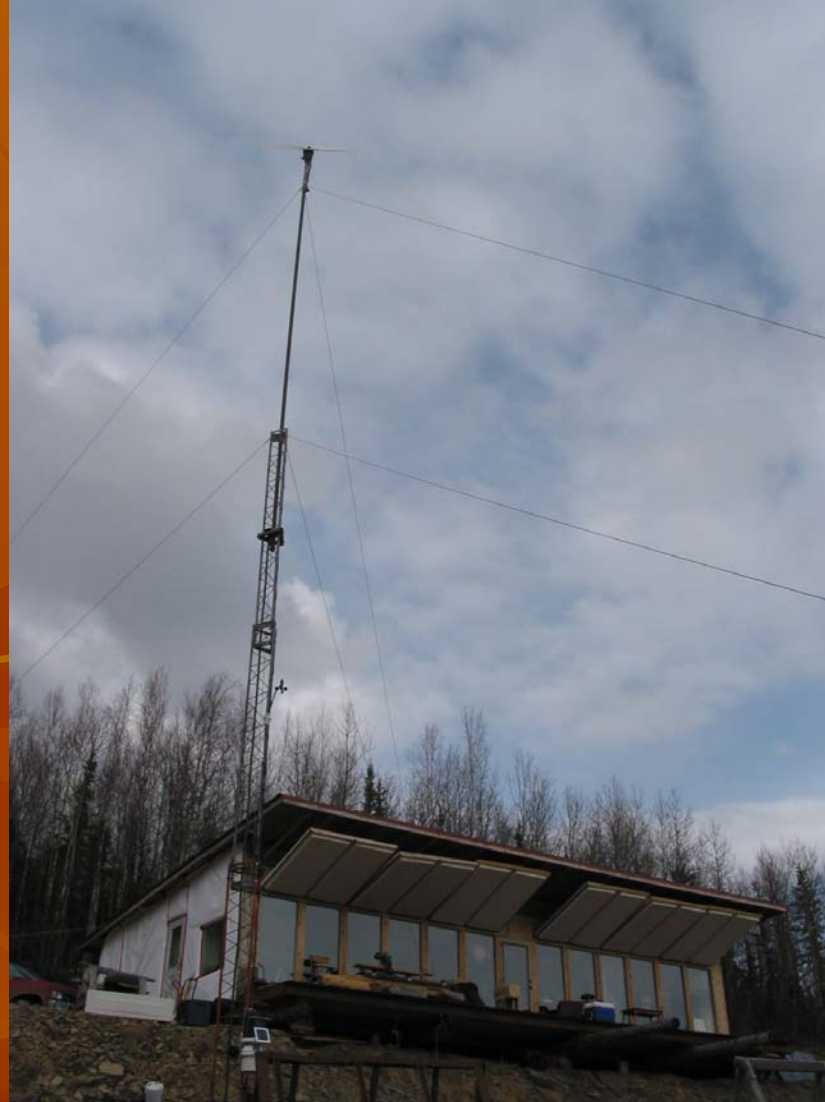
This photo is taken from the Southwest and shows the passive solar windows and the wind generator.

- This home is nearly as self sufficient and green as possible in this day and age. The owners are off the power grid and use photovoltaics and wind power to generate most of their electricity. Their heat is supplied from the sun, oil, and wood.
- Their SB home has straw in the floor, ceiling, and walls. This home is also non-load bearing with framed walls, and the straw is stacked on an 18" ledge on the outside. The vapor barrier was applied to the outside of the OSB, and the straw was then stacked against it.

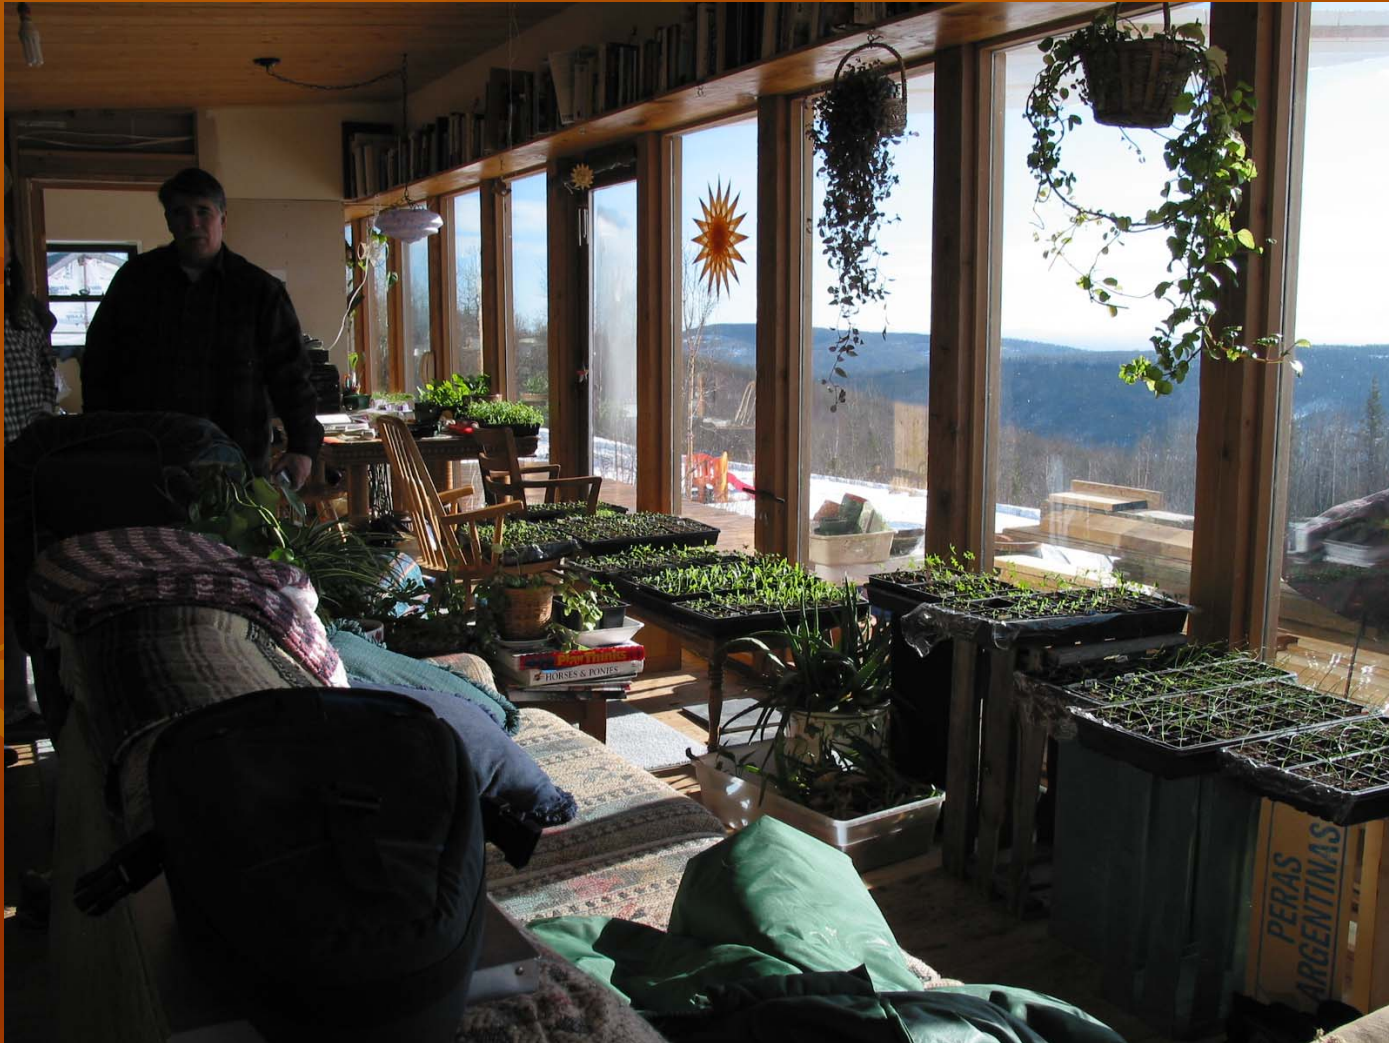
This inside view shows the passive solar effect of the southern orientation.

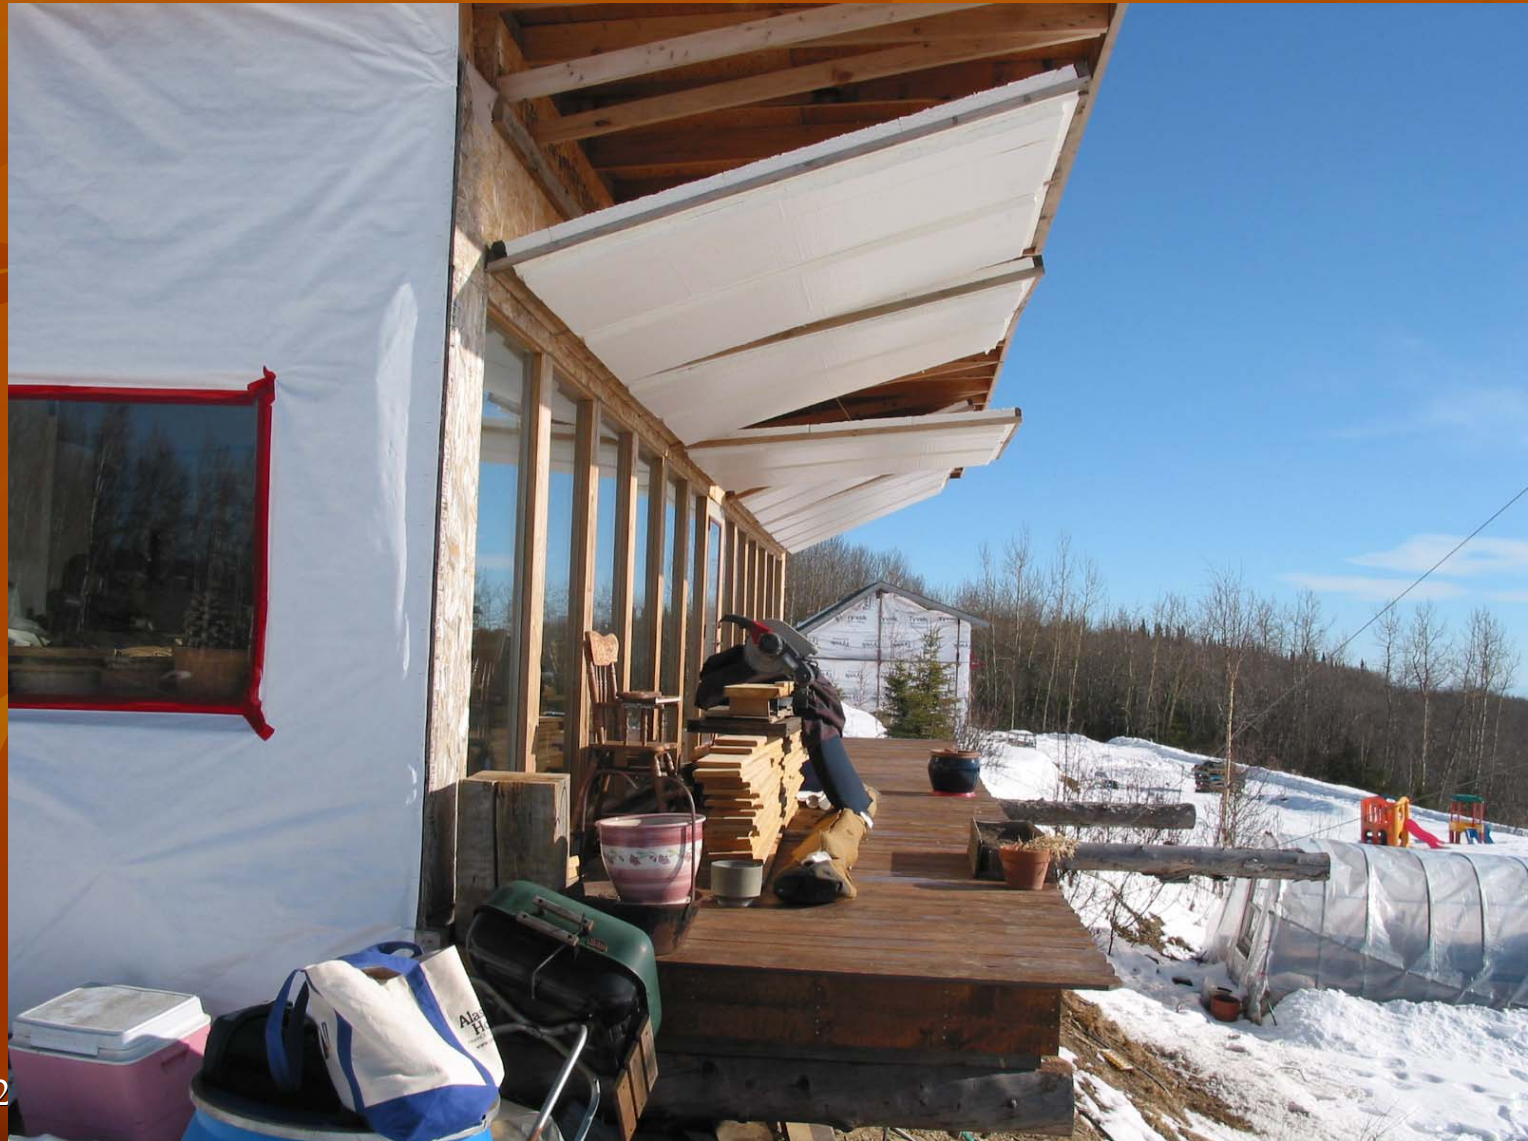
The insulated shades can be raised and lowered from the inside to regulate passive solar heating.

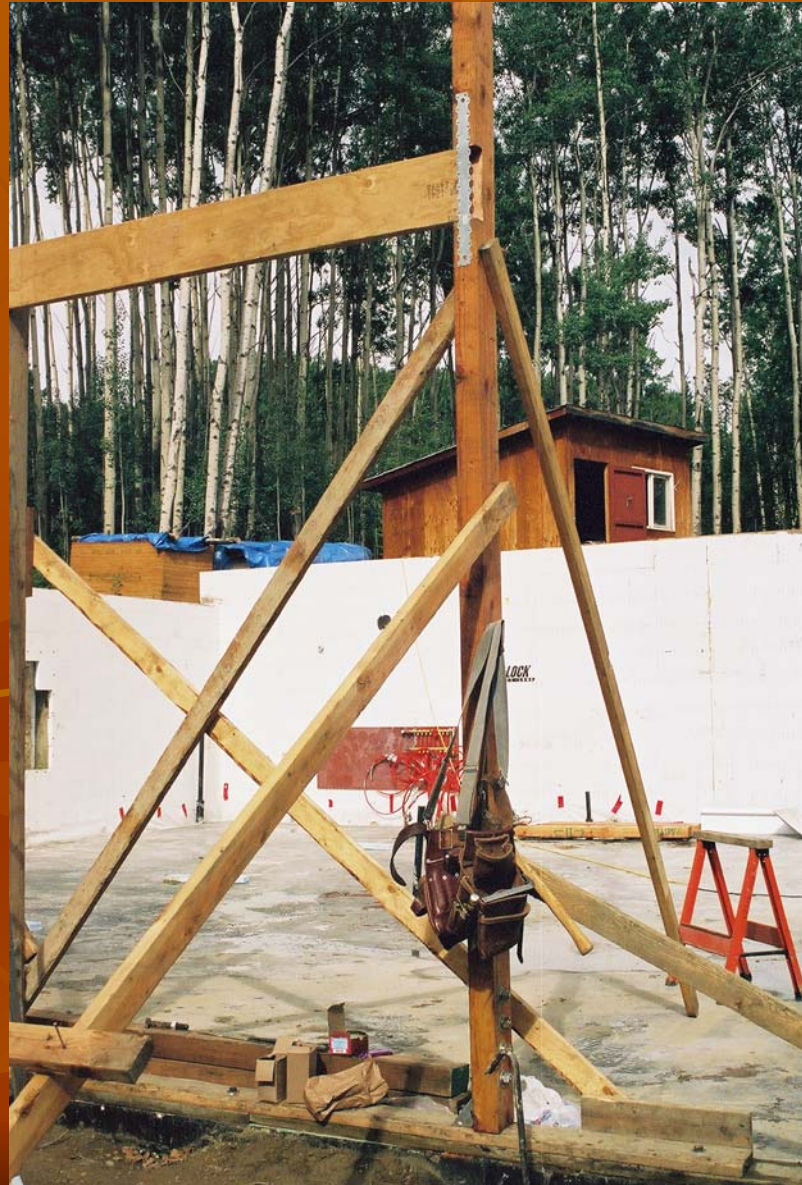
The framing is done with 20' x 4" x 4" posts and
2" x 12" Glulamstm.

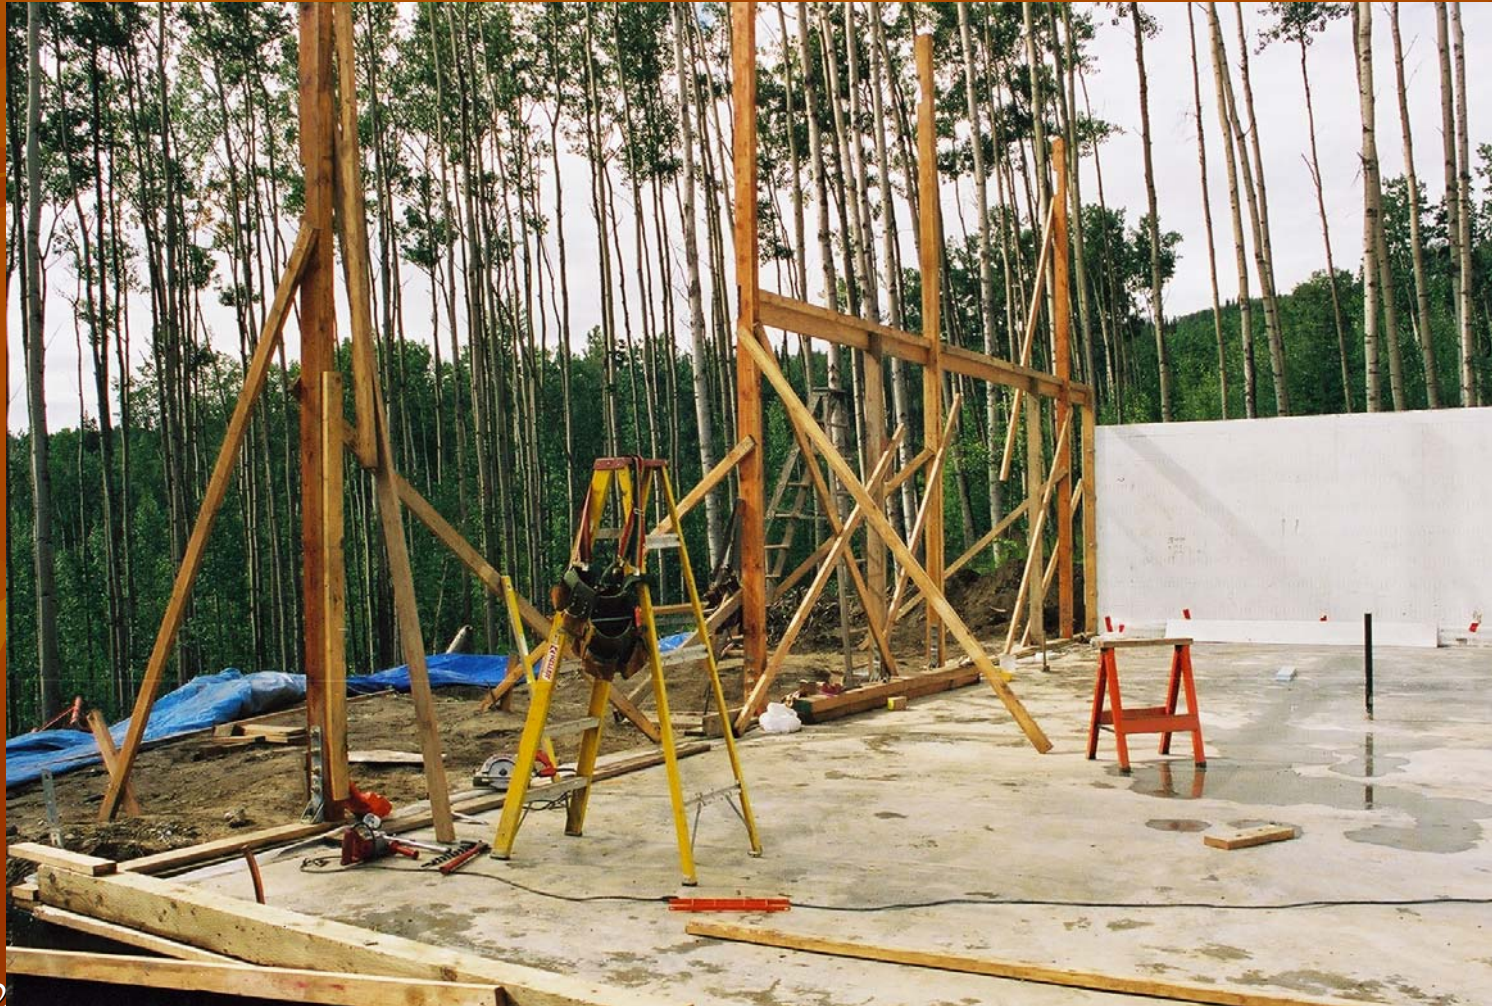
This shows the south wall in the basement. The west and north walls are from concrete filled foam forms. The framing is of 4" x 4"s and 2" x 12" Glulams™. The slab contains hot water radiant heating tubes.

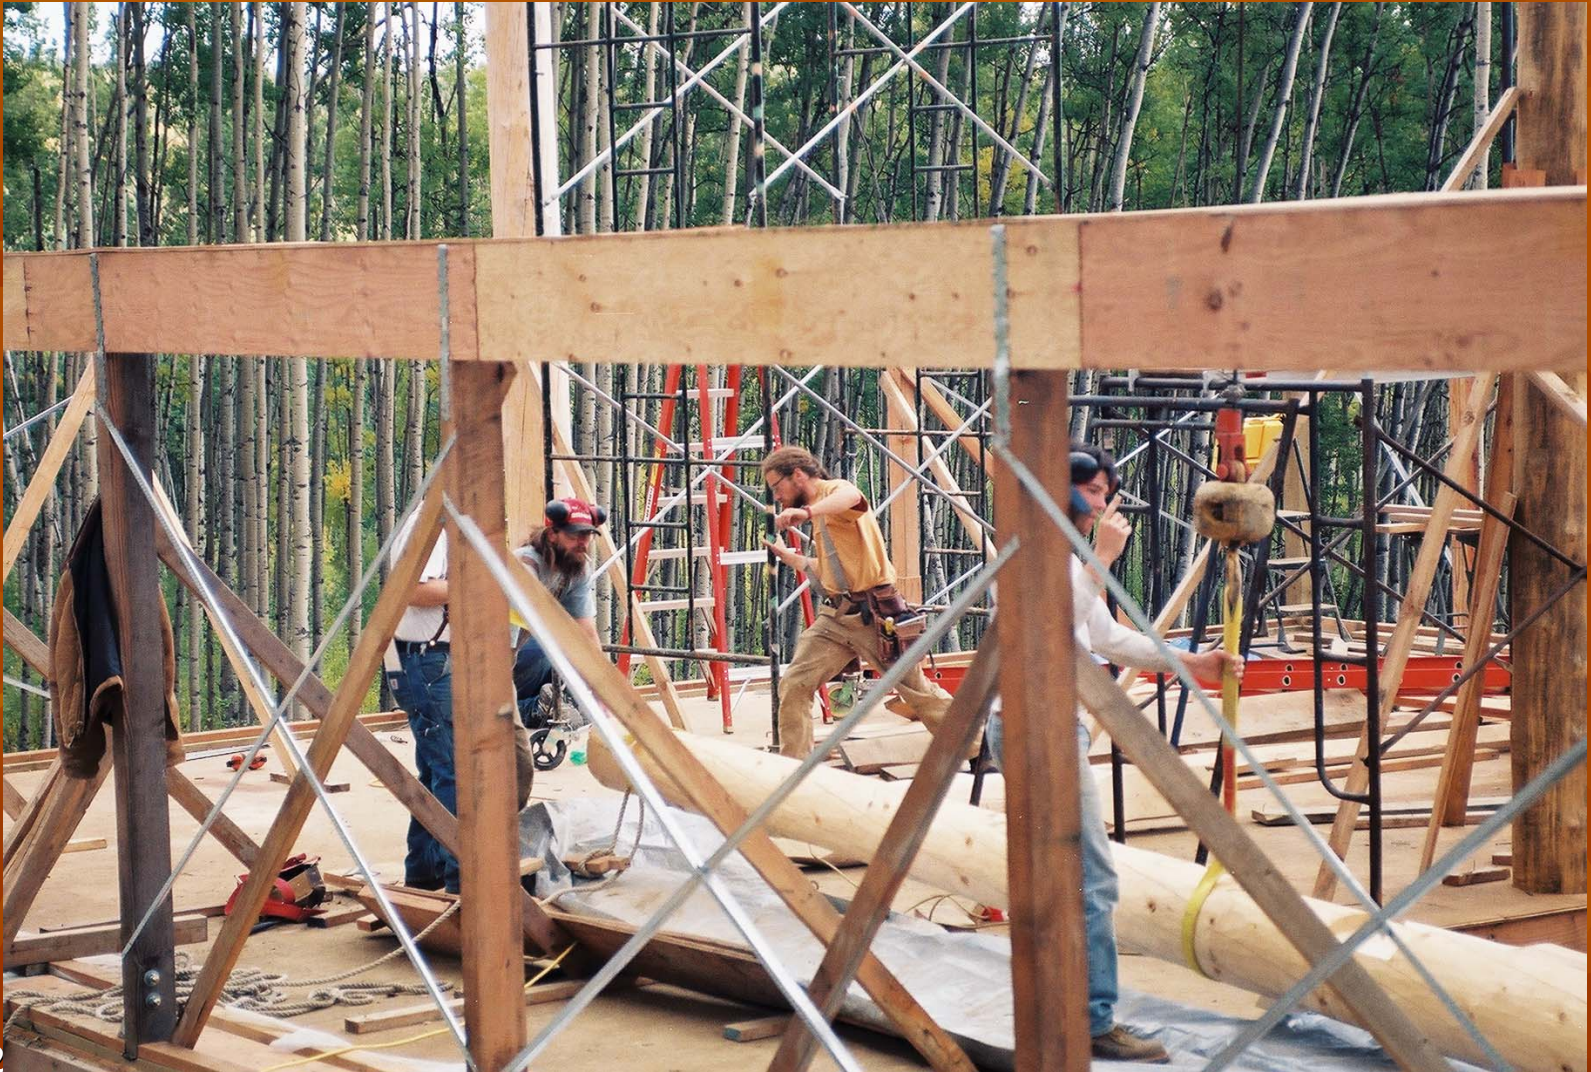
This framing is in the north wall on the first floor. Notice the Simpson ties and strapping. The west roof support post is being raised

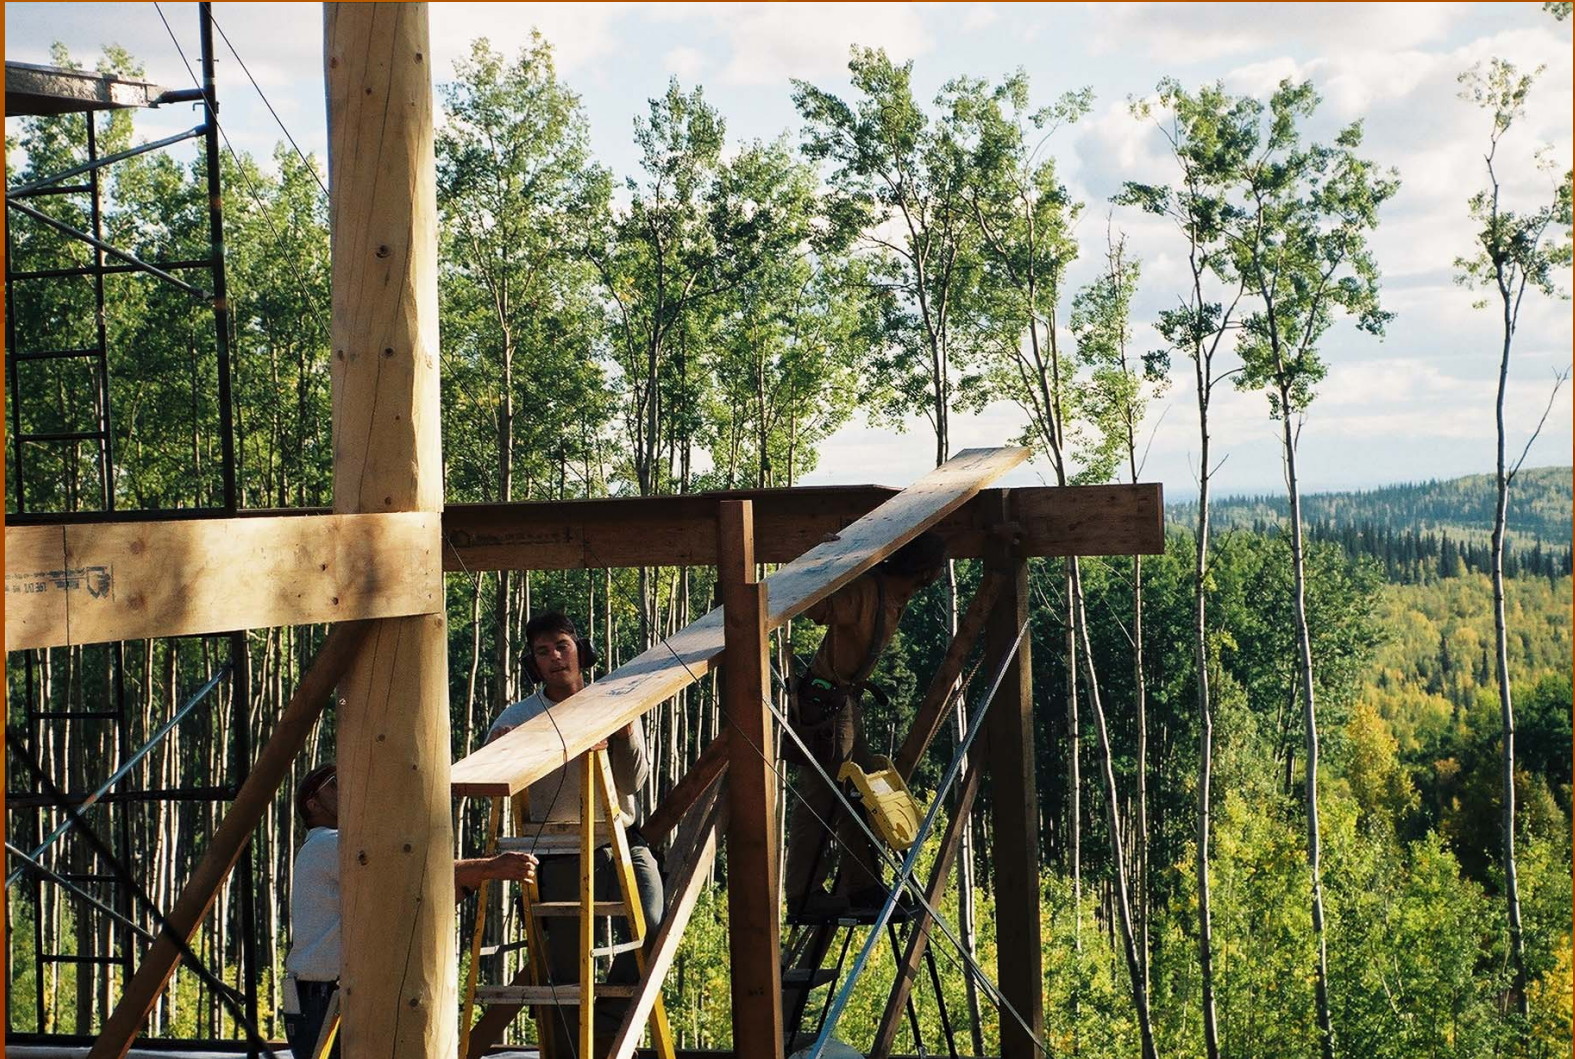
The post is tied to the wall system using rabbit joints, dado joints, and metal.

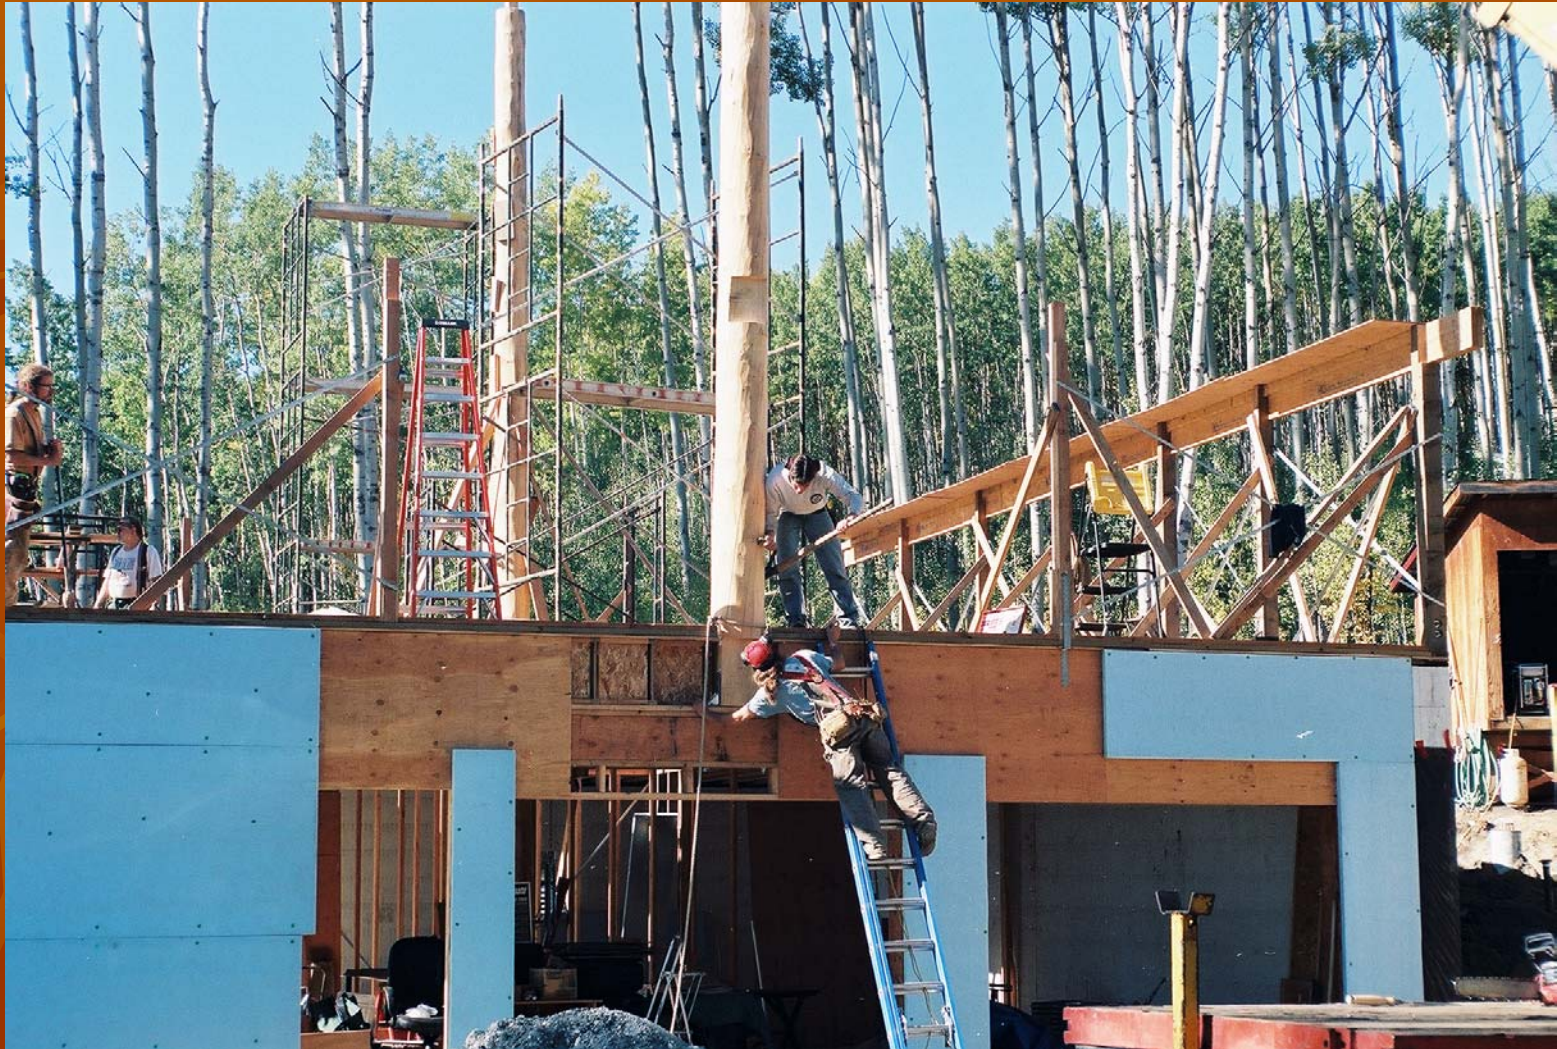
The east post is set into the cradle made of Simpson #10's bolted through 12" x 12" Glulams™ with 7/8" diameter bolts.

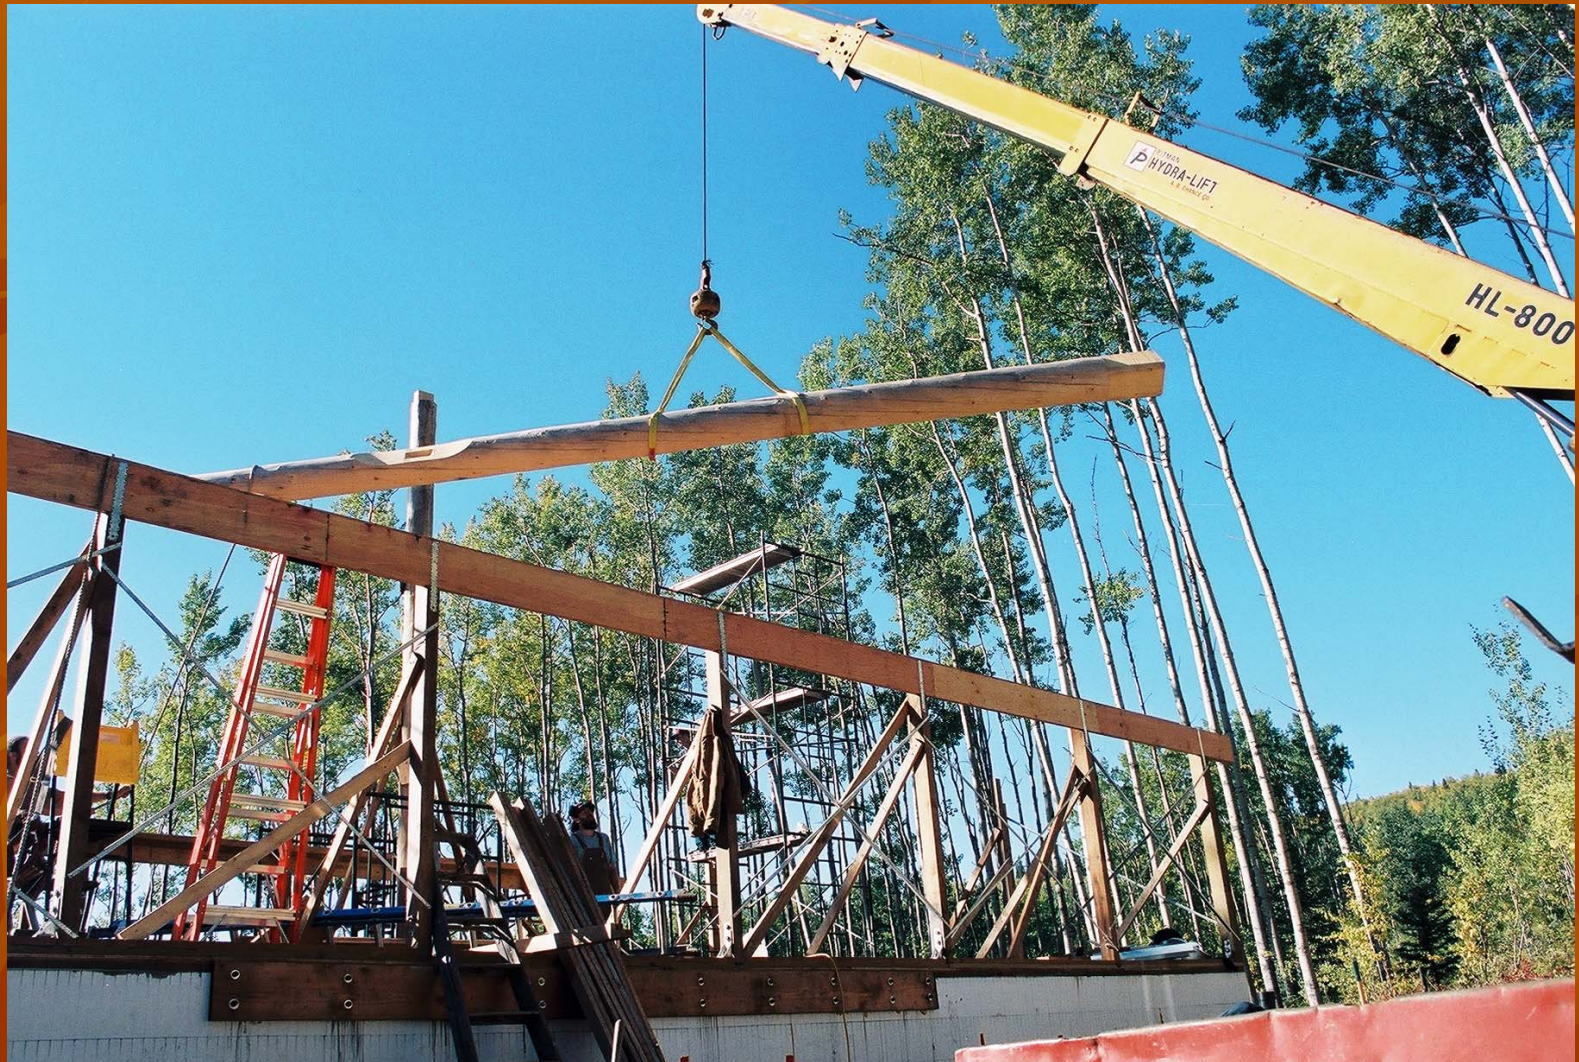
The west pole is being raised. The Simpson ties and strapping can be seen on the north wall.
