Straw Bale Building In Alaska

A CCHRC Presentation

FOUR NON LOAD BEARING HOMES AND A
LOAD BEARING GARAGE IN THE
FAIRBANKS AREA

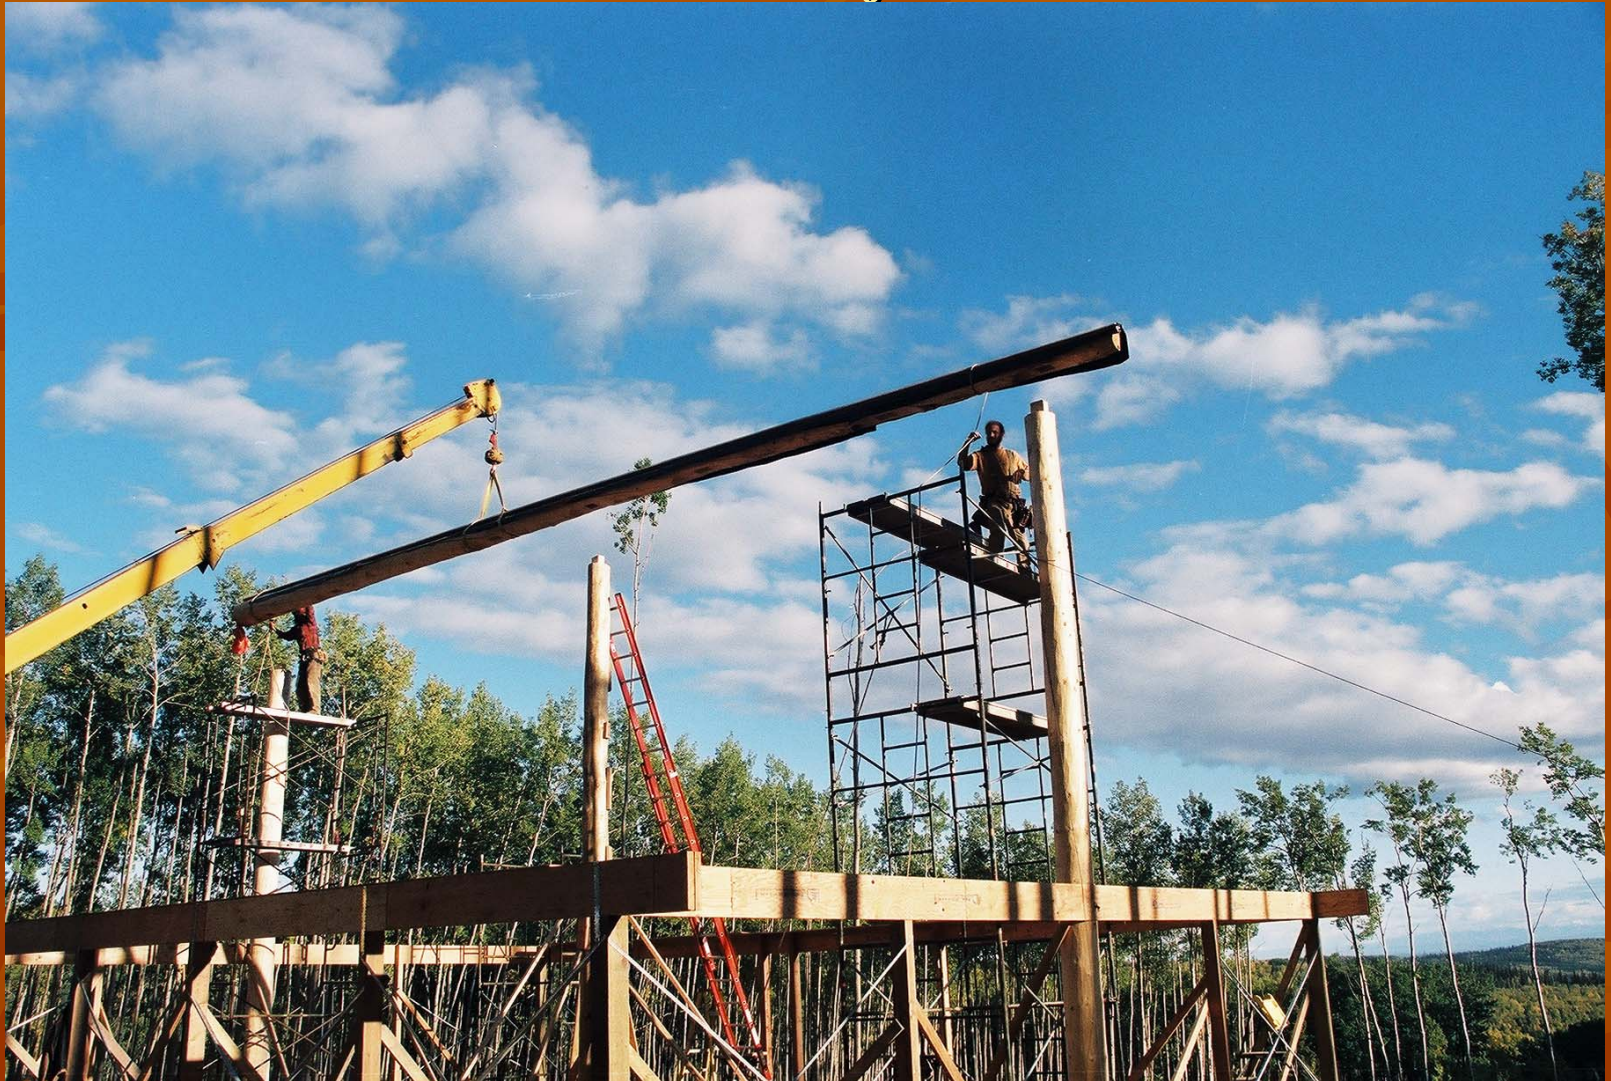
The 52' ridge pole is lowered into place. Notice the mortise and tenon joints.

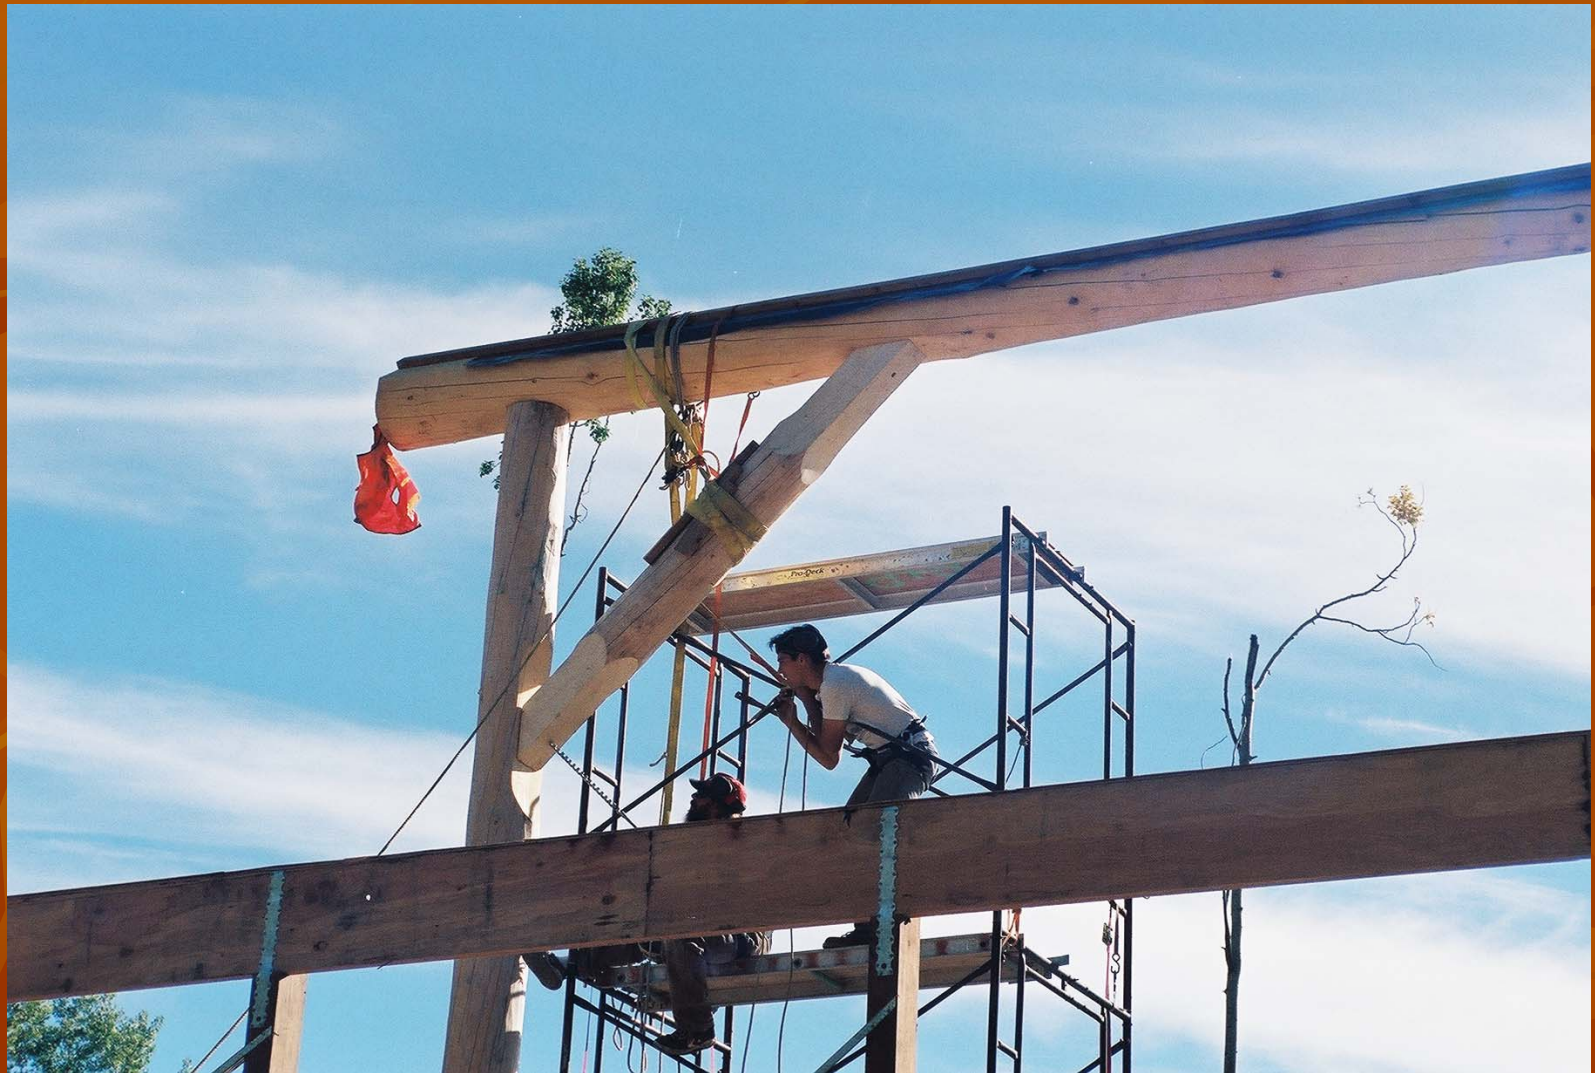
**The diagonal braces are being installed on the ridge pole.
They are bolted through the joints with all thread.**

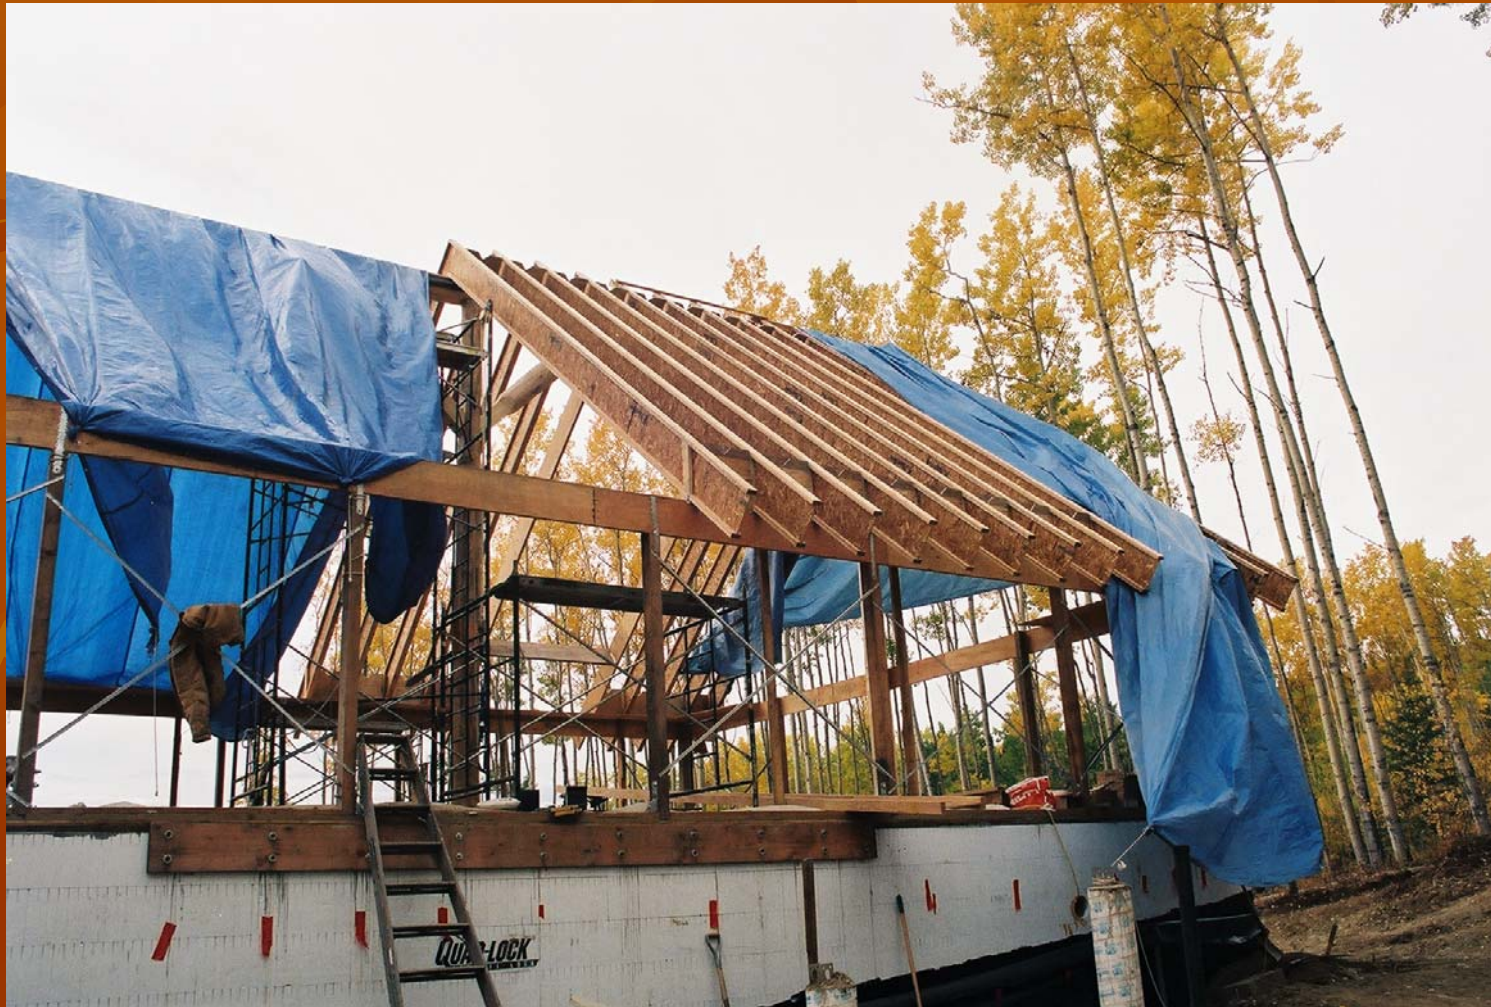
**It took three people and a block and tackle to raise the 16”
“I” joists for the roof. The blue tarp protected them
from rain**

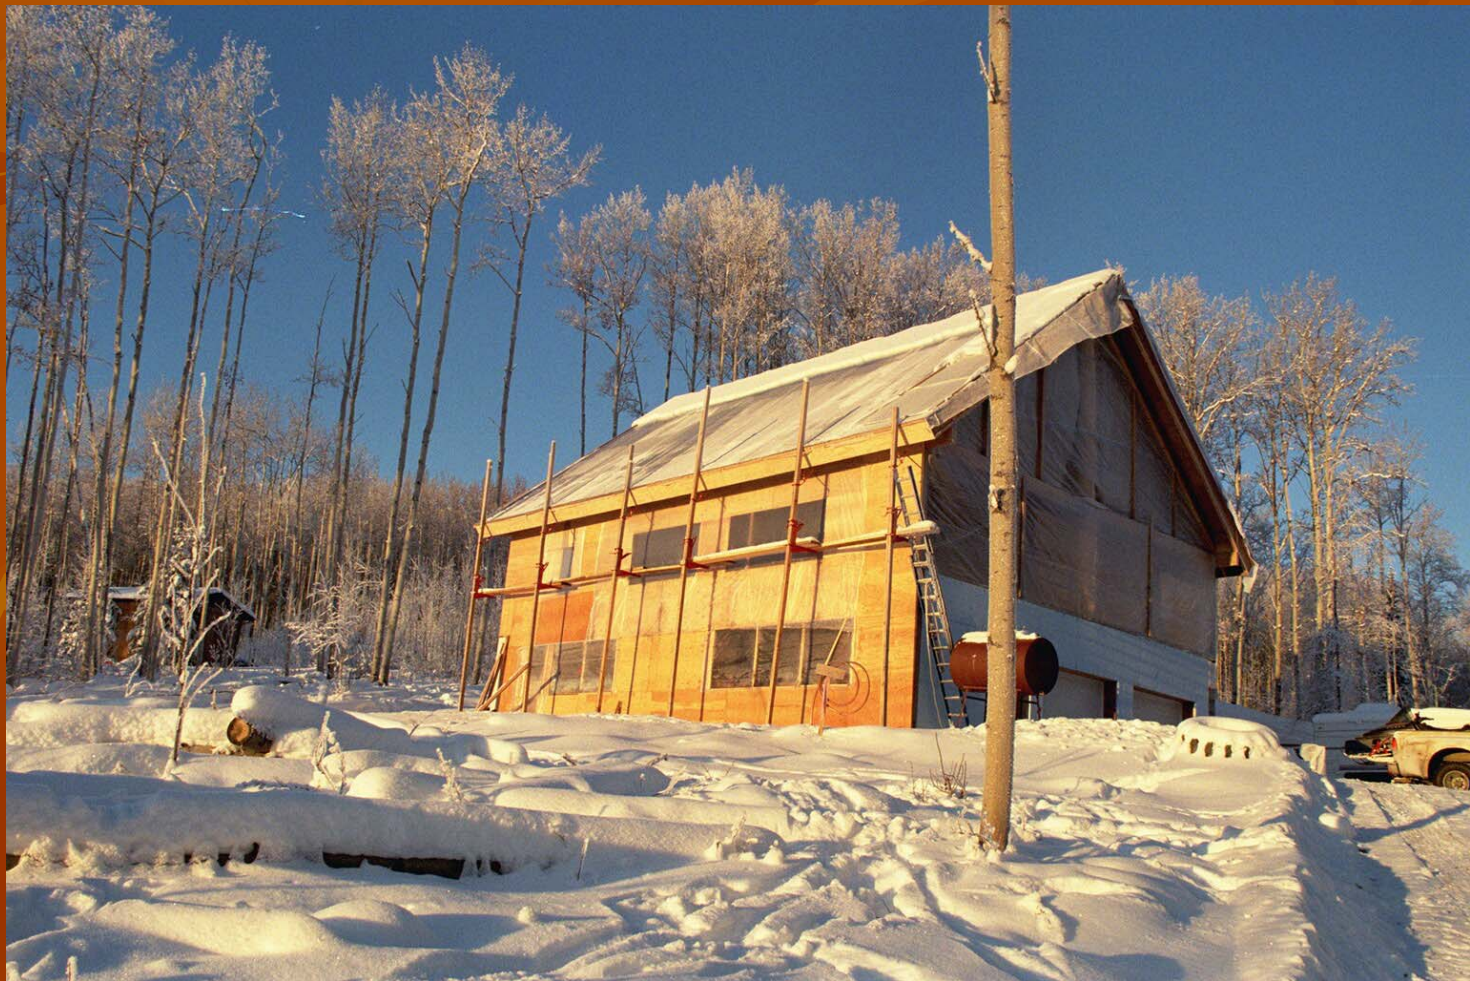
Closed in for the winter, the South face is sheeted with plywood for shear strength because of the many openings for windows and for the large 8' patio doors. Straw was stacked all during the winter.

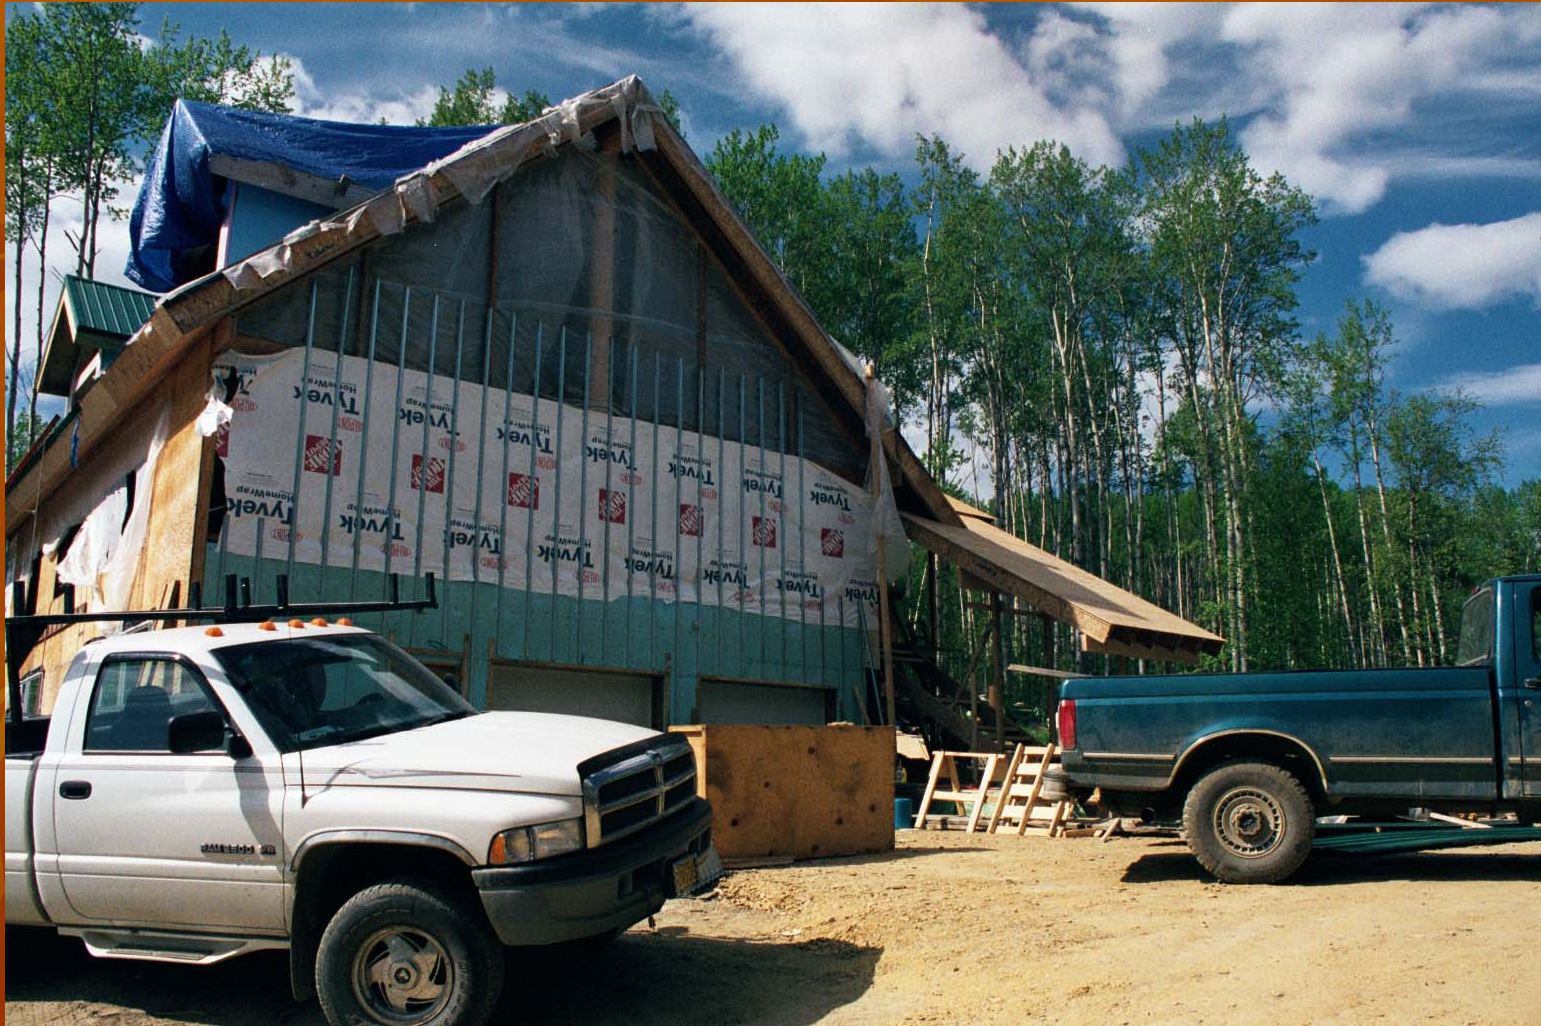
Steel hat channel is run vertically for attaching the siding to the wall with Tyvek underneath. The garage wall is a 2" x 6" framed wall with 2" of blue foam on the outside.

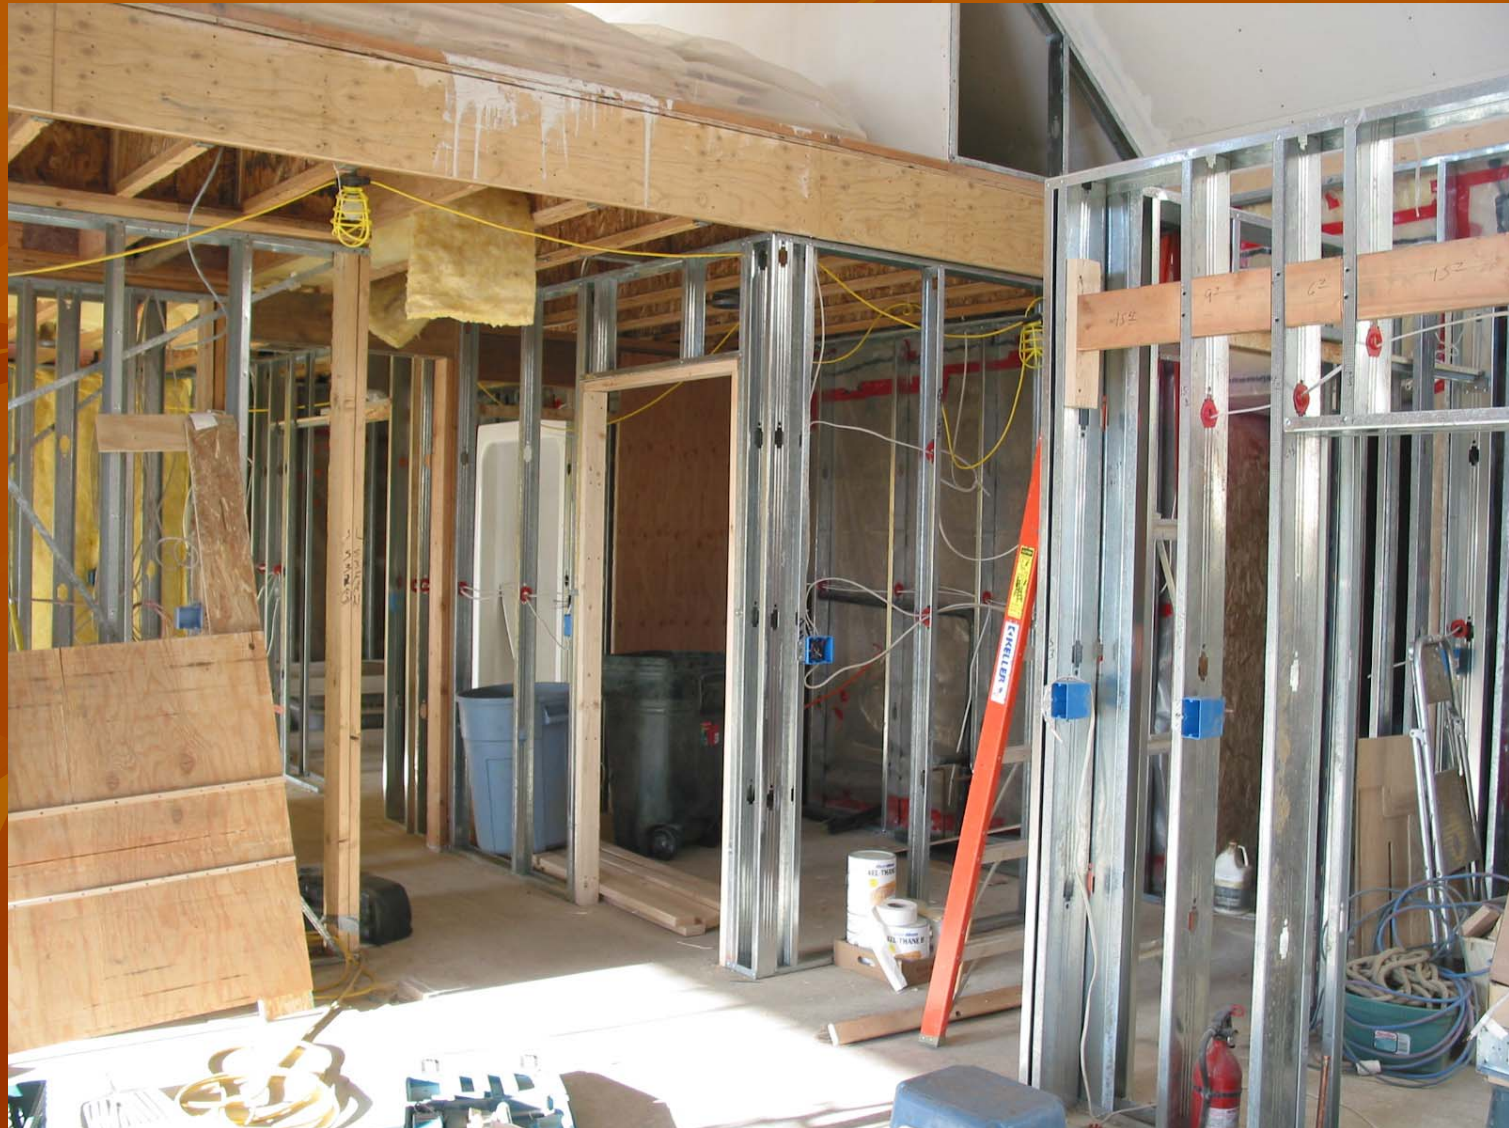
Most of the inside walls are framed with steel.

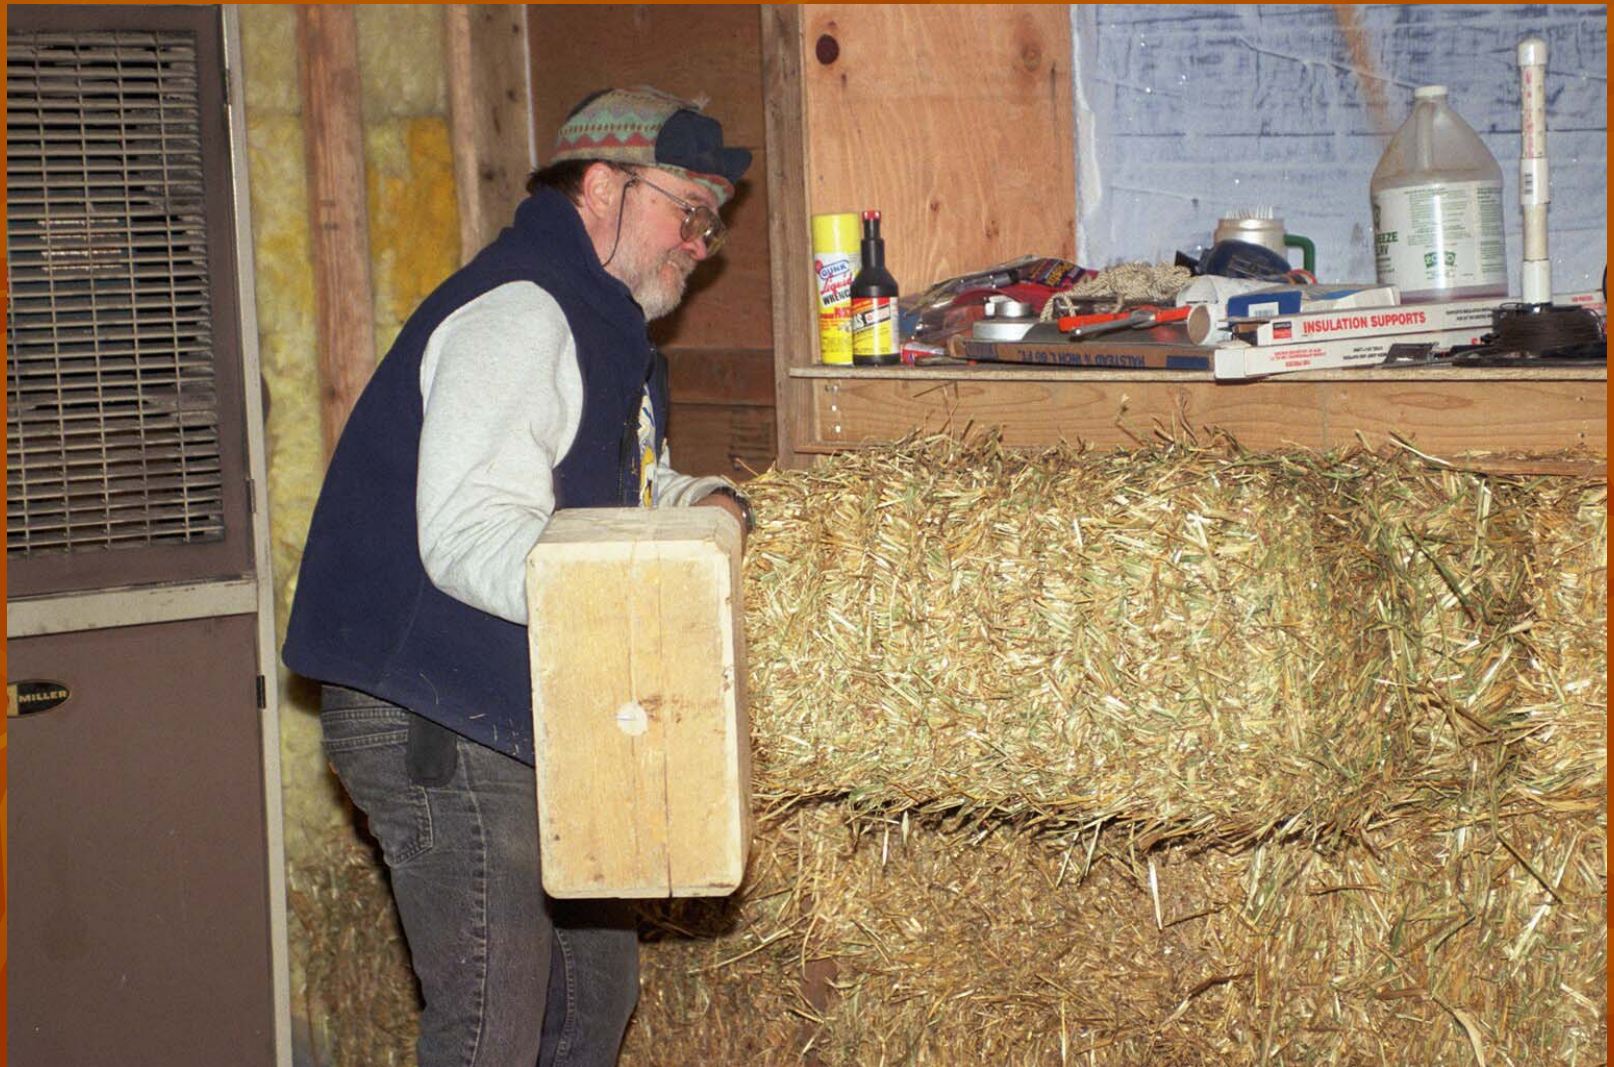
Gerald uses the Bonker to move the straw into place. It is best to trim and make adjustments when each bale is added.

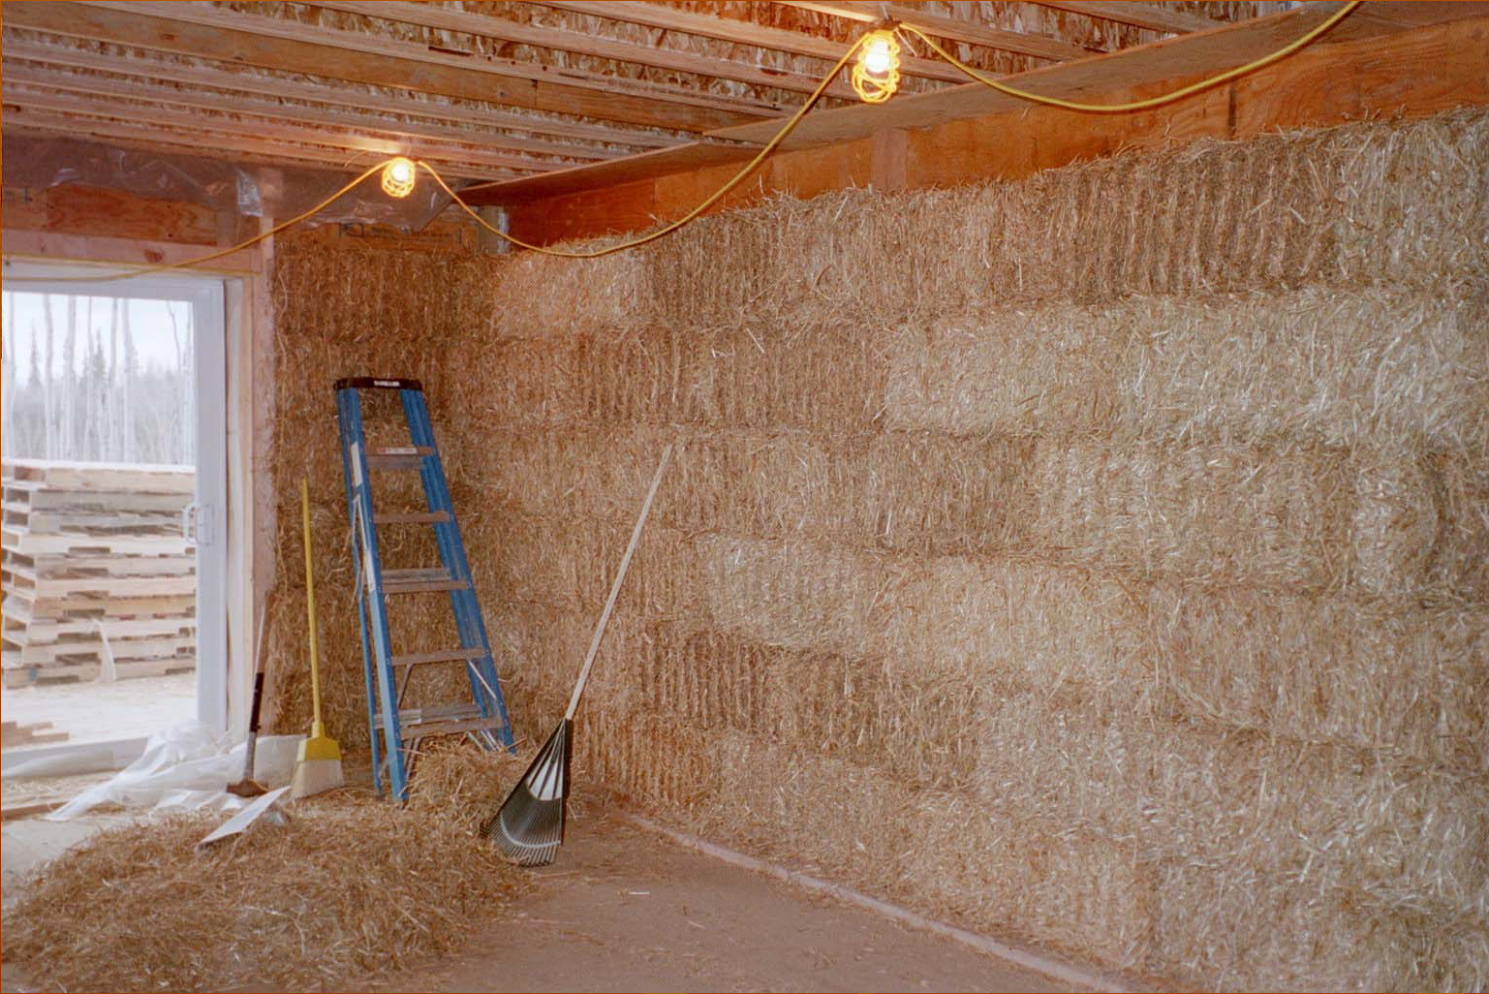
Straw is stacked in the master bedroom on the west wall. Notice the plywood ledge above the straw which is used as a fire block and helps to insulate between the “I” joist.

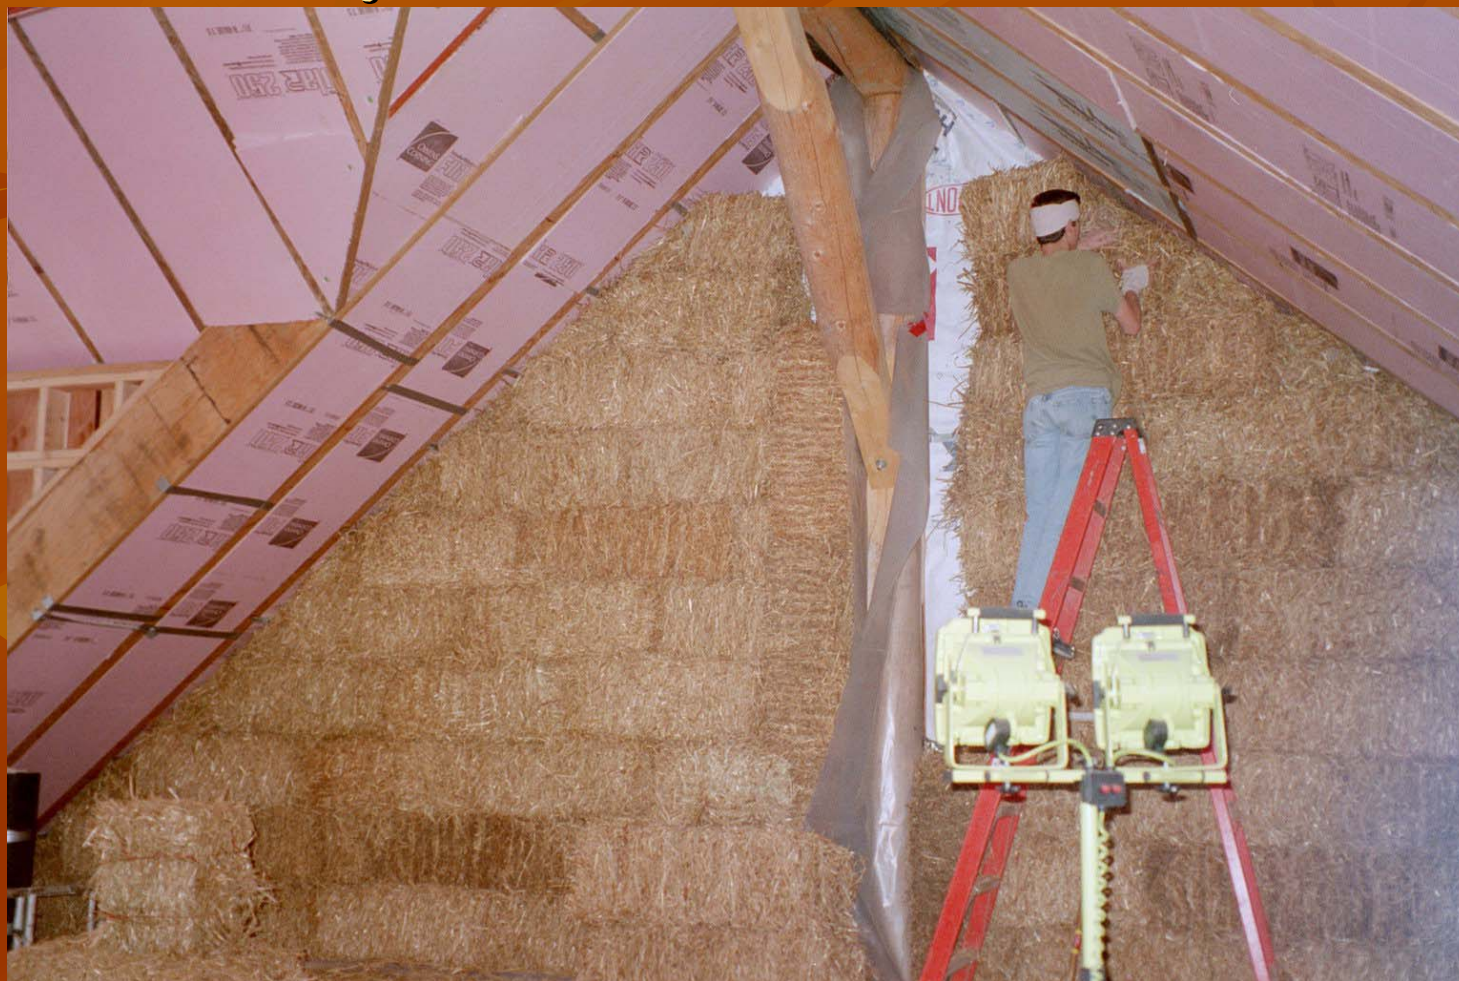
This shows detail in the ceiling. There is 12" (R-38) fiberglass between the webs, then 1" foam is placed between the flanges. Mathew is stuffing straw into the triangular space formed at the junction of the roof and straw.

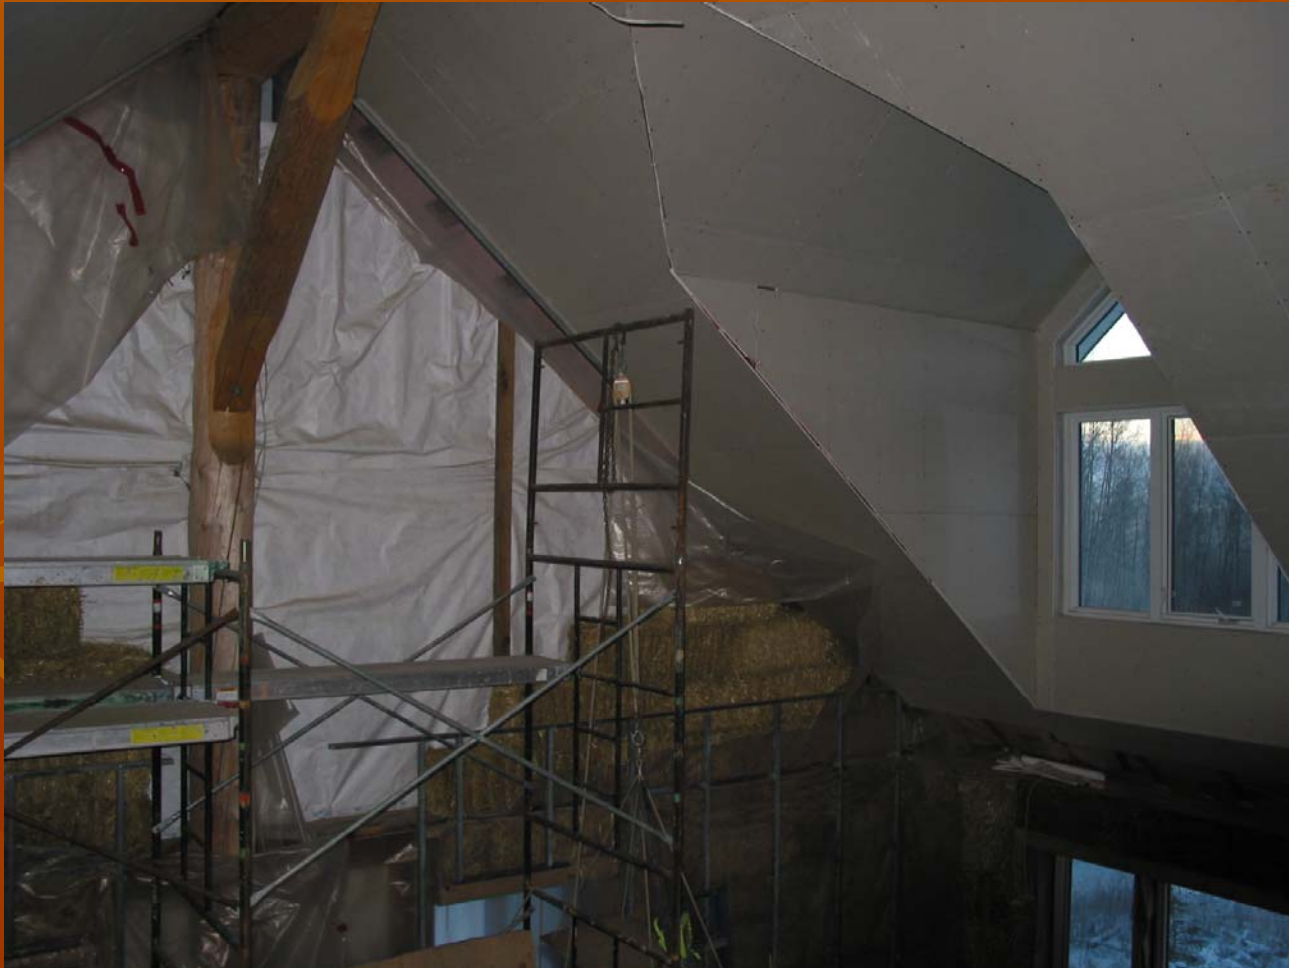
Bales are stacked for the 21' east wall using scaffolding and a block and tackle . Notice the visqueen tabs which are part of the continuous air/vapor retarder system.

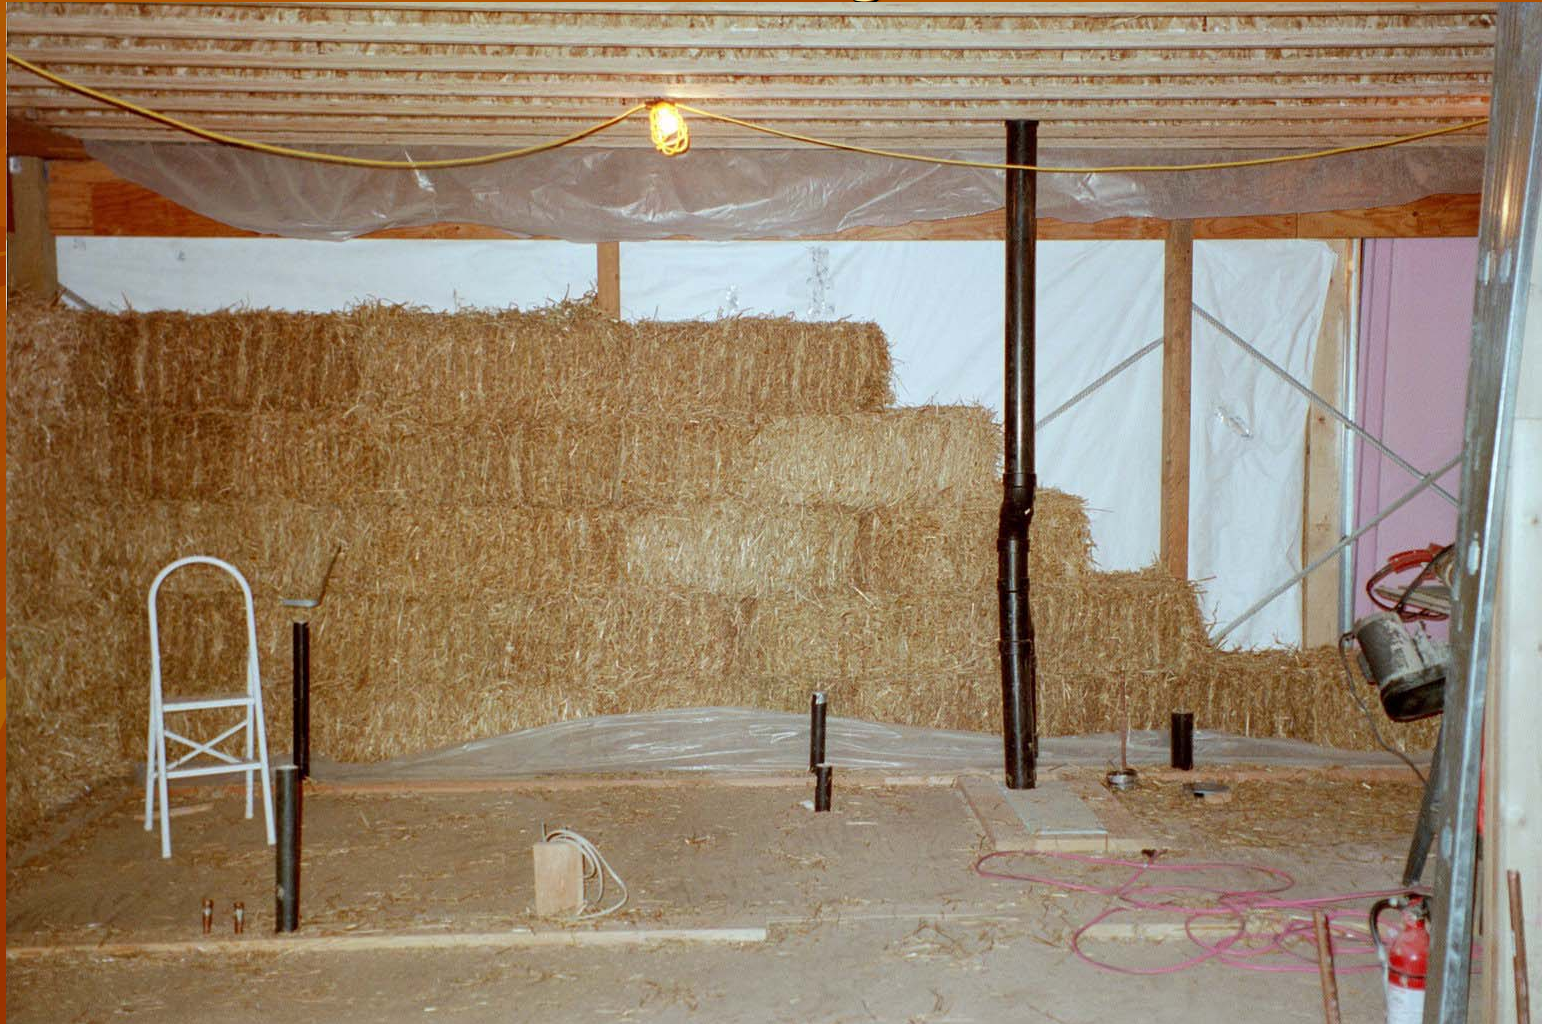
Straw is stacked in the north wall master bathroom. The 1 1/2" ledge allows for pouring the Gypcrete floor over radiant heating tubes.

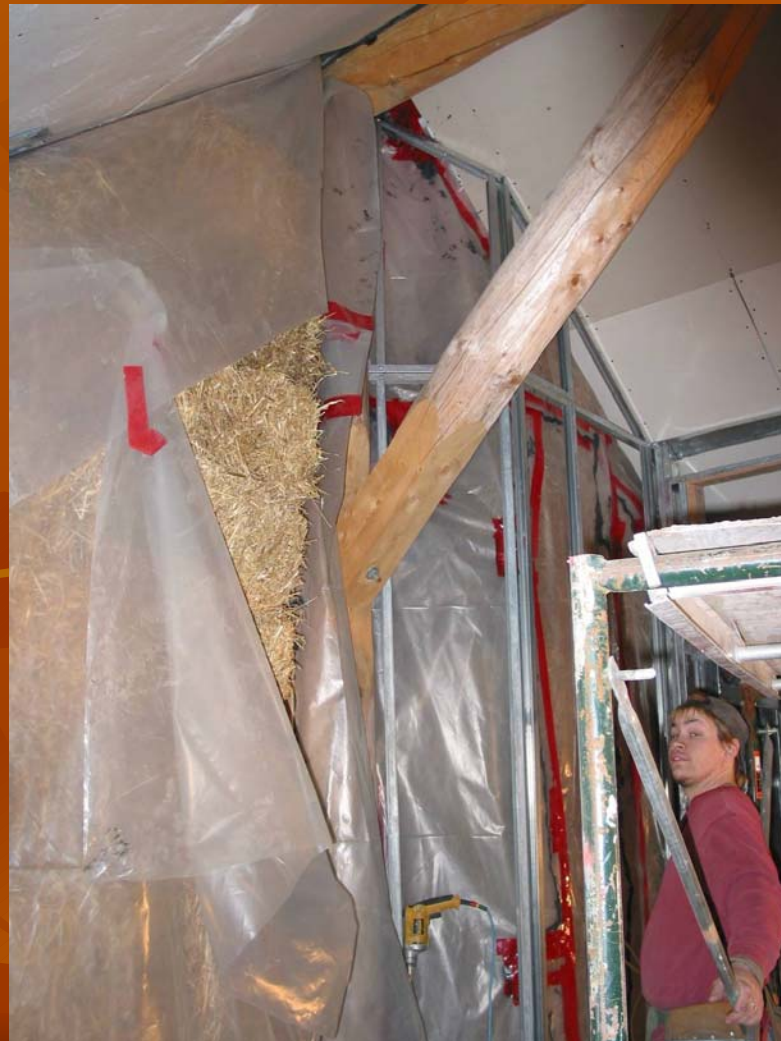
The alcove around the post on the east wall is being framed. The space was filled with cellulose insulation which worked a lot better than trying to cut the bales to fit.

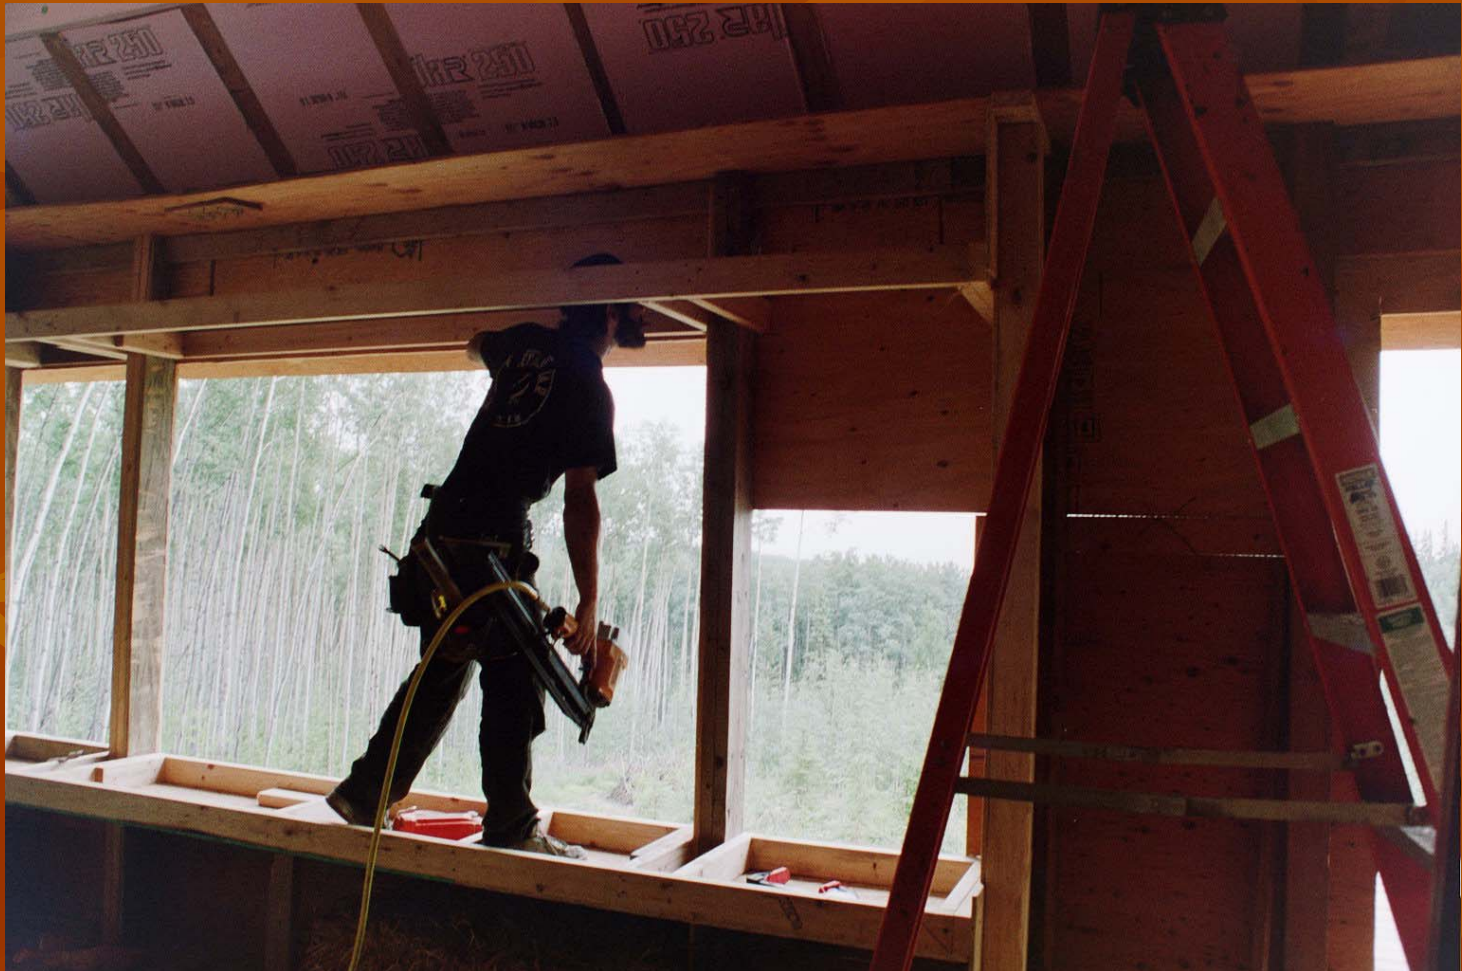
The “window bucks”, as they are called in the straw bale community, are being framed. The cavity is filled with straw and capped with OSB. The ledge on top of the Glulam™ was also filled with cellulose.

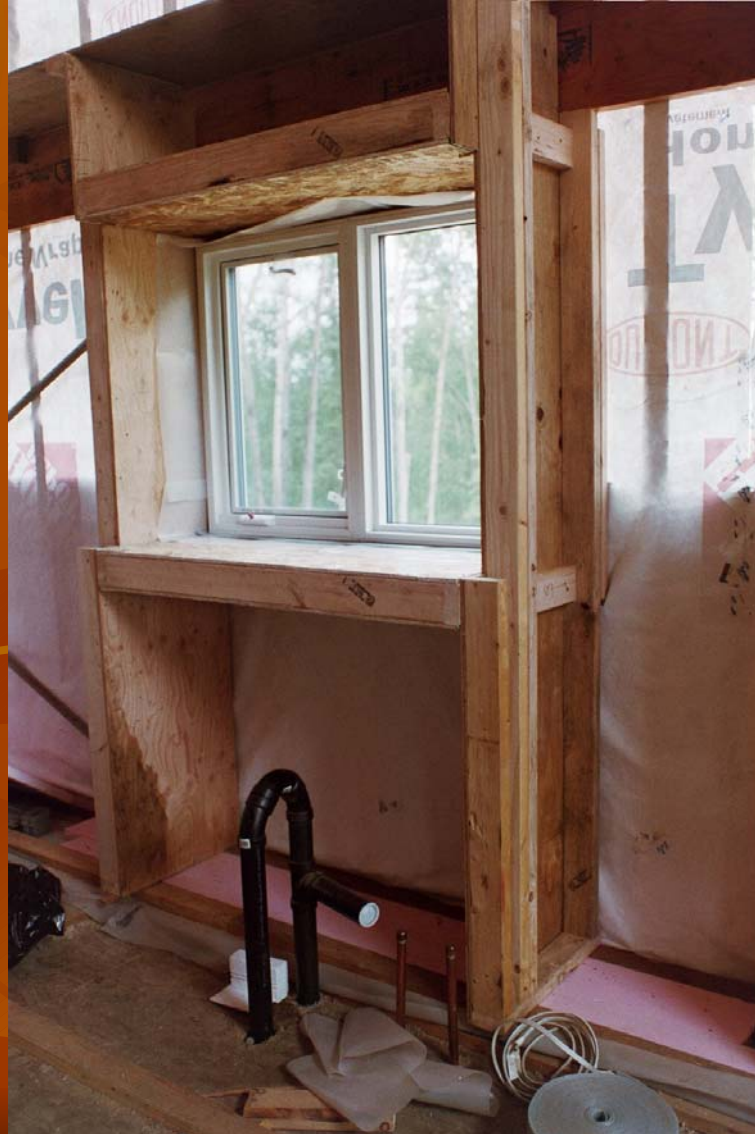
Window bucks on the east wall also serve as structural members to support the Glulams™.

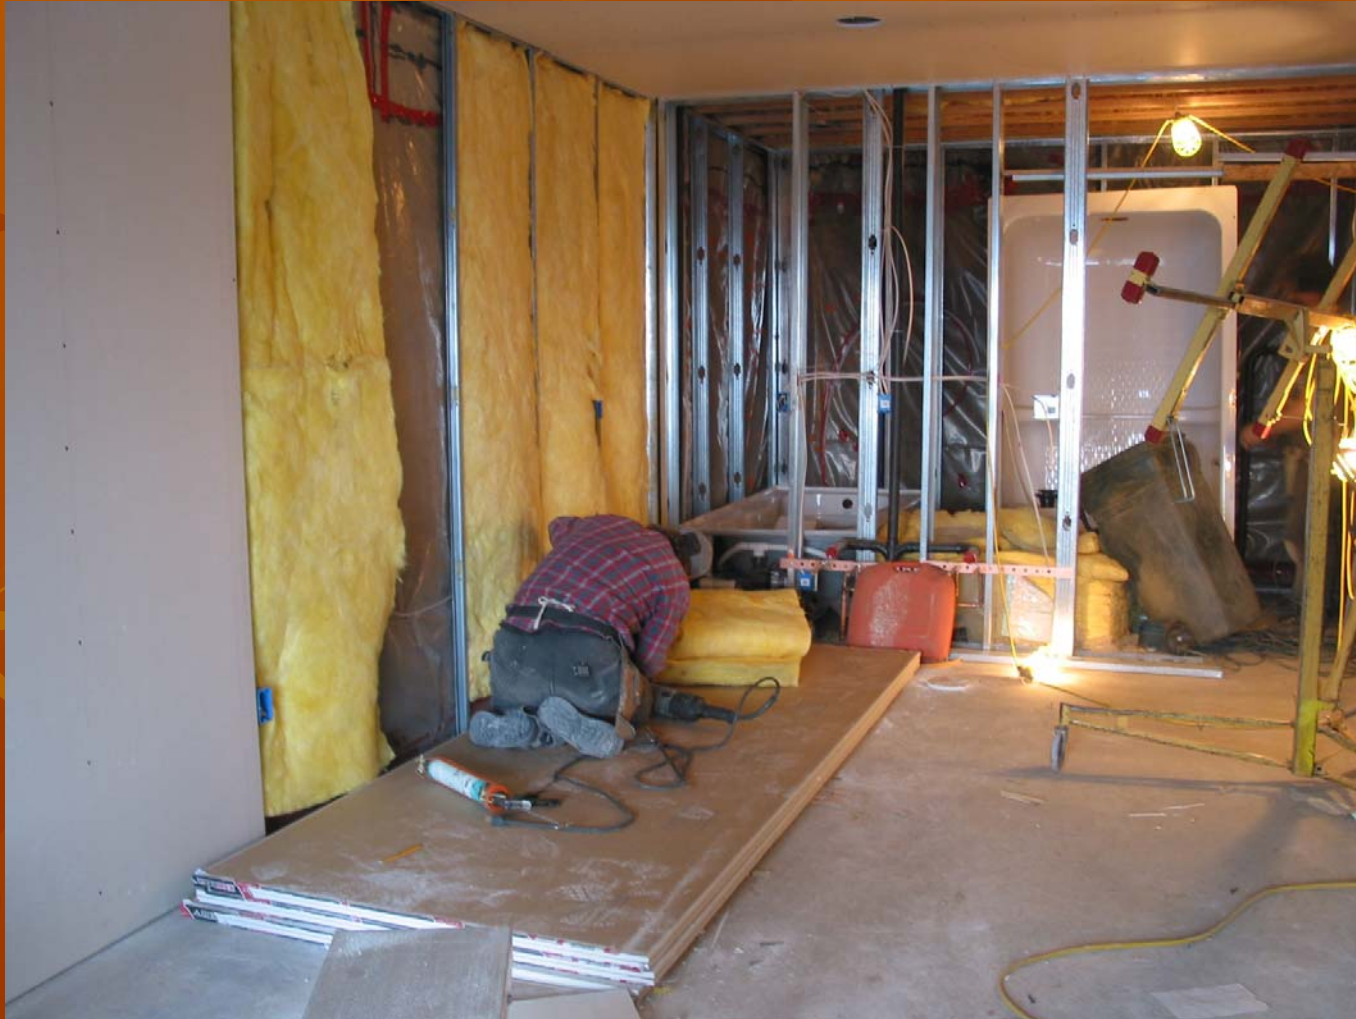
The gap between the 1 5/8" studs and the vapor retarder is filled with sound bats to eliminate convection loops in the wall.

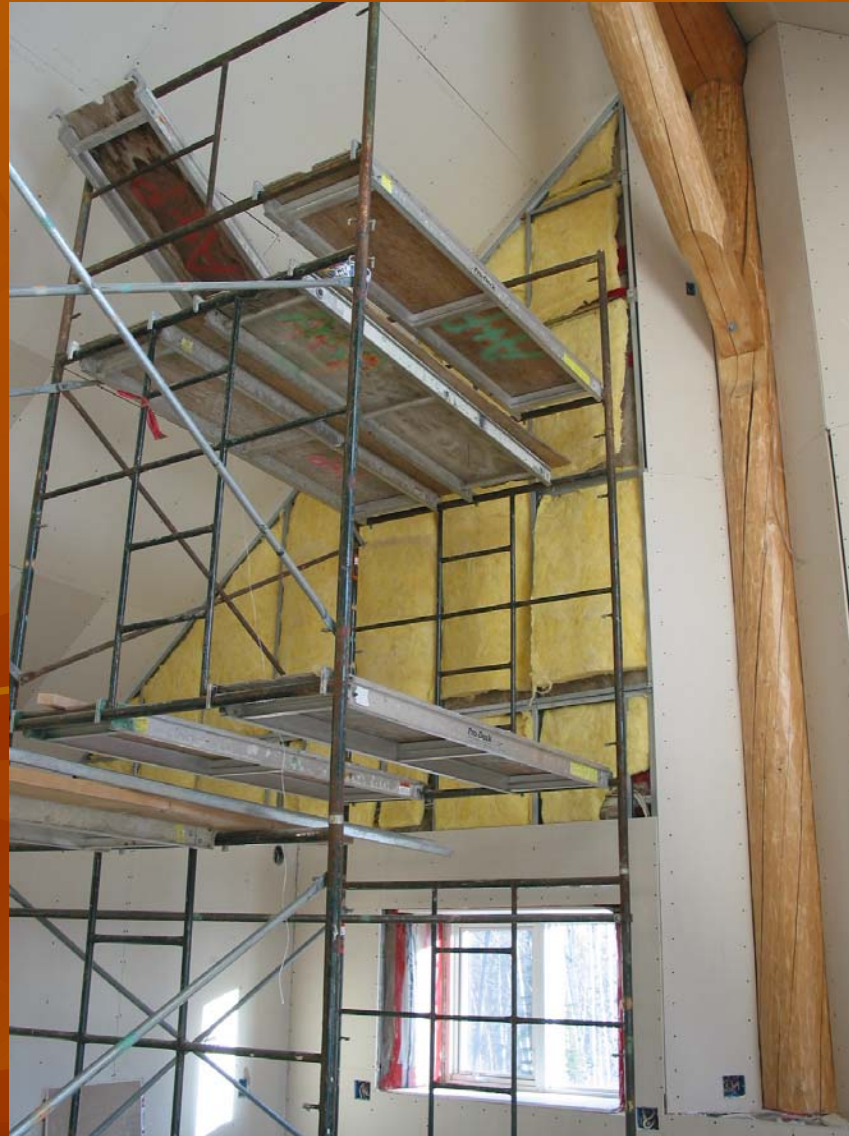
The east end is being sheet rocked. The alcove cavity was densely packed with cellulose after the rock was in place.
