Straw Bale Building In Alaska

A CCHRC Presentation

FOUR NON LOAD BEARING HOMES AND A
LOAD BEARING GARAGE IN THE
FAIRBANKS AREA

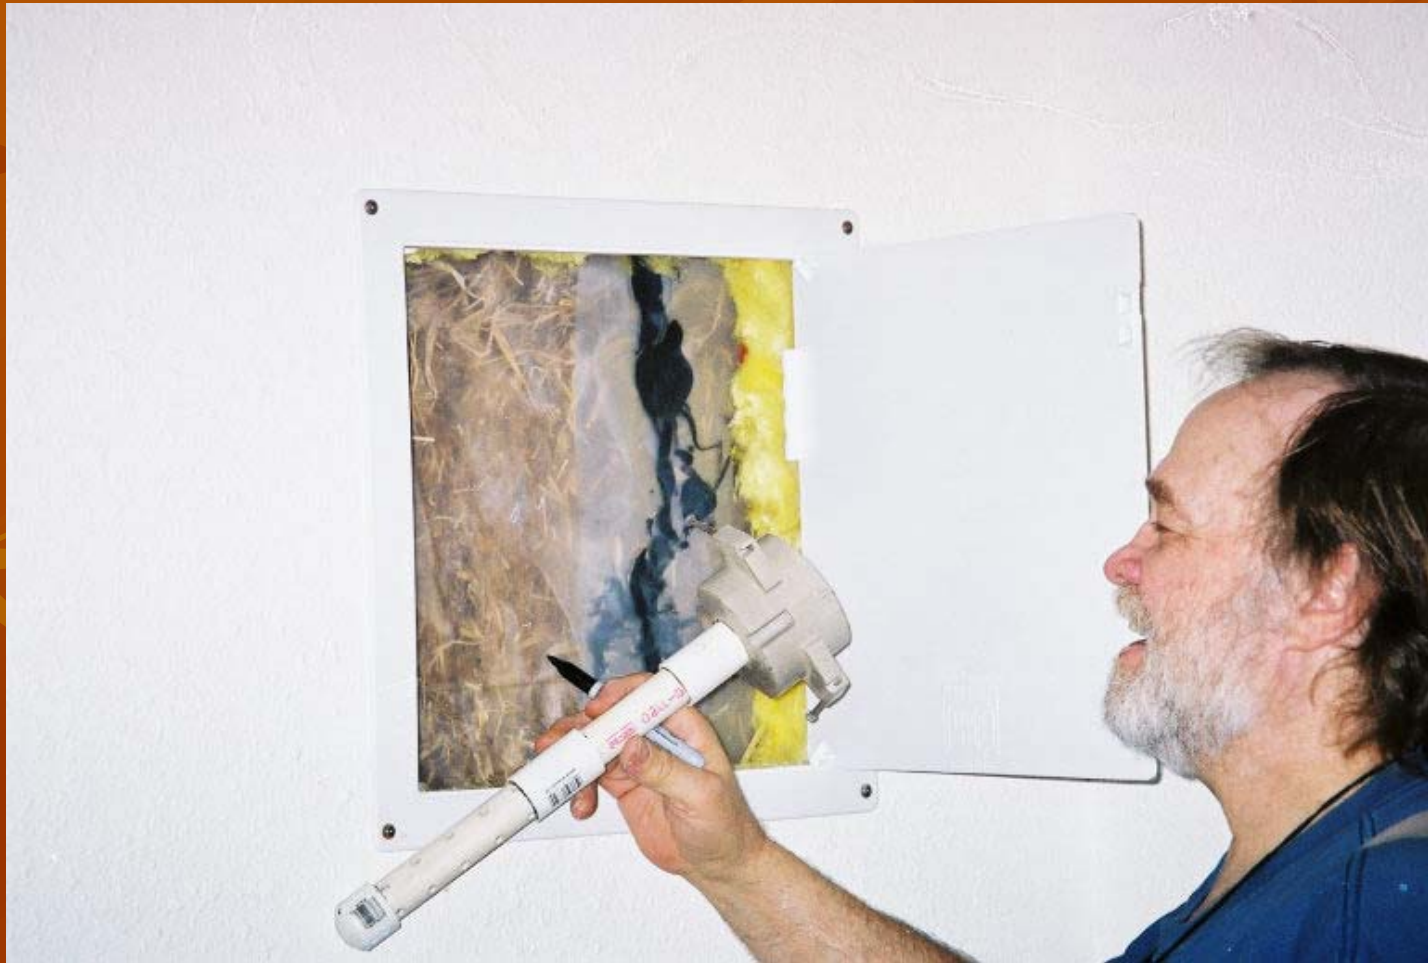
The truth window and the home made moisture meter were placed in the wall along with a hobo sensor. The hobo measures the temperature and humidity on the outside, middle, and the inside of the bales.

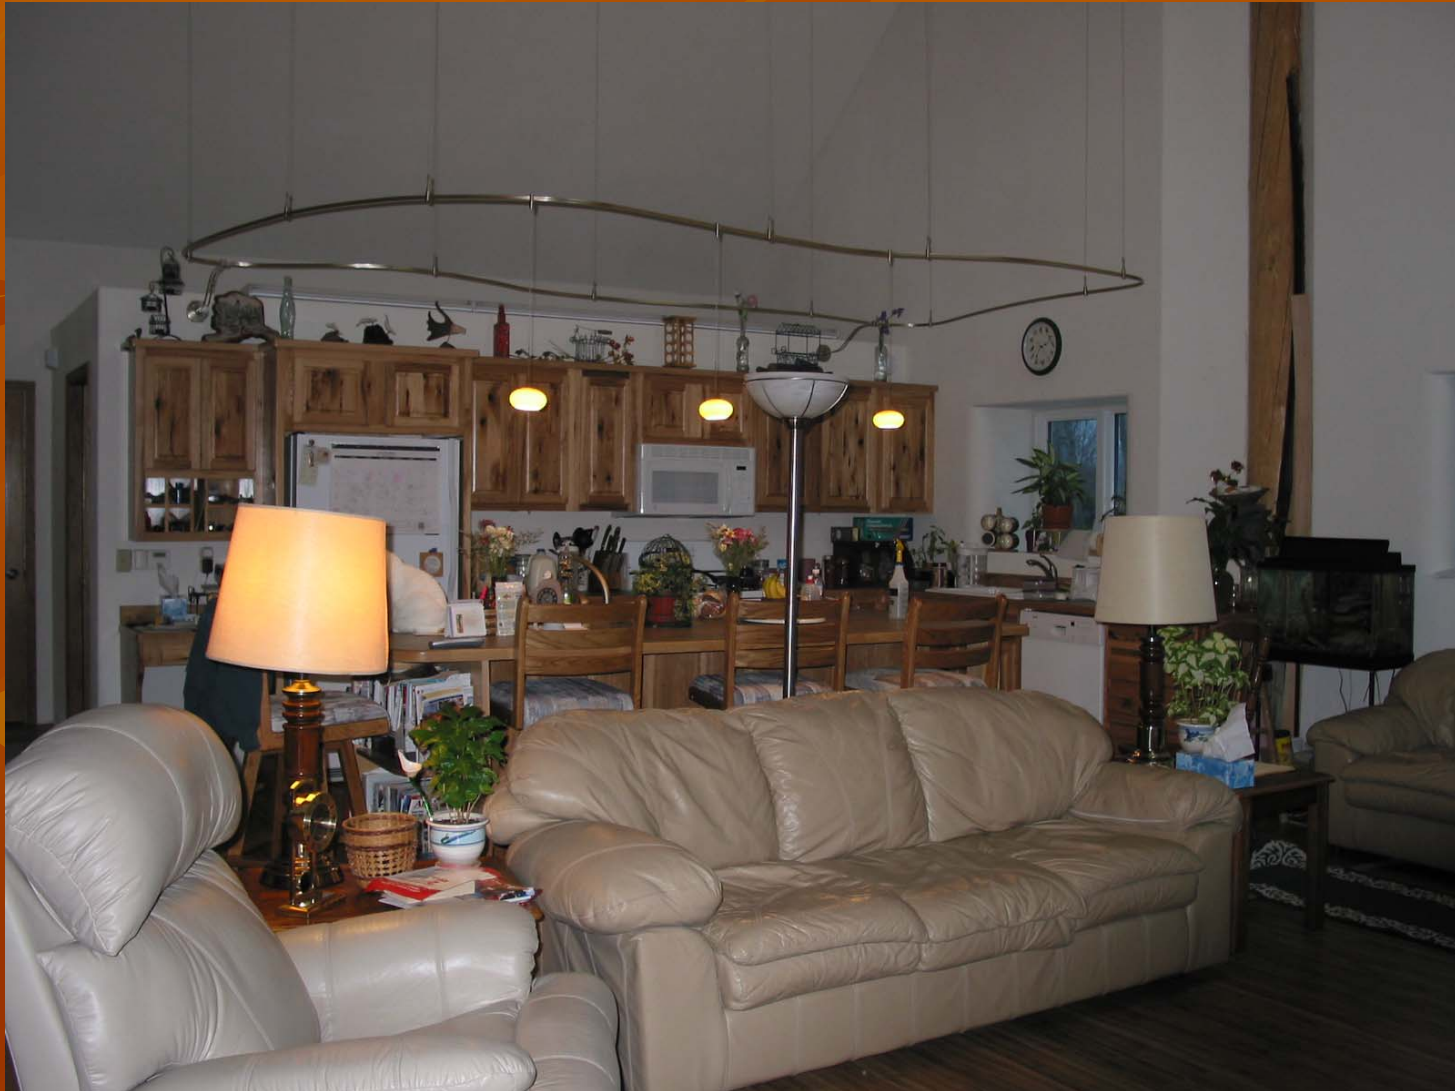
The finished living room, kitchen, and pantry (behind the kitchen wall) use 12v tech lighting with halogen bulbs.

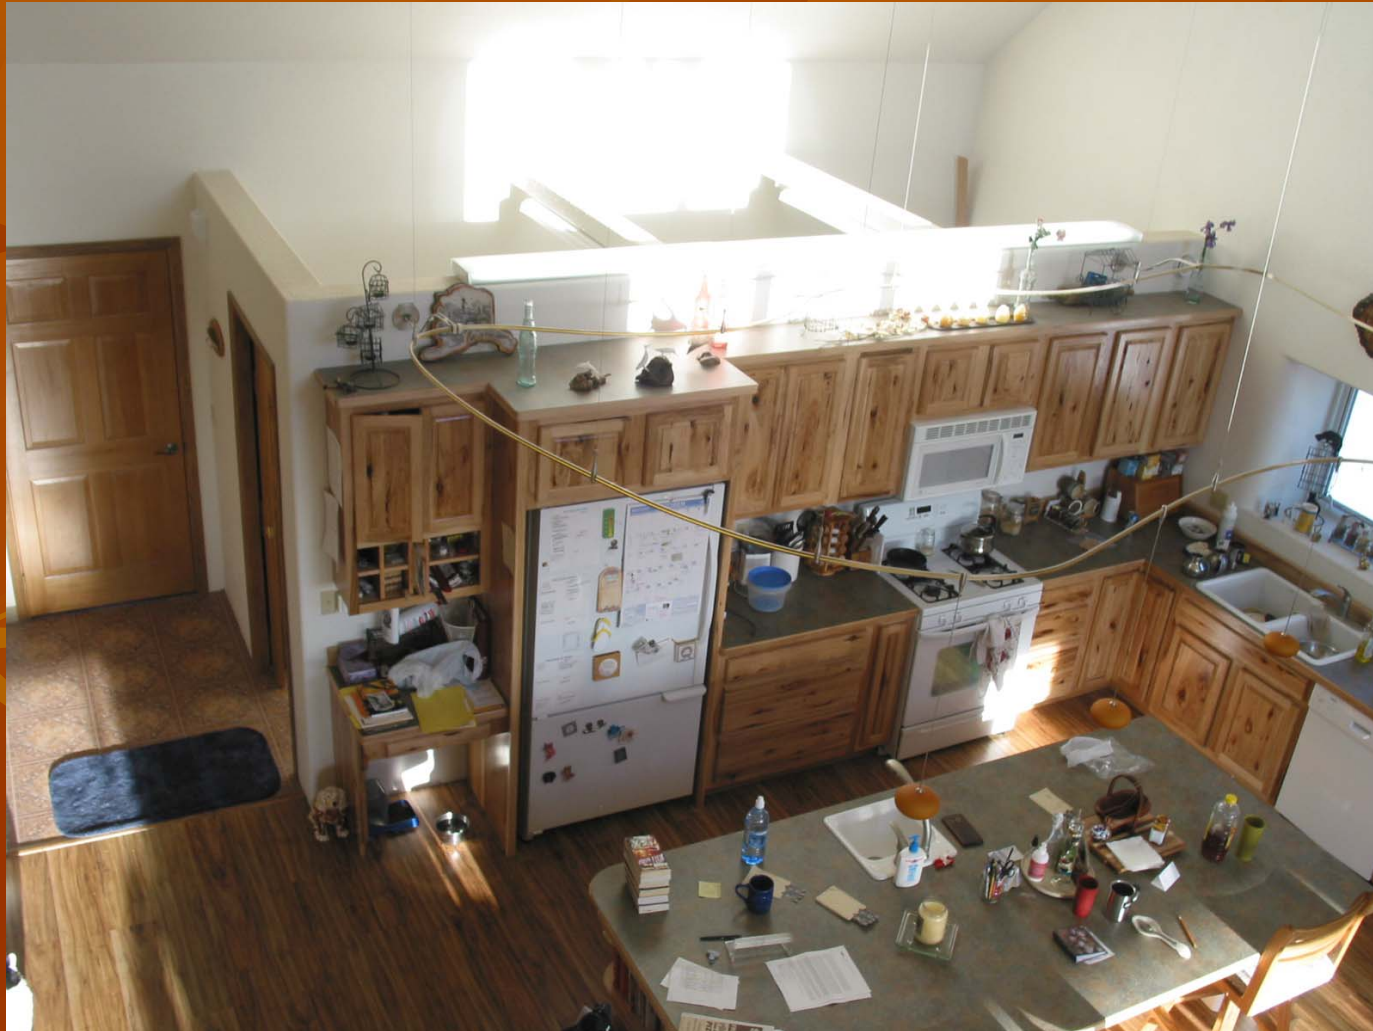
The sun shines on the north ceiling in December and illuminates the pantry and kitchen with natural lighting. Notice the tops of the upper cabinets.
